Device **C515C-8E**
Marking/Step **Step BC**
Package **P-MQFP-80**

This Errata Sheet describes the deviations from the current user documentation.

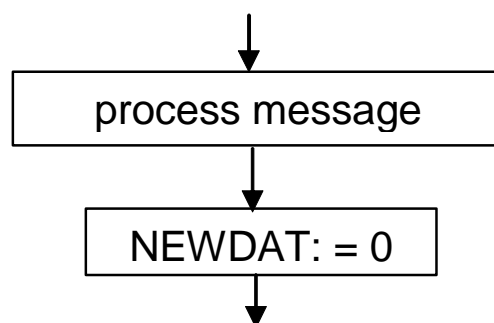
CAN.4: Flowchart sequence in figure in User's Manual regarding Micro-controller handling of the Last Message Object is partly incorrect

For the software flowchart figure 6-48 in User's Manual 11.97, the correct would be to first 'process message contents' and then to 'clear bit NEWDAT'.

This correction will be updated to the future versions of the User's Manuals.
