Device **C515C-8R,
C515C-L**

Marking/Step **Step AA**

Package **P-MQFP-80**

This Errata Sheet describes the deviations from the current user documentation. The module oriented classification and numbering system uses an ascending sequence over several derivatives, including already solved deviations. So gaps inside this enumeration can occur.

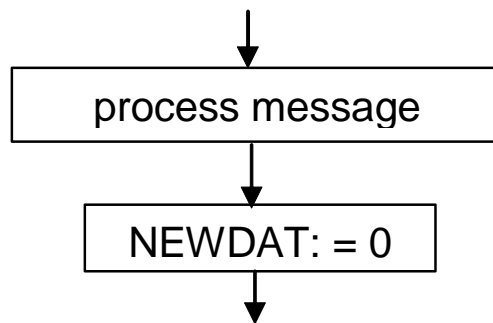
CAN.4: Flowchart sequence in figure in User's Manual regarding Micro-controller handling of the Last Message Object is partly incorrect

For the software flowchart figure 6-48 in User's Manual 11.97, the correct would be to first 'process message contents' and then to 'clear bit NEWDAT'.

This correction will be updated to the future versions of the User's Manuals.
