Errata Sheet

December 23, 1998 / Release 1.1

Device:	SAB 80C166-M SAB 80C166-M-T3 SAB 80C166-M-T4 SAB 80C166-M25
Stepping Code / Marking:	ES-DA, DA
Package:	MQFP-100

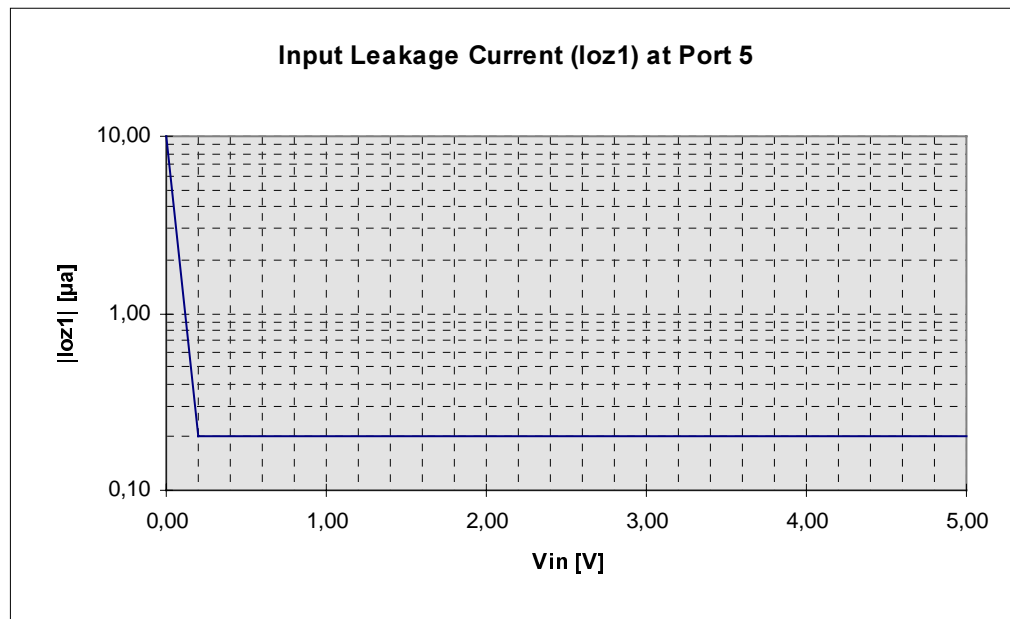
Problem 11: Input Leakage Current (I_{oz1}) at Port 5

The input leakage current (I_{oz1}) of some devices can deviate from the actual specified limit value of ±200 nA at input voltages (V_{in}) close to 0 V. High ambient temperature and maximum supply voltage lead to a maximum increase of the leakage current.

The following equation describes the behavior of the leakage current for input voltages between 0 V and 200 mV and covers all specified operating conditions. This equation stands for an exponential decrease from ±10 µA leakage current at V_{in} = 0 V to ±200 nA at V_{in} = 200 mV.

Input Voltage (V _{in})	$0 \leq V_{in} \leq 200 \text{ mV}$	$200 \text{ mV} \leq V_{in} \leq V_{cc} \text{ } ^1)$
Input Leakage Current (I _{oz1})	$I_{oz1} = \pm a \cdot e^{(b \cdot V_{in})}$ a = 10 µA; b = -0,0196 mV ⁻¹	I _{oz1} = ±200 nA

The figure below shows the input leakage current as function of the input voltage.
