Errata Sheet

December 23, 1998 / Release 1.1

Device:	SAB 80C166W-M SAB 80C166W-M-T3 SAB 80C166W-M-T4
Stepping Code / Marking:	ES-DA, DA
Package:	MQFP-100

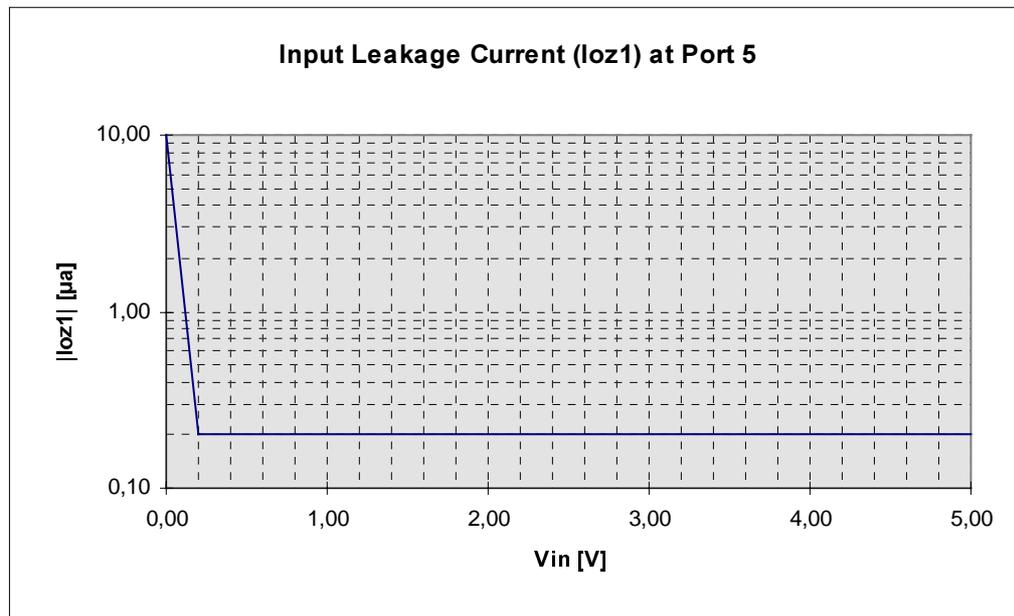
Problem 11: Input Leakage Current (I_{oz1}) at Port 5

The input leakage current (I_{oz1}) of some devices can deviate from the actual specified limit value of ±200 nA at input voltages (V_{in}) close to 0 V. High ambient temperature and maximum supply voltage lead to a maximum increase of the leakage current.

The following equation describes the behavior of the leakage current for input voltages between 0 V and 200 mV and covers all specified operating conditions. This equation stands for an exponential decrease from ±10 µA leakage current at V_{in} = 0 V to ±200 nA at V_{in} = 200 mV.

The figure below shows the input leakage current as function of the input voltage.
