## Errata Sheet

December 23, 1998 / Release 1.1

<b>Device:</b>	<b>SAB 83C166-5M</b> <b>SAB 83C166-5M-T3</b> <b>SAB 83C166-5M-T4</b> <b>SAB 80C166-M</b> <b>SAB 80C166-M-T3</b> <b>SAB 80C166-M-T4</b>
<b>Stepping Code / Marking:</b>	<b>ES-DC, DC</b>
<b>Package:</b>	<b>MQFP-100</b>

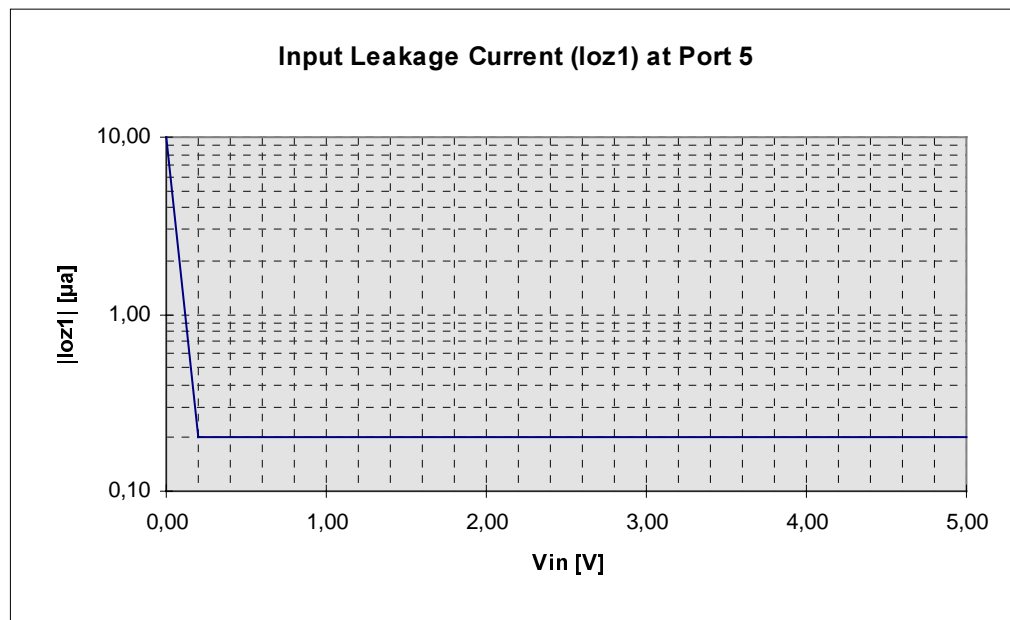
### **Problem 11: Input Leakage Current (I<sub>oz1</sub>) at Port 5**

The input leakage current (I<sub>oz1</sub>) of some devices can deviate from the actual specified limit value of ±200 nA at input voltages (V<sub>in</sub>) close to 0 V. High ambient temperature and maximum supply voltage lead to a maximum increase of the leakage current.

The following equation describes the behavior of the leakage current for input voltages between 0 V and 200 mV and covers all specified operating conditions. This equation stands for an exponential decrease from ±10 µA leakage current at V<sub>in</sub> = 0 V to ±200 nA at V<sub>in</sub> = 200 mV.

The figure below shows the input leakage current as function of the input voltage.
