XC2080ED, XC2090ED

16/32-Bit Single-Chip Microcontroller
with 32-Bit Performance
XC2000 Family / High Line

Errata Sheet

V1.6 2013-03

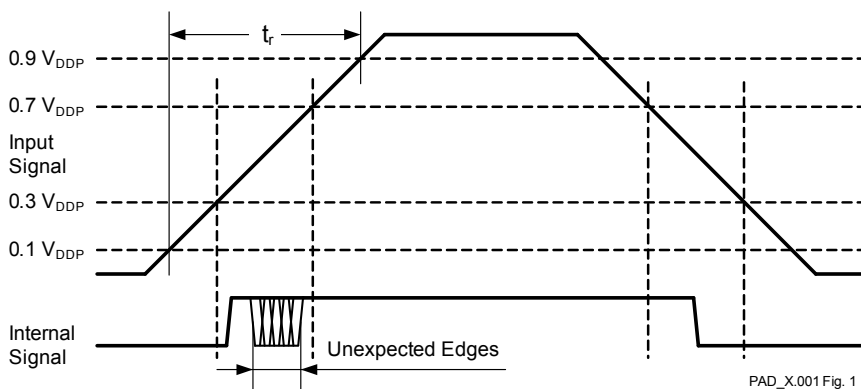
Figure 2 Example for a Slow Input Signal

The digital input- and I/O-pins are designed using Schmitt trigger input structures with hysteresis. Even with this structure, it is possible that very slow rising edges may generate spikes, resulting in unexpected additional edges at the input signal.

The next picture **Figure 2** is an example for a slow input signal, with spikes shown on the slow rising input signal.

The first rising edge in [Figure 2](#) of the internal signal is always valid. The edges which are marked with “Unexpected Edges” must be ignored.

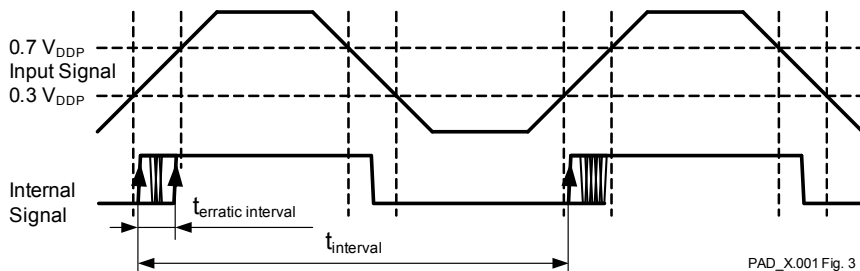
Figure 4 Rising Edge Detection Approach

In case of rising edge detection multiple interrupts would be generated when the spike occurs. The time interval since the last interrupt can be measured – if it is very small compared to the expected value, this would indicate a spike and the interrupt should be ignored.

If the time between the rising signal edge and the rising edge caused by a spike $t_{erratic}$ is less than the ISR service time, a workaround would be to clear the interrupt request (IR) flag before the return from interrupt is done. The clearing of the IR flag will avoid a further erratic interrupt.

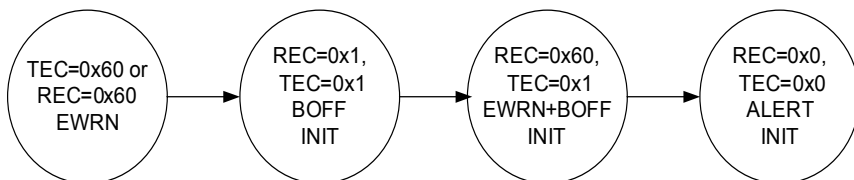
Figure 6 Alert Interrupt Behavior in case of Bus-Off

The MultiCAN module shows the following behavior in case of a bus-off status:

When the threshold for error warning (EWRN) is reached (default value of Error Warning Level EWRN = 0x60), then the EWRN interrupt is issued. The bus-off (BOFF) status is reached if TEC > 255 according to CAN specification, changing the MultiCAN module with REC and TEC to the same value 0x1, setting the INIT bit to 1_B, and issuing the BOFF interrupt. The bus-off recovery phase starts automatically. Every time an idle time is seen, REC is incremented. If REC = 0x60, a combined status EWRN+BOFF is reached. The corresponding interrupt can also be seen as a pre-warning interrupt, that the bus-off recovery phase will be finished soon. When the bus-off recovery phase has finished (128 times idle time have been seen on the bus), EWRN and BOFF are cleared, the ALERT interrupt bit is set and the INIT bit is still set.
