XC2200I Derivatives

16/32-Bit Single-Chip Microcontroller
with 32-Bit Performance

Errata Sheet

V1.2 2013-07

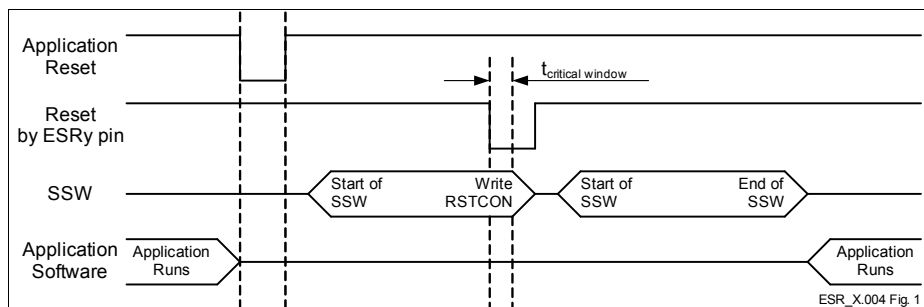
Figure 1 Critical application reset sequence

SCU_RSTCONx registers are reset only by Power-On, but they may be wrongly affected after a second application reset requested by an ESRy pin. This may lead to the SCU_RSTCONx register values being set to zero, which could unexpectedly disable reset sources within the user application. The conditions which lead to this behavior are:

1. First, an application reset by SW (software), CPU (Central Processing Unit), MP (Memory), WDT (Watchdog Timer) or ESRy (External Service Request y) occurs.
2. Following this, an application reset on an ESRy pin occurs.
3. If the above mentioned ESRy reset occurs during a critical time window of the SSW (startup software), then it's possible that the application will operate with the wrong SCU_RSTCONx register value. The critical time window occurs when the SSW is writing the SCU_RSTCONx registers, and at the same time, the ESRy reset request is processed by the reset circuitry. The width of this critical window $t_{critical\ window}$ is less than 13 cycles.

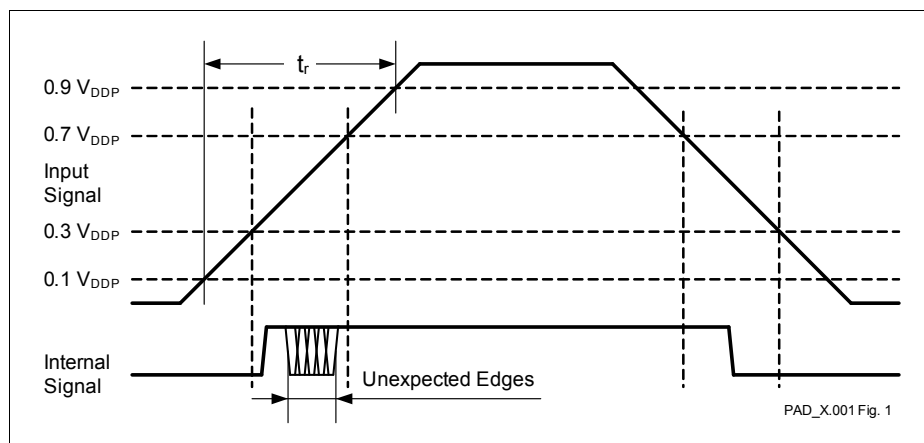
Figure 2 Example for a Slow Input Signal

The digital input- and I/O-pins are designed using Schmitt trigger input structures with hysteresis. Even with this structure, it is possible that very slow rising edges may generate spikes, resulting in unexpected additional edges at the input signal.

The next picture **Figure 2** is an example for a slow input signal, with spikes shown on the slow rising input signal.

The first rising edge in **Figure 2** of the internal signal is always valid. The edges which are marked with “Unexpected Edges” must be ignored.

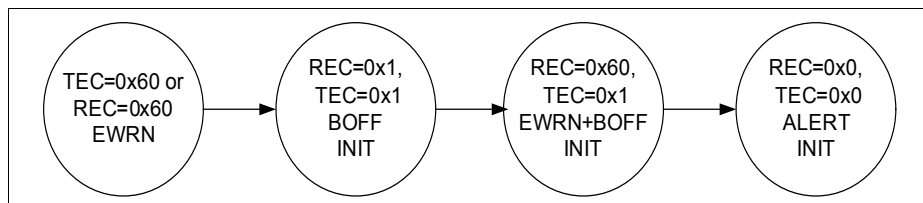
Figure 6 Alert Interrupt Behavior in case of Bus-Off

MultiCAN_AI.H007 Alert Interrupt Behavior in case of Bus-Off

The MultiCAN module shows the following behavior in case of a bus-off status:

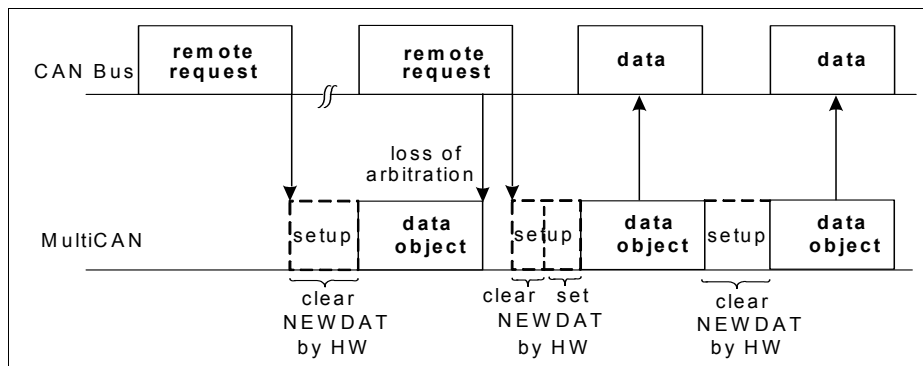
Figure 7 Loss of Arbitration

When the appropriate message object (data frame) triggered by the first remote frame wins the arbitration, it will be sent out and `NEWDAT` is not reset. This leads to an additional data frame, that will be sent by this message object (clearing `NEWDAT`).

There will, however, not be more data frames than there are corresponding remote requests.
