XC2200M Derivatives

16/32-Bit Single-Chip Microcontroller
with 32-Bit Performance

Errata Sheet

V1.6 2013-06

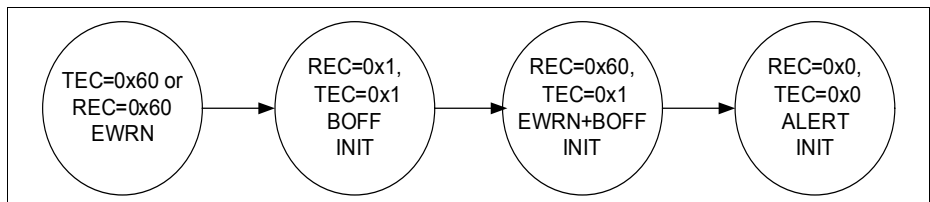
Figure 7 Alert Interrupt Behavior in case of Bus-Off

The MultiCAN module shows the following behavior in case of a bus-off status:
