XC2200U Derivatives

16/32-Bit Single-Chip Microcontroller
with 32-Bit Performance

Errata Sheet

V1.2 2013-09

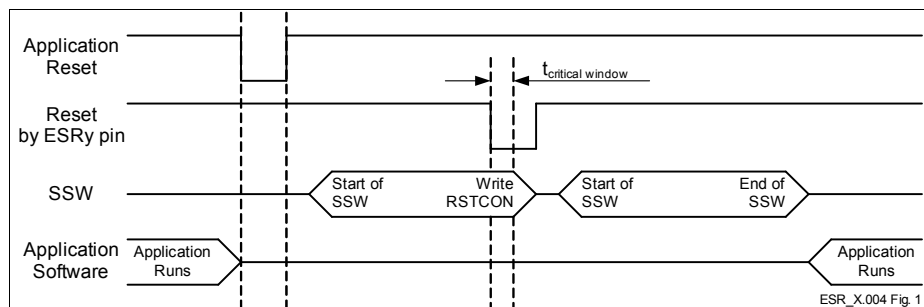
Figure 1 Critical application reset sequence

ESR_X.004 Wrong Value of SCU_RSTCONx Registers after ESRy Application Reset

SCU_RSTCONx registers are reset only by Power-On, but they may be wrongly affected after a second application reset requested by an ESRy pin. This may lead to the SCU_RSTCONx register values being set to zero, which could unexpectedly disable reset sources within the user application. The conditions which lead to this behavior are:

1. First, an application reset by SW (software), CPU (Central Processing Unit), MP (Memory), WDT (Watchdog Timer) or ESRy (External Service Request y) occurs.
2. Following this, an application reset on an ESRy pin occurs.
3. If the above mentioned ESRy reset occurs during a critical time window of the SSW (startup software), then it's possible that the application will operate with the wrong SCU_RSTCONx register value. The critical time window occurs when the SSW is writing the SCU_RSTCONx registers, and at the same time, the ESRy reset request is processed by the reset circuitry. The width of this critical window $t_{\text{critical window}}$ is less than 13 cycles.

- Initialize SCU_RSTCONx registers by user software after any reset, or
- assure that a second application reset request with an ESR pin does not occur during the critical time window.
