XC2300A Derivatives

16/32-Bit Single-Chip Microcontroller
with 32-Bit Performance

Errata Sheet

V1.6 2013-06

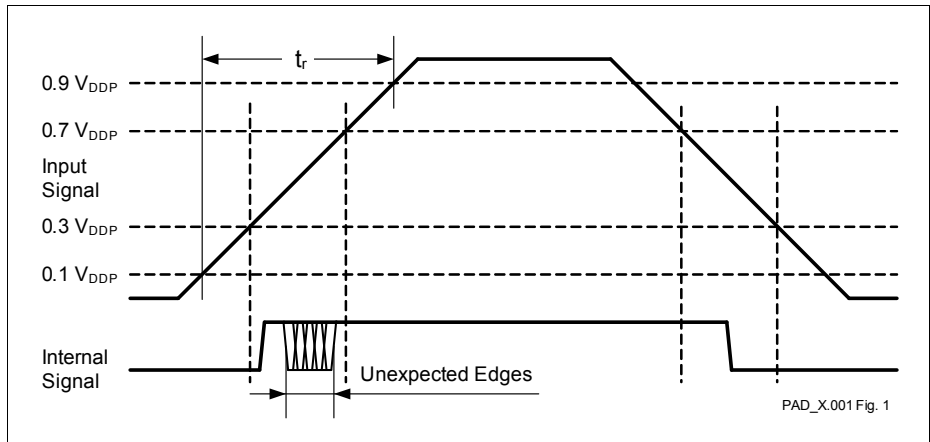
Figure 3 Example for a Slow Input Signal

rising edges may generate spikes, resulting in unexpected additional edges at the input signal.

The next picture **Figure 3** is an example for a slow input signal, with spikes shown on the slow rising input signal.

The first rising edge in **Figure 3** of the internal signal is always valid. The edges which are marked with “Unexpected Edges” must be ignored.

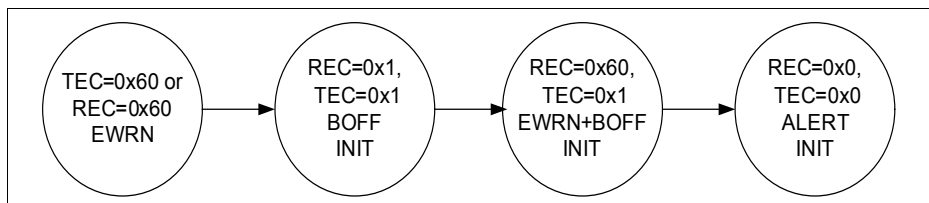
Figure 7 Alert Interrupt Behavior in case of Bus-Off

MultiCAN_AI.H007 Alert Interrupt Behavior in case of Bus-Off

The MultiCAN module shows the following behavior in case of a bus-off status:
