XC2300B Derivatives

16/32-Bit Single-Chip Microcontroller
with 32-Bit Performance

Errata Sheet

V1.7 2013-06

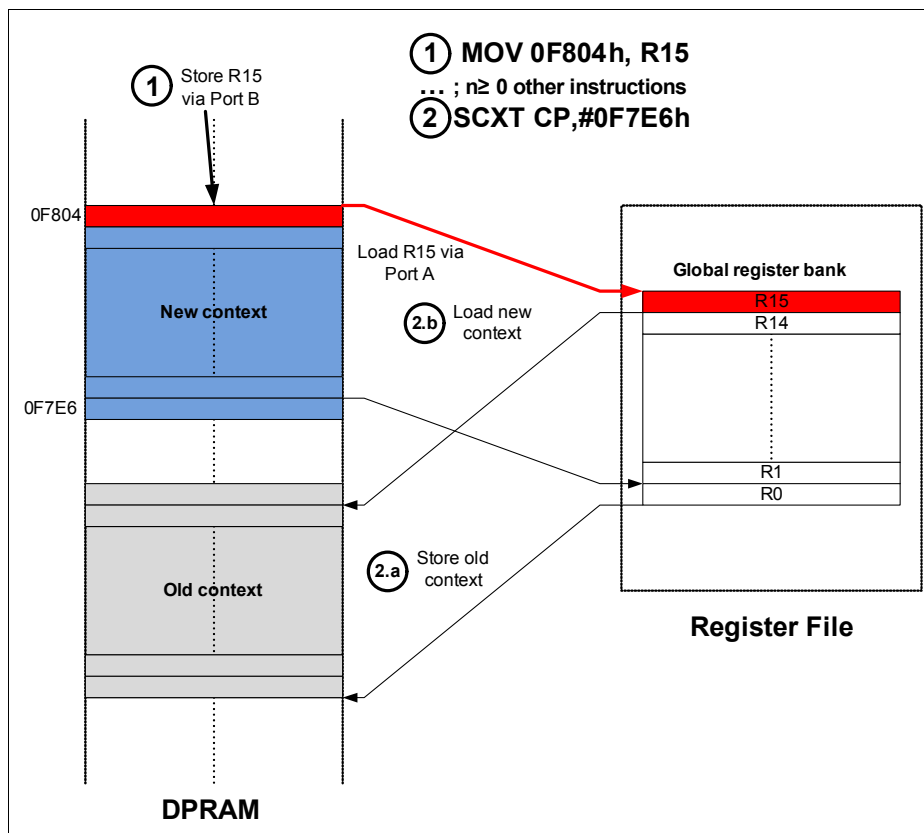
Figure 1 Context Switch with Pointer Passing in R15

2. An explicit software write operation (i.e. no context switch) to L_1 and/or L_2 is performed, and
3. The Context Pointer (register CP) is modified (e.g. by MOV/POP/SCXT CP, ...) in one of the following instructions, leading to a context store (old context) and a context load (new context) of the global bank into/from DPRAM, and
4. One of the General Purpose Registers Rx with an odd register number x ($x = 1, 3, \dots, 15$) is loaded from locations L_1 or L_2 .

In this case, the contents of Rx may be incorrect.

This scenario may typically occur at the beginning of interrupt routines when a GPR (e.g. R15 used as user stack pointer) is saved into the new GPR context in DPRAM, as shown in the following **Figure 1**.

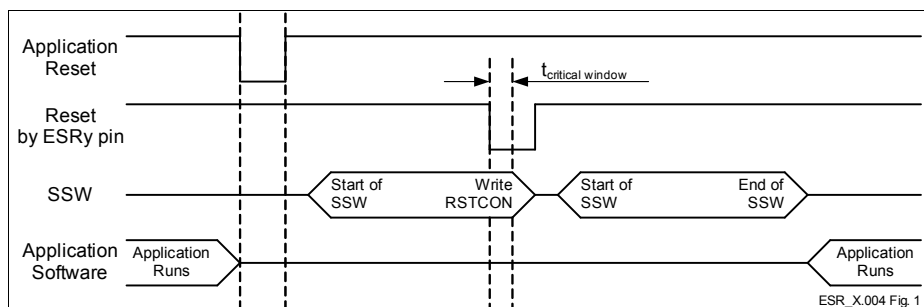
Figure 2 Critical application reset sequence

SCU_RSTCONx registers are reset only by Power-On, but they may be wrongly affected after a second application reset requested by an ESRy pin. This may lead to the SCU_RSTCONx register values being set to zero, which could unexpectedly disable reset sources within the user application. The conditions which lead to this behavior are:

1. First, an application reset by SW (software), CPU (Central Processing Unit), MP (Memory), WDT (Watchdog Timer) or ESRy (External Service Request y) occurs.
2. Following this, an application reset on an ESRy pin occurs.
3. If the above mentioned ESRy reset occurs during a critical time window of the SSW (startup software), then it's possible that the application will operate with the wrong SCU_RSTCONx register value. The critical time window occurs when the SSW is writing the SCU_RSTCONx registers, and at the same time, the ESRy reset request is processed by the reset circuitry. The width of this critical window $t_{\text{critical window}}$ is less than 13 cycles.

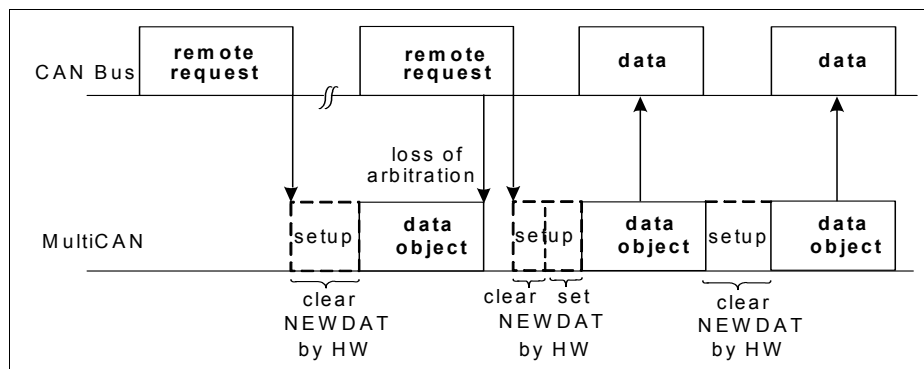
Figure 8 Loss of Arbitration

When the appropriate message object (data frame) triggered by the first remote frame wins the arbitration, it will be sent out and **NEWDAT** is not reset. This leads to an additional data frame, that will be sent by this message object (clearing **NEWDAT**).

There will, however, not be more data frames than there are corresponding remote requests.
