## XC2300D Derivatives

16/32-Bit Single-Chip Microcontroller  
with 32-Bit Performance

Errata Sheet

V1.3 2013-09

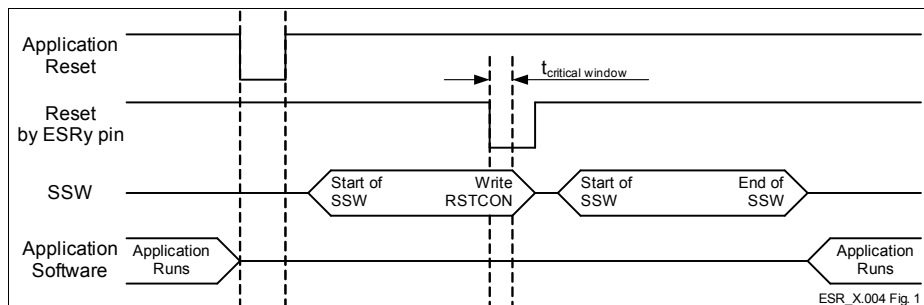
**Figure 1 Critical application reset sequence**

### **ESR\_X.004 Wrong Value of SCU\_RSTCONx Registers after ESRy Application Reset**

SCU\_RSTCONx registers are reset only by Power-On, but they may be wrongly affected after a second application reset requested by an ESRy pin. This may lead to the SCU\_RSTCONx register values being set to zero, which could unexpectedly disable reset sources within the user application. The conditions which lead to this behavior are:

1. First, an application reset by SW (software), CPU (Central Processing Unit), MP (Memory), WDT (Watchdog Timer) or ESRy (External Service Request y) occurs.
2. Following this, an application reset on an ESRy pin occurs.
3. If the above mentioned ESRy reset occurs during a critical time window of the SSW (startup software), then it's possible that the application will operate with the wrong SCU\_RSTCONx register value. The critical time window occurs when the SSW is writing the SCU\_RSTCONx registers, and at the same time, the ESRy reset request is processed by the reset circuitry. The width of this critical window  $f_{\text{critical window}}$  is less than 13 cycles.

- Initialize `SCU_RSTCONx` registers by user software after any reset, or
- assure that a second application reset request with an ESR pin does not occur during the critical time window.

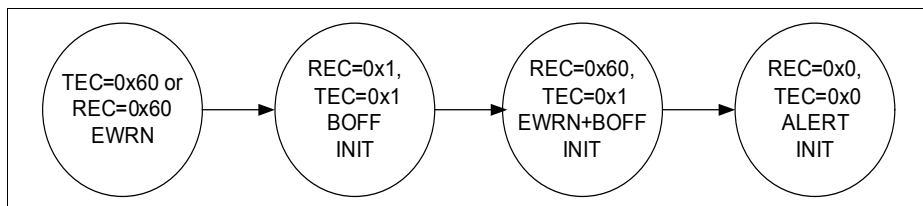
**Figure 2 Alert Interrupt Behavior in case of Bus-Off**

### **MultiCAN\_AI.H007 Alert Interrupt Behavior in case of Bus-Off**

When the threshold for error warning (EWRN) is reached (default value of Error Warning Level EWRN = 0x60), then the EWRN interrupt is issued. The bus-off (BOFF) status is reached if  $TEC > 255$  according to CAN specification, changing the MultiCAN module with REC and TEC to the same value 0x1, setting the INIT bit to 1<sub>B</sub>, and issuing the BOFF interrupt. The bus-off recovery phase starts automatically. Every time an idle time is seen, REC is incremented. If REC = 0x60, a combined status EWRN+BOFF is reached. The corresponding interrupt can also be seen as a pre-warning interrupt, that the bus-off recovery phase will be finished soon. When the bus-off recovery phase has finished (128 times idle time have been seen on the bus), EWRN and BOFF are cleared, the ALERT interrupt bit is set and the INIT bit is still set.

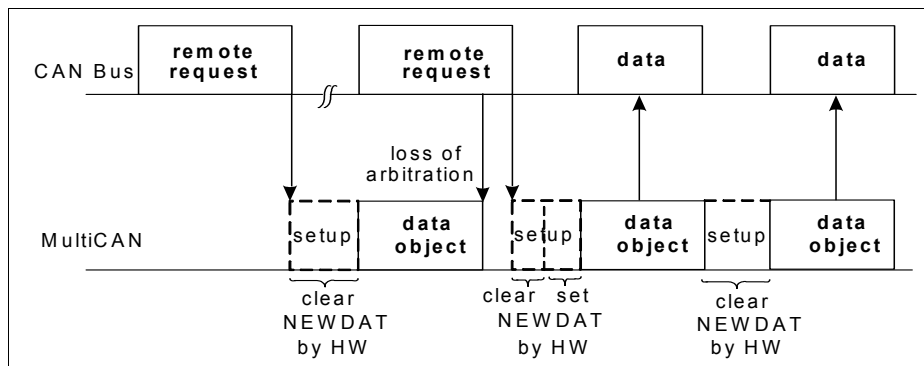
**Figure 3 Loss of Arbitration**

When the appropriate message object (data frame) triggered by the first remote frame wins the arbitration, it will be sent out and `NEWDAT` is not reset. This leads to an additional data frame, that will be sent by this message object (clearing `NEWDAT`).

There will, however, not be more data frames than there are corresponding remote requests.
