## XC2300E Derivatives

16/32-Bit Single-Chip Microcontroller  
with 32-Bit Performance

Errata Sheet

V1.2 2013-07

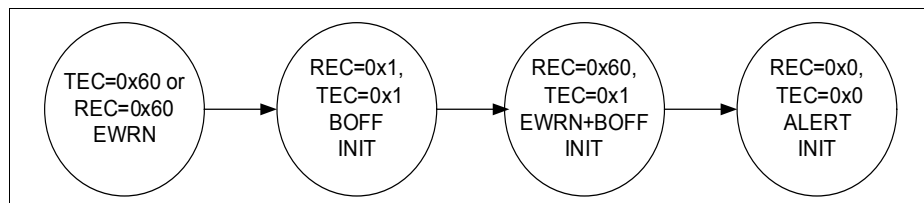
**Figure 6 Alert Interrupt Behavior in case of Bus-Off**

The MultiCAN module shows the following behavior in case of a bus-off status:
