XC27x3X Derivatives

16/32-Bit Single-Chip Microcontroller
with 32-Bit Performance
XC2000 Family / Econo Line

Errata Sheet

V1.3 2013-09

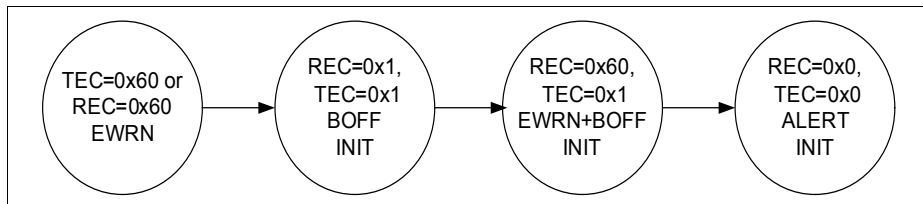
Figure 2 Alert Interrupt Behavior in case of Bus-Off

MultiCAN_AI.H007 Alert Interrupt Behavior in case of Bus-Off

The MultiCAN module shows the following behavior in case of a bus-off status:

When the threshold for error warning (EWRN) is reached (default value of Error Warning Level EWRN = 0x60), then the EWRN interrupt is issued. The bus-off (BOFF) status is reached if TEC > 255 according to CAN specification, changing the MultiCAN module with REC and TEC to the same value 0x1, setting the INIT bit to 1_B, and issuing the BOFF interrupt. The bus-off recovery phase starts automatically. Every time an idle time is seen, REC is incremented. If REC = 0x60, a combined status EWRN+BOFF is reached. The corresponding interrupt can also be seen as a pre-warning interrupt, that the bus-off recovery phase will be finished soon. When the bus-off recovery phase has finished (128 times idle time have been seen on the bus), EWRN and BOFF are cleared, the ALERT interrupt bit is set and the INIT bit is still set.
