## XC27x4X Derivatives

16/32-Bit Single-Chip Microcontroller  
with 32-Bit Performance  
XC2000 Family / Value Line

Errata Sheet

V1.7 2013-06

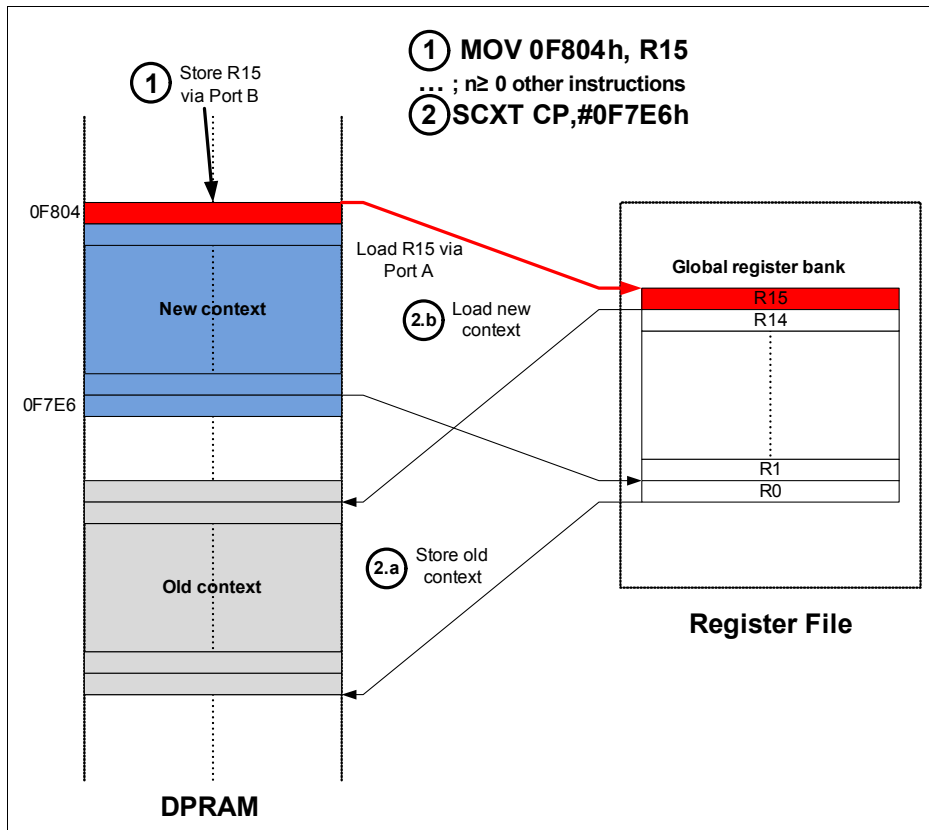
**Figure 1 Context Switch with Pointer Passing in R15**

In this case, the contents of Rx may be incorrect.

This scenario may typically occur at the beginning of interrupt routines when a GPR (e.g. R15 used as user stack pointer) is saved into the new GPR context in DPRAM, as shown in the following **Figure 1**.
