XC27x5X Derivatives

16/32-Bit Single-Chip Microcontroller
with 32-Bit Performance
XC2000 Family / Base Line

Errata Sheet

V1.6 2013-06

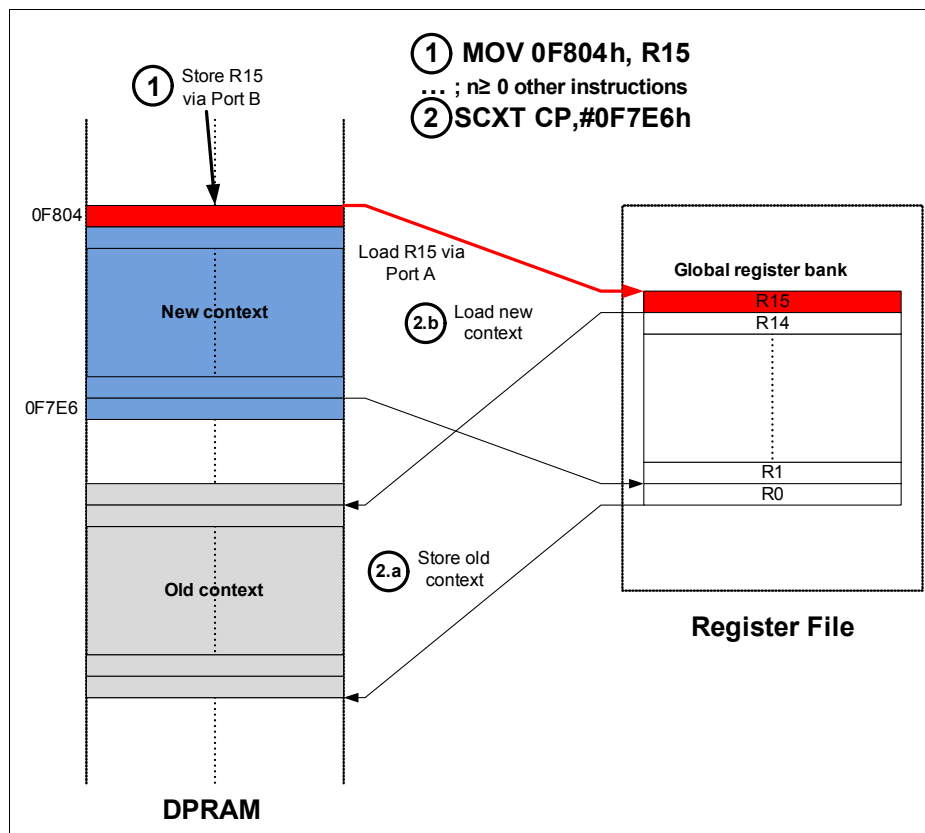
Figure 1 Context Switch with Pointer Passing in R15

Under special conditions, undefined data may be read from up to two word locations L_1 , L_2 in the DPRAM (address range $F600_H \dots FDFH_H$).

In this case, the contents of Rx may be incorrect.

This scenario may typically occur at the beginning of interrupt routines when a GPR (e.g. R15 used as user stack pointer) is saved into the new GPR context in DPRAM, as shown in the following **Figure 1**.

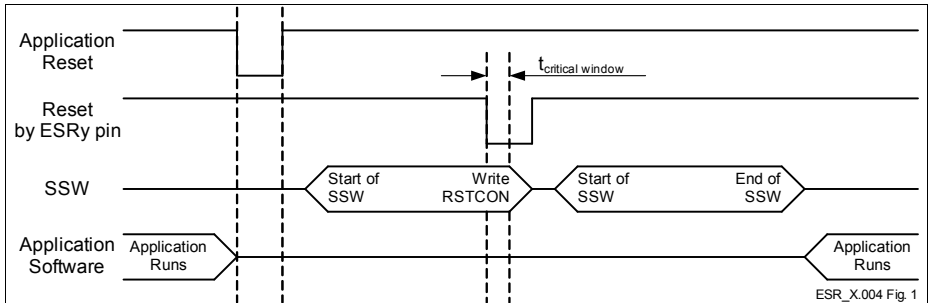
Figure 2 Critical application reset sequence

`SCU_RSTCONx` registers are reset only by Power-On, but they may be wrongly affected after a second application reset requested by an ESRy pin. This may lead to the `SCU_RSTCONx` register values being set to zero, which could unexpectedly disable reset sources within the user application. The conditions which lead to this behavior are:

1. First, an application reset by SW (software), CPU (Central Processing Unit), MP (Memory), WDT (Watchdog Timer) or ESRy (External Service Request y) occurs.
2. Following this, an application reset on an ESRy pin occurs.
3. If the above mentioned ESRy reset occurs during a critical time window of the SSW (startup software), then it's possible that the application will operate with the wrong `SCU_RSTCONx` register value. The critical time window occurs when the SSW is writing the `SCU_RSTCONx` registers, and at the same time, the ESRy reset request is processed by the reset circuitry. The width of this critical window $f_{\text{critical window}}$ is less than 13 cycles.

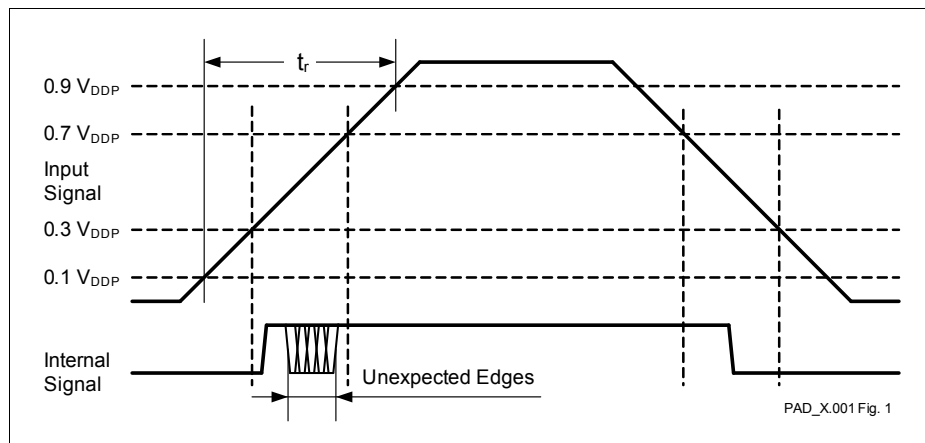
Figure 3 Example for a Slow Input Signal

rising edges may generate spikes, resulting in unexpected additional edges at the input signal.

The next picture **Figure 3** is an example for a slow input signal, with spikes shown on the slow rising input signal.

The first rising edge in **Figure 3** of the internal signal is always valid. The edges which are marked with “Unexpected Edges” must be ignored.

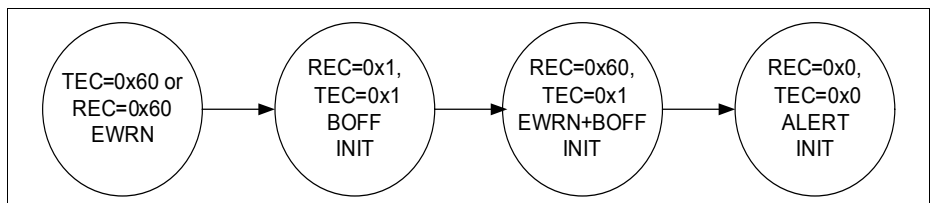
Figure 7 Alert Interrupt Behavior in case of Bus-Off

MultiCAN_AI.H007 Alert Interrupt Behavior in case of Bus-Off

The MultiCAN module shows the following behavior in case of a bus-off status:
