XC27x7X Derivatives

16/32-Bit Single-Chip Microcontroller
with 32-Bit Performance
XC2000 Family / High Line

Errata Sheet

V1.6 2013-03

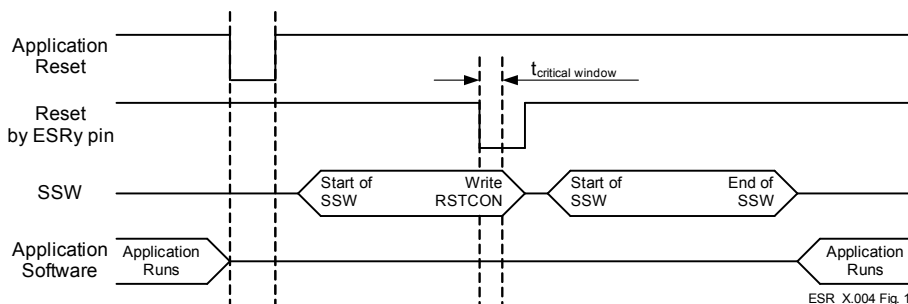
ESR_X.004 Fig. 1

SCU_RSTCONx registers are reset only by Power-On, but they may be wrongly affected after a second application reset requested by an ESRy pin. This may lead to the SCU_RSTCONx register values being set to zero, which could unexpectedly disable reset sources within the user application. The conditions which lead to this behavior are:

1. First, an application reset by SW (software), CPU (Central Processing Unit), MP (Memory), WDT (Watchdog Timer) or ESRy (External Service Request y) occurs.
2. Following this, an application reset on an ESRy pin occurs.
3. If the above mentioned ESRy reset occurs during a critical time window of the SSW (startup software), then it's possible that the application will operate with the wrong SCU_RSTCONx register value. The critical time window occurs when the SSW is writing the SCU_RSTCONx registers, and

at the same time, the ESRy reset request is processed by the reset circuitry. The width of this critical window $t_{\text{critical window}}$ is less than 13 cycles.

Figure 1 Critical application reset sequence

- Initialize `SCU_RSTCONx` registers by user software after any reset, or
- assure that a second application reset request with an ESR pin does not occur during the critical time window.

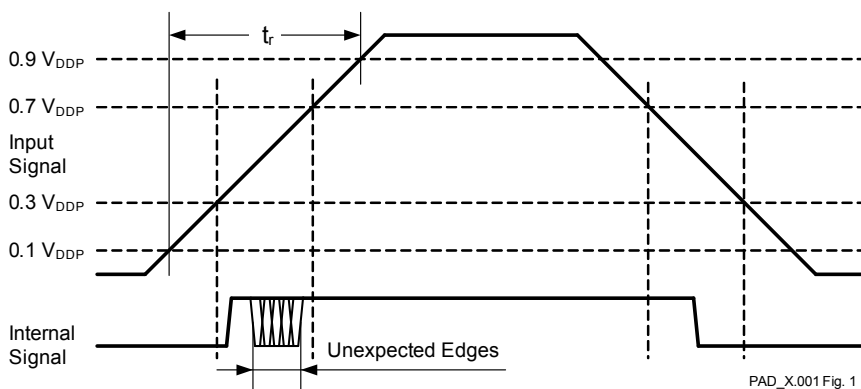
rising edges may generate spikes, resulting in unexpected additional edges at the input signal.

The next picture **Figure 2** is an example for a slow input signal, with spikes shown on the slow rising input signal.

Figure 2 Example for a Slow Input Signal

The first rising edge in **Figure 2** of the internal signal is always valid. The edges which are marked with "Unexpected Edges" must be ignored.

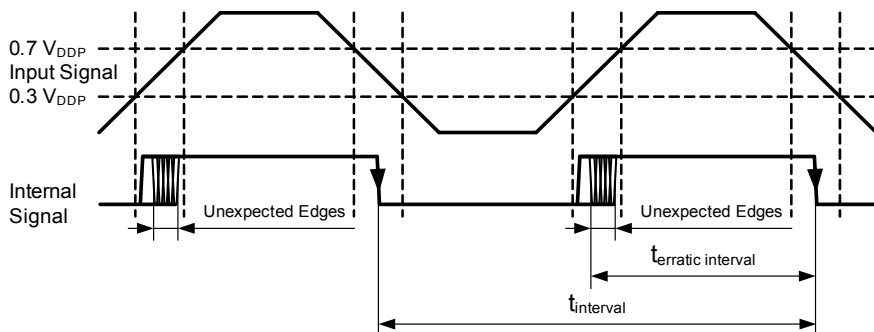
PAD_X.001 Fig. 2

Figure 3 Falling Edge Detection Approach

- Measure the time interval since the last interrupt (shown as in t_{interval} in [Figure 3](#) below) and check that it is in the expected time range.
 In the example, an erratic edge would cause the measured time interval/erratic interval to be approximately 50% of the expected value.
- The state of the input pin that caused the interrupt could be read several times in the interrupt service routine and a majority decision made to check if the input pin really is at a low level to determine whether this is a genuine falling edge interrupt or whether the interrupt was triggered by a spike generated by a slow rising edge.

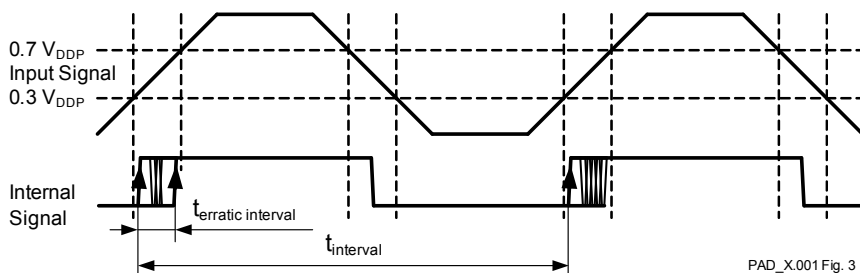
PAD_X.001 Fig. 3

Figure 4 Rising Edge Detection Approach

In case of rising edge detection multiple interrupts would be generated when the spike occurs. The time interval since the last interrupt can be measured – if it is very small compared to the expected value, this would indicate a spike and the interrupt should be ignored.

If the time between the rising signal edge and the rising edge caused by a spike $t_{erratic}$ is less than the ISR service time, a workaround would be to clear the interrupt request (IR) flag before the return from interrupt is done. The clearing of the IR flag will avoid a further erratic interrupt.

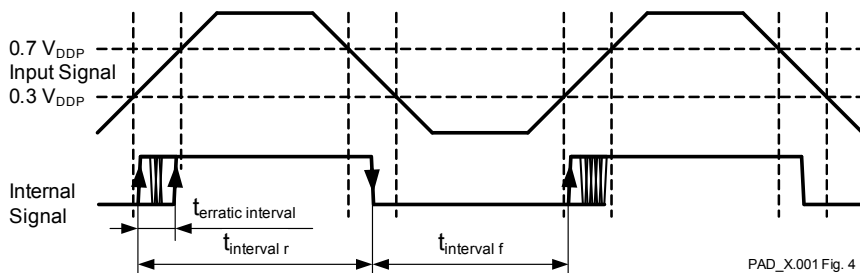
Figure 5 Rising Edge and Falling Edge Detection Approach

The rising edge detection workaround works also if both edges are used as trigger for interrupt and the following conditions are valid:

- $t_{erratic\ interval} \ll t_{interval\ r}$ and
- $t_{erratic\ interval} \ll t_{interval\ f}$

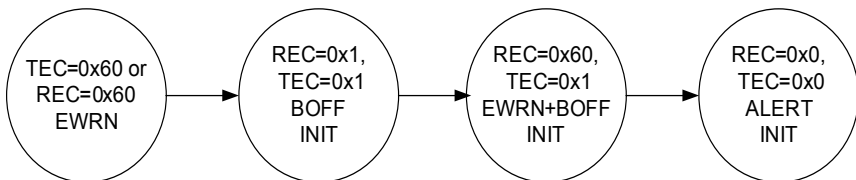
The MultiCAN module shows the following behavior in case of a bus-off status:

Figure 6 Alert Interrupt Behavior in case of Bus-Off

When the threshold for error warning (EWRN) is reached (default value of Error Warning Level EWRN = 0x60), then the EWRN interrupt is issued. The bus-off (BOFF) status is reached if $TEC > 255$ according to CAN specification, changing the MultiCAN module with REC and TEC to the same value 0x1, setting the INIT bit to 1_B, and issuing the BOFF interrupt. The bus-off recovery phase starts automatically. Every time an idle time is seen, REC is incremented. If REC = 0x60, a combined status EWRN+BOFF is reached. The corresponding interrupt can also be seen as a pre-warning interrupt, that the bus-off recovery phase will be finished soon. When the bus-off recovery phase has finished (128 times idle time have been seen on the bus), EWRN and BOFF are cleared, the ALERT interrupt bit is set and the INIT bit is still set.

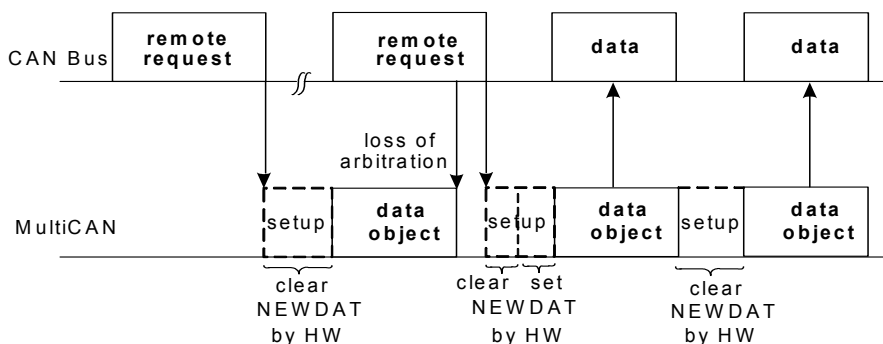
When the appropriate message object (data frame) triggered by the first remote frame wins the arbitration, it will be sent out and **NEWDAT** is not reset. This leads to an additional data frame, that will be sent by this message object (clearing **NEWDAT**).

There will, however, not be more data frames than there are corresponding remote requests.

Figure 7 Loss of Arbitration
