XE166H Derivatives

XE166 Family / High Line

Errata Sheet

V1.6 2013-03

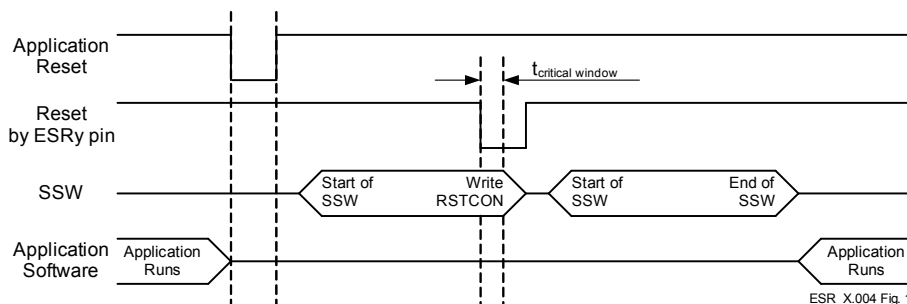
Figure 1 Critical application reset sequence

SCU_RSTCONx registers are reset only by Power-On, but they may be wrongly affected after a second application reset requested by an ESRy pin. This may lead to the SCU_RSTCONx register values being set to zero, which could unexpectedly disable reset sources within the user application. The conditions which lead to this behavior are:

1. First, an application reset by SW (software), CPU (Central Processing Unit), MP (Memory), WDT (Watchdog Timer) or ESRy (External Service Request y) occurs.
2. Following this, an application reset on an ESRy pin occurs.
3. If the above mentioned ESRy reset occurs during a critical time window of the SSW (startup software), then it's possible that the application will operate with the wrong SCU_RSTCONx register value. The critical time window occurs when the SSW is writing the SCU_RSTCONx registers, and

at the same time, the ESRy reset request is processed by the reset circuitry. The width of this critical window $t_{\text{critical window}}$ is less than 13 cycles.

- Initialize `SCU_RSTCONx` registers by user software after any reset, or
- assure that a second application reset request with an ESR pin does not occur during the critical time window.

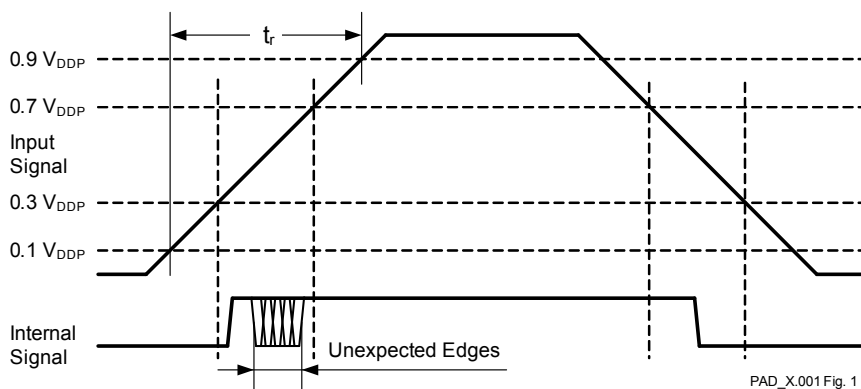
Figure 2 Example for a Slow Input Signal

rising edges may generate spikes, resulting in unexpected additional edges at the input signal.

The next picture **Figure 2** is an example for a slow input signal, with spikes shown on the slow rising input signal.

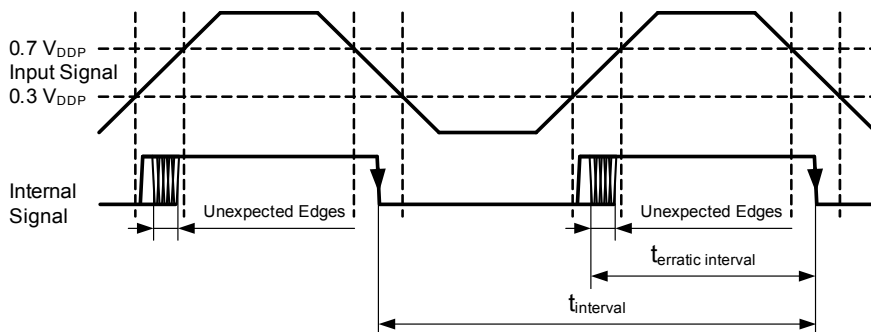
Figure 3 Falling Edge Detection Approach

- Measure the time interval since the last interrupt (shown as in t_{interval} in [Figure 3](#) below) and check that it is in the expected time range.
 In the example, an erratic edge would cause the measured time interval/erratic interval to be approximately 50% of the expected value.
- The state of the input pin that caused the interrupt could be read several times in the interrupt service routine and a majority decision made to check if the input pin really is at a low level to determine whether this is a genuine falling edge interrupt or whether the interrupt was triggered by a spike generated by a slow rising edge.

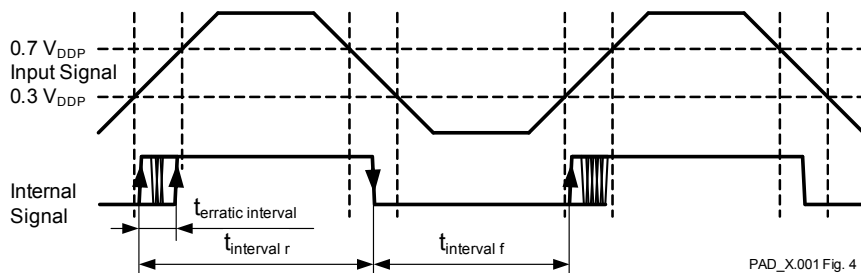
Figure 5 Rising Edge and Falling Edge Detection Approach

The rising edge detection workaround works also if both edges are used as trigger for interrupt and the following conditions are valid:

- $t_{erratic\ interval} \ll t_{interval\ r}$ and
- $t_{erratic\ interval} \ll t_{interval\ f}$

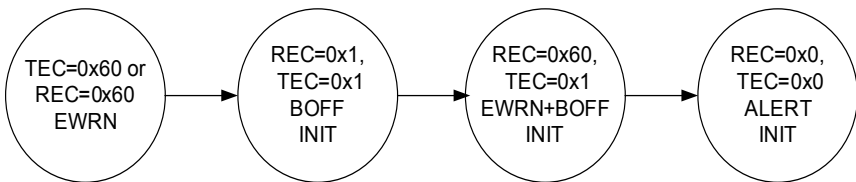
Figure 6 Alert Interrupt Behavior in case of Bus-Off

The MultiCAN module shows the following behavior in case of a bus-off status:

When the threshold for error warning (EWRN) is reached (default value of Error Warning Level EWRN = 0x60), then the EWRN interrupt is issued. The bus-off (BOFF) status is reached if $TEC > 255$ according to CAN specification, changing the MultiCAN module with REC and TEC to the same value 0x1, setting the INIT bit to 1_B, and issuing the BOFF interrupt. The bus-off recovery phase starts automatically. Every time an idle time is seen, REC is incremented. If REC = 0x60, a combined status EWRN+BOFF is reached. The corresponding interrupt can also be seen as a pre-warning interrupt, that the bus-off recovery phase will be finished soon. When the bus-off recovery phase has finished (128 times idle time have been seen on the bus), EWRN and BOFF are cleared, the ALERT interrupt bit is set and the INIT bit is still set.
