## XE166M Derivatives

Real Time Signal Controller

Errata Sheet

V1.6 2013-06

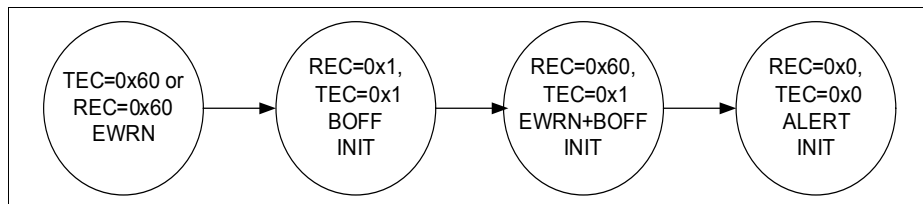
**Figure 7 Alert Interrupt Behavior in case of Bus-Off**

### **MultiCAN\_AI.H007 Alert Interrupt Behavior in case of Bus-Off**

The MultiCAN module shows the following behavior in case of a bus-off status:
