## XE166N Derivatives

XE166 Family / Value Line

Errata Sheet

V1.7 2013-06

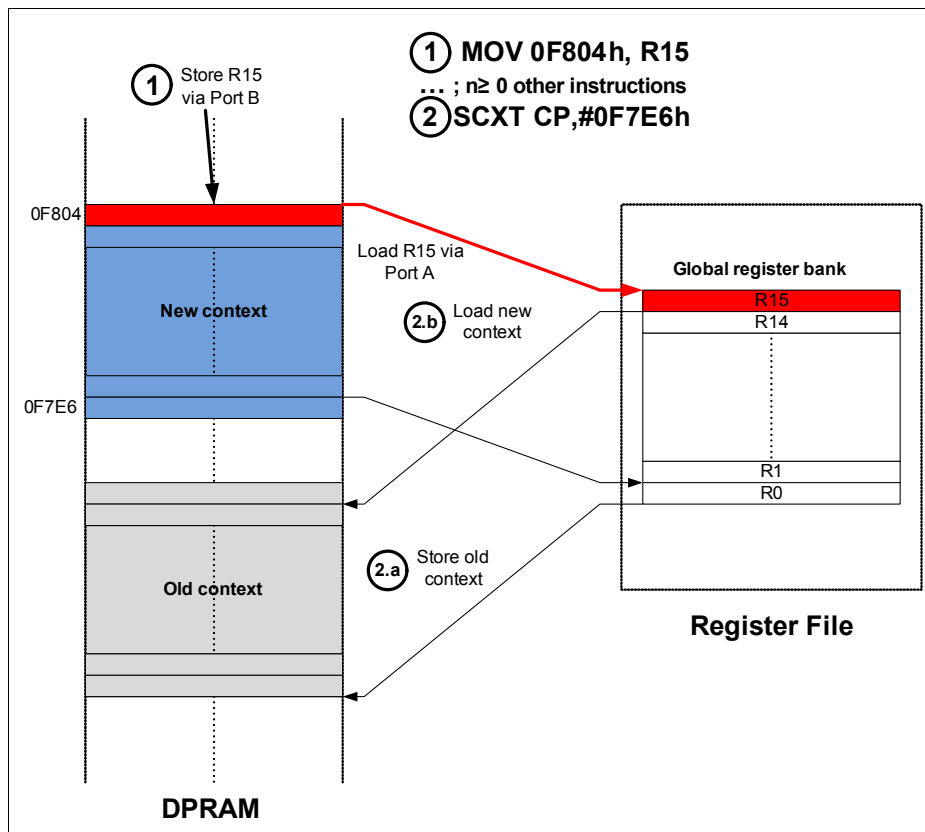
**Figure 1 Context Switch with Pointer Passing in R15**

In this case, the contents of Rx may be incorrect.

This scenario may typically occur at the beginning of interrupt routines when a GPR (e.g. R15 used as user stack pointer) is saved into the new GPR context in DPRAM, as shown in the following **Figure 1**.

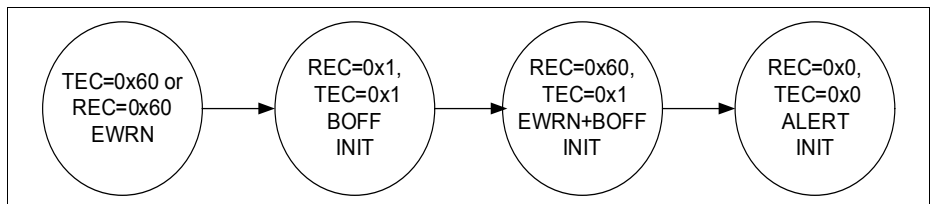
**Figure 7 Alert Interrupt Behavior in case of Bus-Off**

The MultiCAN module shows the following behavior in case of a bus-off status:

When the threshold for error warning (EWRN) is reached (default value of Error Warning Level EWRN = 0x60), then the EWRN interrupt is issued. The bus-off (BOFF) status is reached if  $TEC > 255$  according to CAN specification, changing the MultiCAN module with REC and TEC to the same value 0x1, setting the INIT bit to 1<sub>B</sub>, and issuing the BOFF interrupt. The bus-off recovery phase starts automatically. Every time an idle time is seen, REC is incremented. If REC = 0x60, a combined status EWRN+BOFF is reached. The corresponding interrupt can also be seen as a pre-warning interrupt, that the bus-off recovery phase will be finished soon. When the bus-off recovery phase has finished (128 times idle time have been seen on the bus), EWRN and BOFF are cleared, the ALERT interrupt bit is set and the INIT bit is still set.

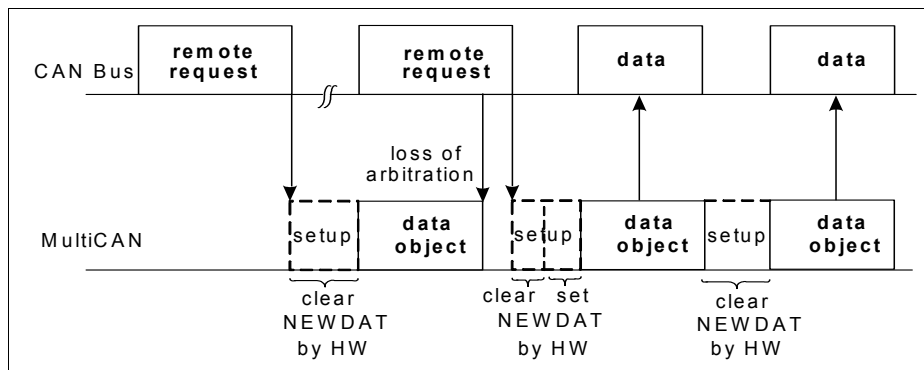
**Figure 8 Loss of Arbitration**

When the appropriate message object (data frame) triggered by the first remote frame wins the arbitration, it will be sent out and **NEWDAT** is not reset. This leads to an additional data frame, that will be sent by this message object (clearing **NEWDAT**).

There will, however, not be more data frames than there are corresponding remote requests.
