Device TC1796
Marking/Step EES-BD, ES-BD, BD
Package P-BGA-416, PG-BGA-416

02129AERRA

This Errata Sheet describes the deviations from the current user documentation.

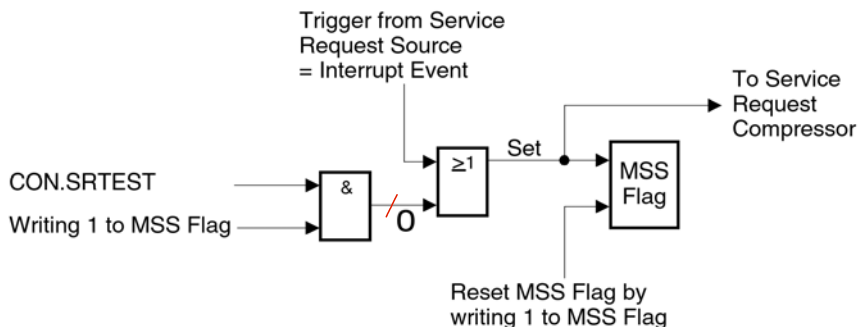
Figure 1

ADC_TC.023 Setting the MSS-flag doesn't generate an interrupt in TEST-MODE

It is possible to generate a software triggered interrupt event in TESTMODE (ADCx_CON.SRTEST=1) by setting one of the bitflags in register ADCx_MSS0/1. Due to the fact, that this mechanism is not working, it is not possible to generate a corresponding interrupt by software.

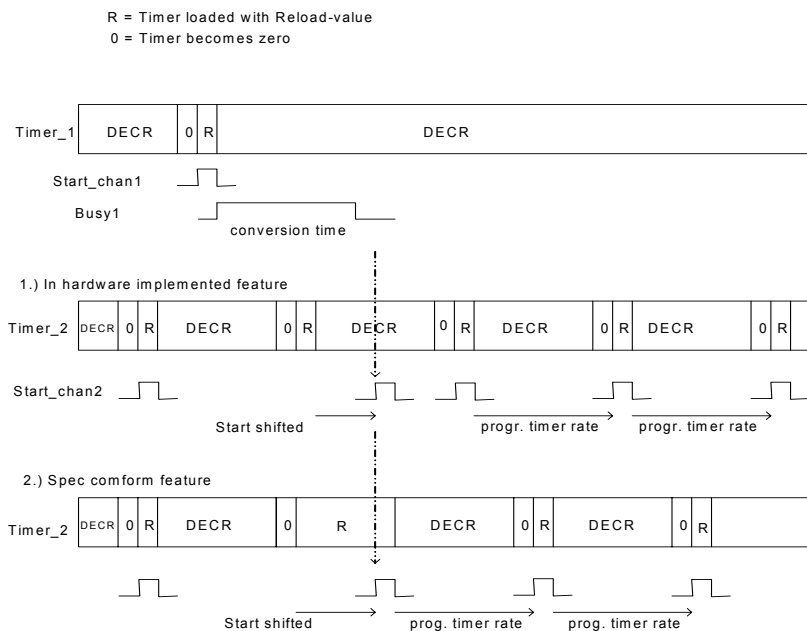
Figure 3 Timing concerning equidistant multiple timers

The correct behavior would be a reload when the requested conversion (of channel_2) is started.

Therefore the start of conversion for channel_2 is delayed by maximum one conversion-time. After this delay it will be continued with equidistant conversion-starts. Please refer to the following figure.

Note: the programmed timer rate is much longer than the conversion time, this means that the fault is much smaller than in the picture

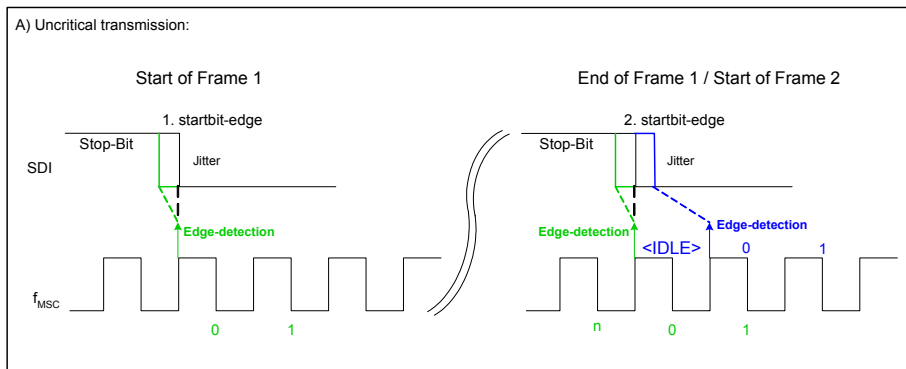
Figure 4 Uncritical transmission

As the falling startbit edge is shifted to the left of the rising clock edge (**Figure 4** left), there occurs a secure detection of the next startbit edge in the last cycle of the previous frame (here cycle n, **Figure 4** right) independent from the applied jitter to this edge.

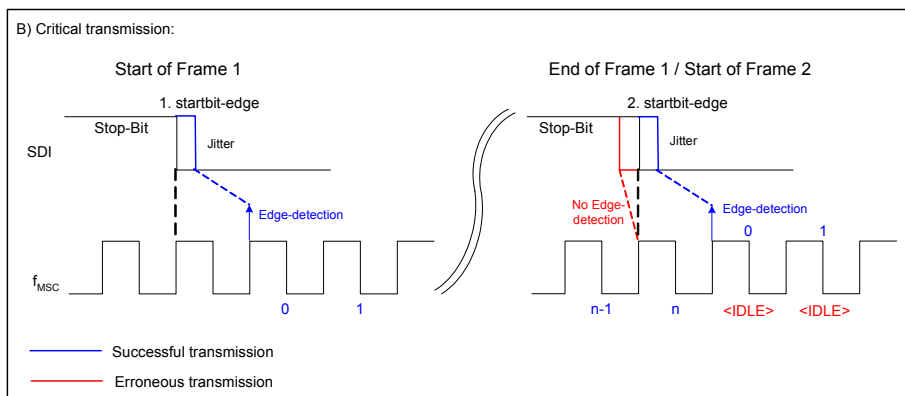
Figure 5 Critical transmission

If the high-low edge of the start-bit in the first frame is just not detected by the near clock-edge (**Figure 5** - left) and the start-bit edge of the second frame is jittering to cycle $n-1$ (**Figure 5** - right, red coloured), then an erroneous transmission will take place. In this case the state-machine switches to IDLE after the last state n and wakes up on the next falling edge that may be a data-bit recognized as a start-bit. If the start-bit of the second frame is jittering to cycle n (**Figure 5** - right, blue colored), then the state-machine will not switch to IDLE but will start receiving the next frame correctly.

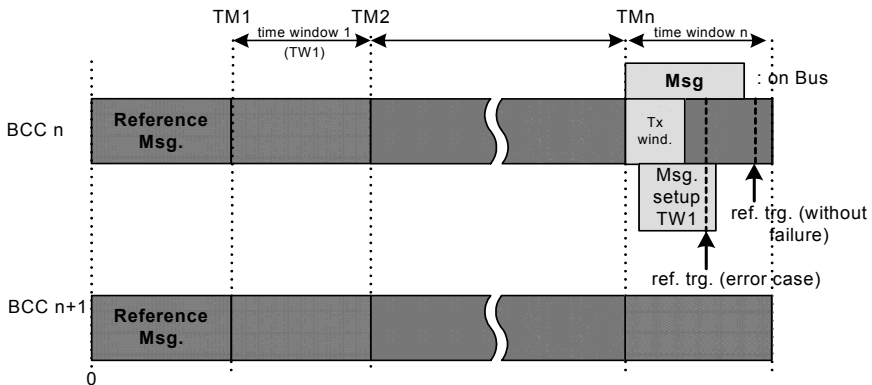
Figure 9

MultiCAN_TC.036 Wrong message may be sent during reference message trigger in a gap

The TTCAN controller is configured as timer master, gap mode has been selected and no message is transferred (reception or transmission) after the transmit enable window in the last time window. With the end of the transmit enable window, the TTCAN logic starts waiting for a reference message trigger to send a reference message. At the beginning of each time window, the TTCAN logic evaluates the scheduler entries for the following time window and prepares the setup of the corresponding message for the next transfer window. If the reference trigger becomes active after the end of the transmit enable window, but still during the setup phase, the prepared message will be sent out instead of the reference message. After this erroneously sent message, the reference message will be sent out correctly. The error does not occur if the reference trigger becomes active after the end of the setup time.

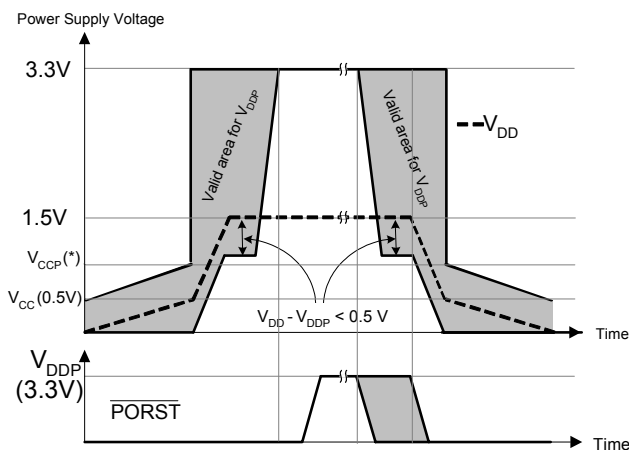
Figure 14 Exemplary power-up/down sequence

As per Data Sheet, $V_{DD} - V_{DDP} < 0.5 \text{ V}$ has to be valid at any time in order to avoid increased latch-up risk. The figure below shows the possible V_{DDP} values as shaded region for an exemplary V_{DD} ramp. Moreover, the following rules apply:

- V_{DDEBU} and all analog voltages (V_{DDOSC3} , V_{DDM} , V_{DDMF} , V_{DDFL3}) must also follow V_{DDP} power-up/down sequence.
- V_{DDAF} , V_{DDOSC} must follow V_{DD} power-up/down sequence.
- The absolute value of the maximum allowed deviation between any two supplies is 0.5 V while the 1.5V supplies are below their specified operating conditions.

Note: V_{CC} and V_{CCP} in [Figure 14](#) refer to devices with [PWR_TC.P009](#) erratum.

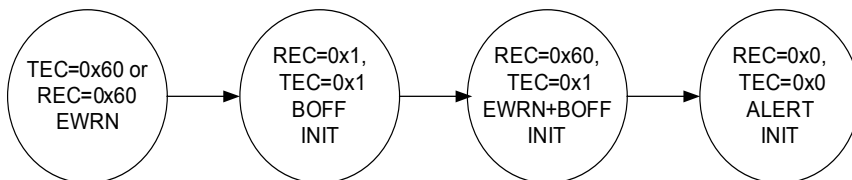
Figure 15 Alert Interrupt Behavior in case of Bus-Off

MultiCAN_AI.H007 Alert Interrupt Behavior in case of Bus-Off

When the threshold for error warning (EWRN) is reached (default value of Error Warning Level EWRN = 0x60), then the EWRN interrupt is issued. The bus-off (BOFF) status is reached if $TEC > 255$ according to CAN specification, changing the MultiCAN module with REC and TEC to the same value 0x1, setting the INIT bit to 1_B, and issuing the BOFF interrupt. The bus-off recovery phase starts automatically. Every time an idle time is seen, REC is incremented. If REC = 0x60, a combined status EWRN+BOFF is reached. The corresponding interrupt can also be seen as a pre-warning interrupt, that the bus-off recovery phase will be finished soon. When the bus-off recovery phase has finished (128 times idle time have been seen on the bus), EWRN and BOFF are cleared, the ALERT interrupt bit is set and the INIT bit is still set.

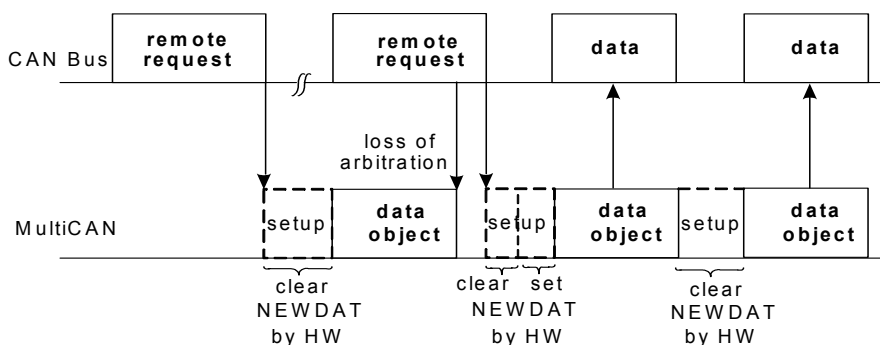
Figure 16 Loss of Arbitration

When the appropriate message object (data frame) triggered by the first remote frame wins the arbitration, it will be sent out and `NEWDAT` is not reset. This leads to an additional data frame, that will be sent by this message object (clearing `NEWDAT`).

There will, however, not be more data frames than there are corresponding remote requests.
