**Device**                **XC886C-8FF**  
**Marking/Step**      **ES AB**  
**Package**            **PG-TQFP-48**

This Errata Sheet describes the deviations from the current user documentation. The module oriented classification and numbering system uses an ascending sequence over several derivatives, including already solved deviations. So gaps inside this enumeration can occur.

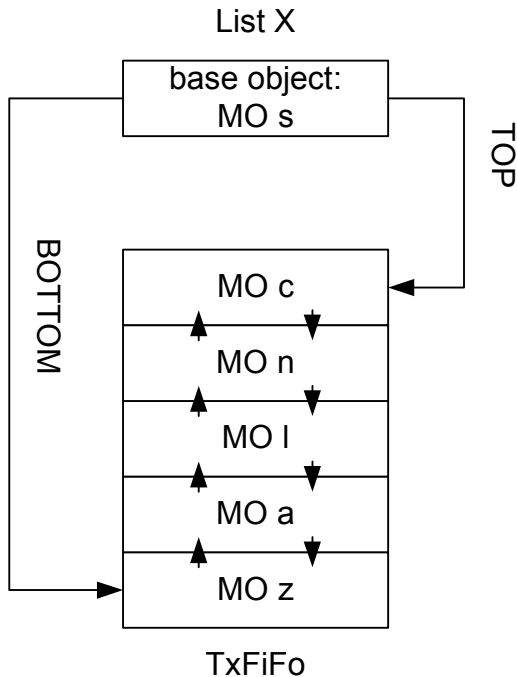
**Figure 6**    **FIFO structure**

After the successful transmission of a Tx FIFO element, a Tx overflow interrupt is generated if the FIFO base object fulfils these conditions:

If Tx FIFO overflow interrupt needed, take the FIFO base object out of the circular list of the Tx message objects. That is to say, just use the FIFO base object for FIFO control, but not to store a Tx message.
