## Errata

This errata sheet is for MB90820B Series Hardware Manual Rev. 2\_(CM44-10147-2E).

F<sup>2</sup>MC-16LX  
16-BIT MICROCONTROLLER  
MB90820B Series  
HARDWARE MANUAL

2012.12.7

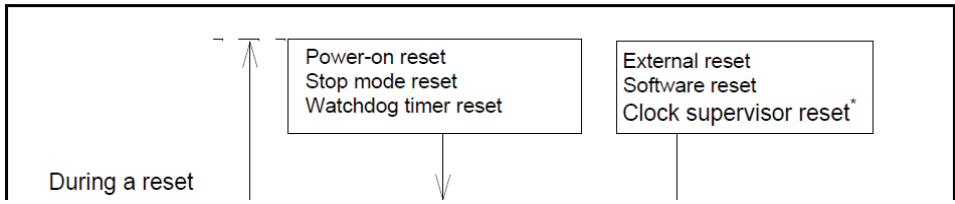
Date	Page	Item	Description																				
2012/12/7	69	3.4	<p>"Figure 3.4-1 Reset operation flow" should be corrected as indicated by the shading below.</p> <p>(Error)</p> <div>

</div> <p style="text-align: right;">*: MB90F828B only</p> <p>(Correct)</p> <div>

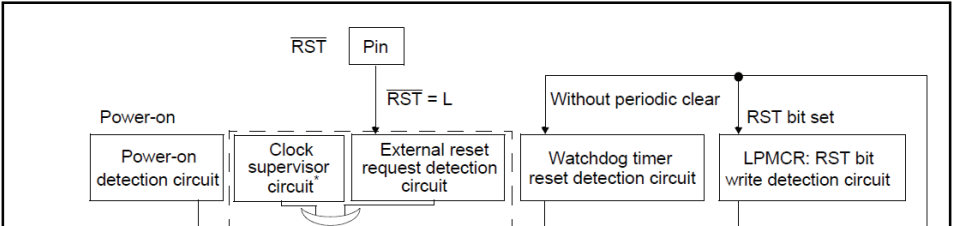
</div> <p style="text-align: right;">[mcu_doc1192]</p>																				
2012/12/7	71	3.5	<p>"Figure 3.5-1 Block diagram of reset cause bits" should be corrected as indicated by the shading below.</p> <p>(Error)</p> <div>

</div> <p style="text-align: right;">*: MB90F828B only</p> <p>(Correct)</p> <div>
