TC1775

32-Bit Single-Chip Microcontroller

TC1775 Documentation Addendum

Revision History: 2004-11

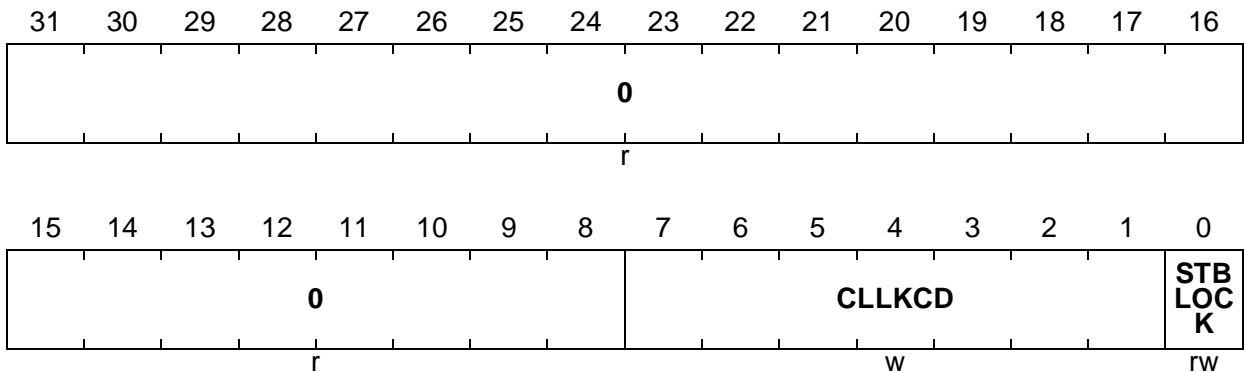
DMU_CON
DMU Control Register **Reset Value: 0000 0000_H**

Page 9-11

The description of register DMU_CON must be corrected in the following way:

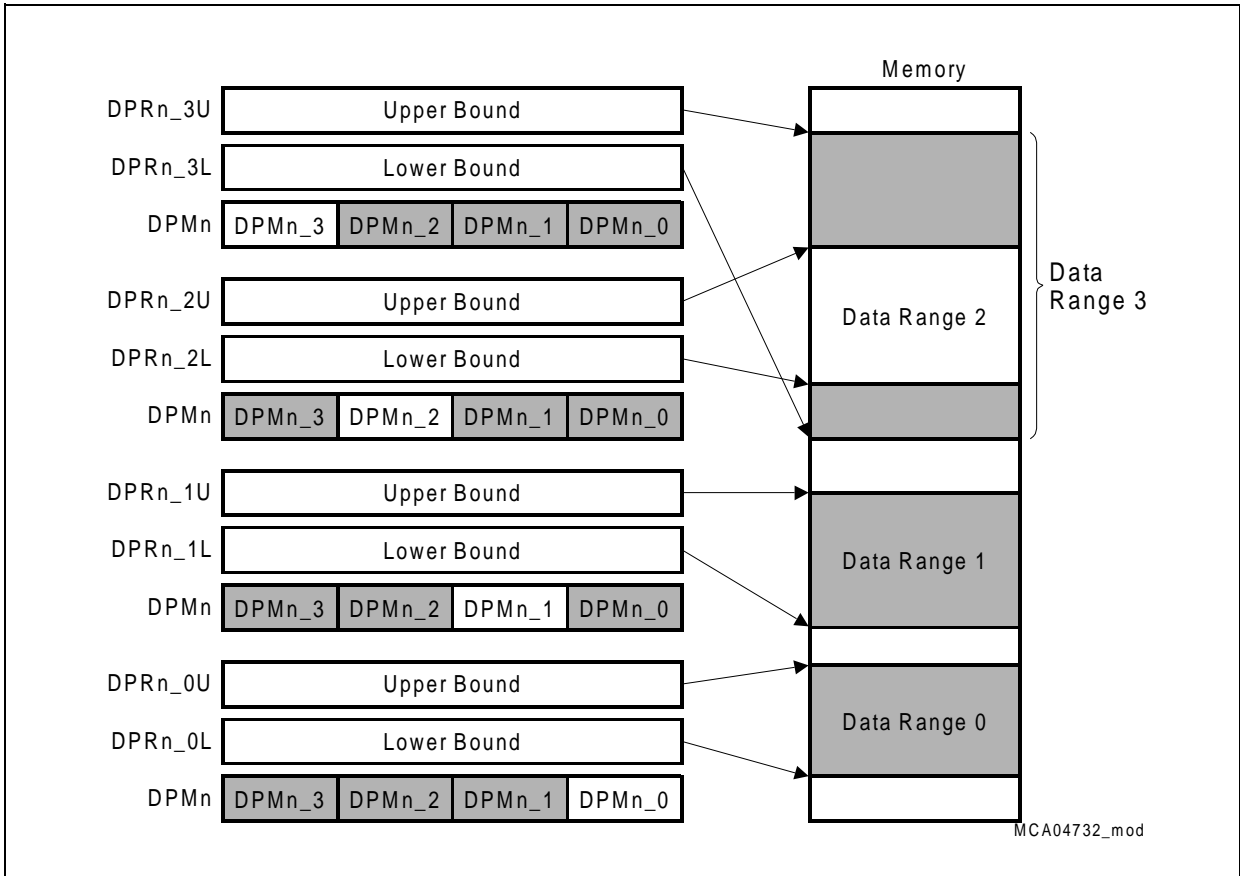
Figure 10-2 Example Configuration of a Data Protection Register Set

The Data Range numbering in **Figure 10-2** is not correct. The figure must be updated in the following way:

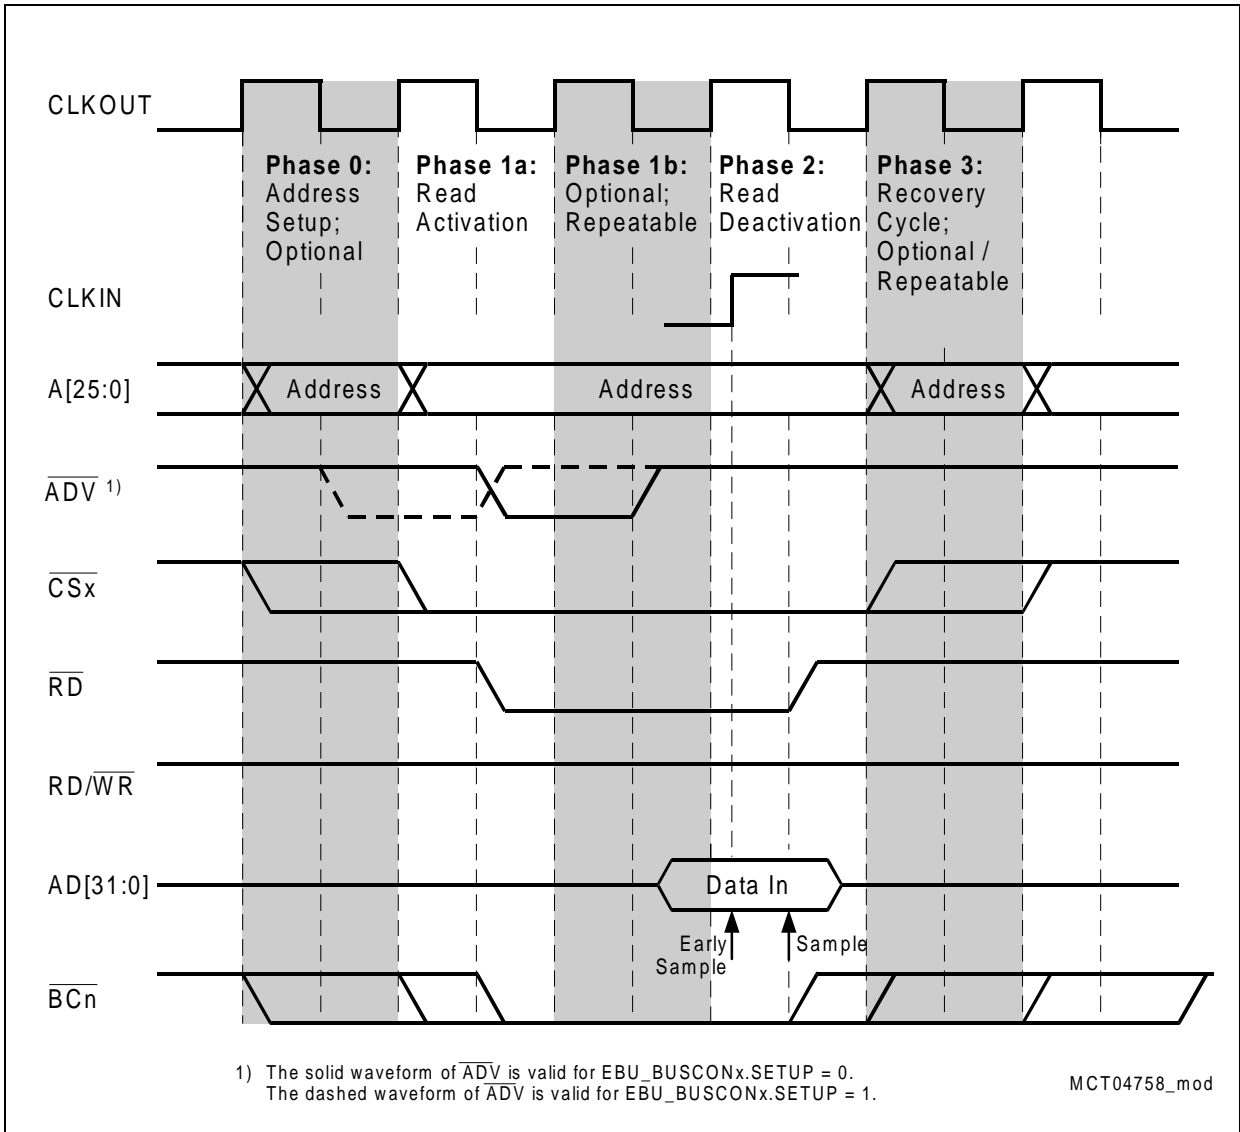
Figure 12-6 Basic Read Access Timing in Demultiplexed Mode

The TC1775 provides an additional demultiplexed read timing feature called “Early Sample”. This feature is shown in the corrected **Figure 12-6** and controlled via bit 26 (called ES for “Early Read Sample Select”) in register EBU_BUSCONx. EBU_BUSCONx.ES must be added as described on **Page 12**).

Figure 12-6 and **Figure 12-7** are also corrected concerning signal \overline{ADV} . As shown in these two figures, the \overline{ADV} timing depends on the setting of bit `EBU_BUSCONx.SETUP`.

Due to this new feature, the paragraph starting with “Phase 2: ...” on page 12-21 must be replaced by the following description:

- “Phase 2: This cycle is always part of a read access. Please note that the read signal is deactivated (high) on the falling edge of CLKOUT. The data input is sampled and latched with this clock edge (EBU_BUSCONx.ES = 0) or with the rising edge of CLKIN when early sample is enabled with EBU_BUSCONx.ES = 1.”

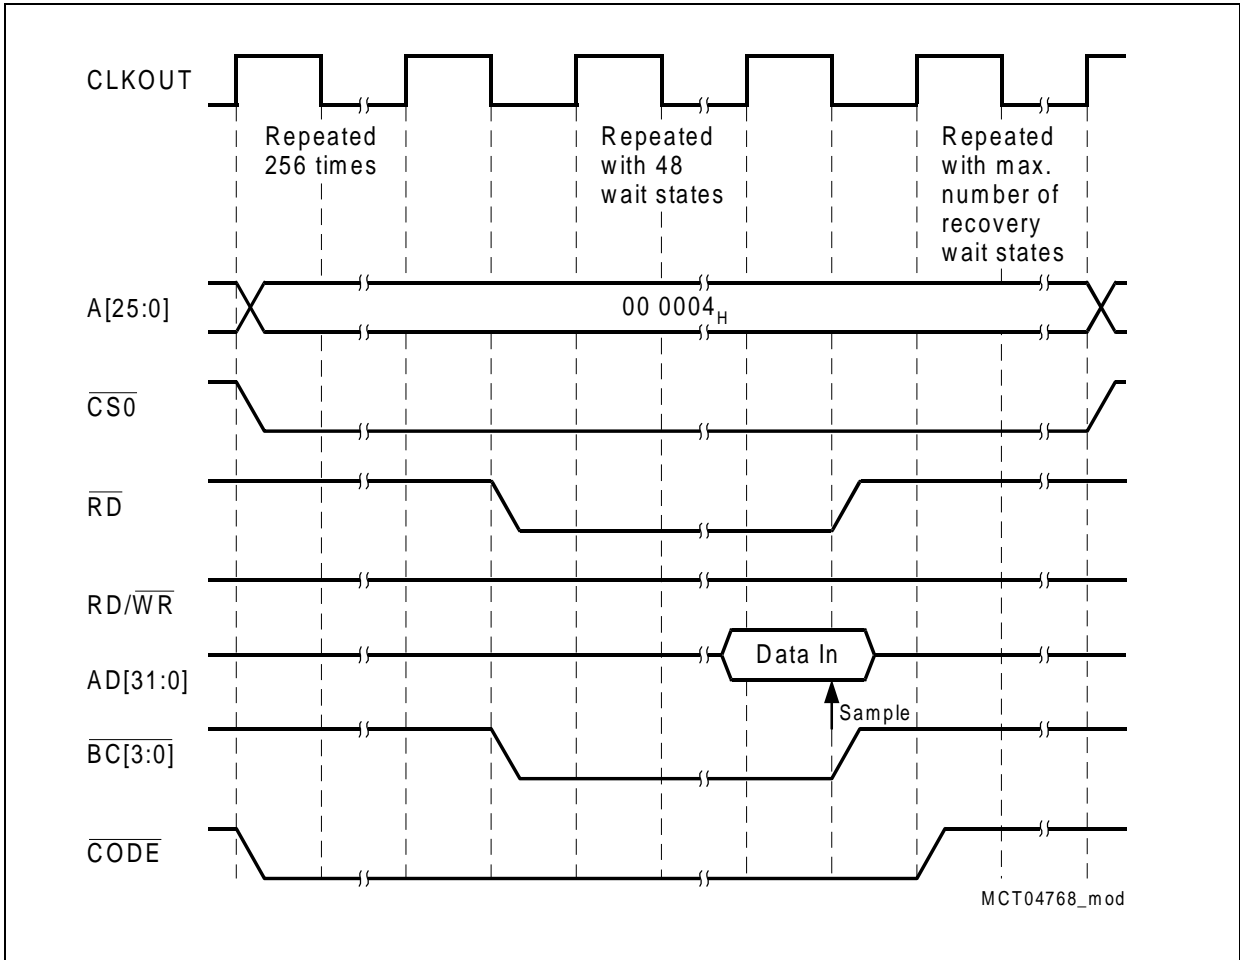
Figure 12-16 EBU Boot Process after Reset

Figure 12-16 should be update with the following drawing:

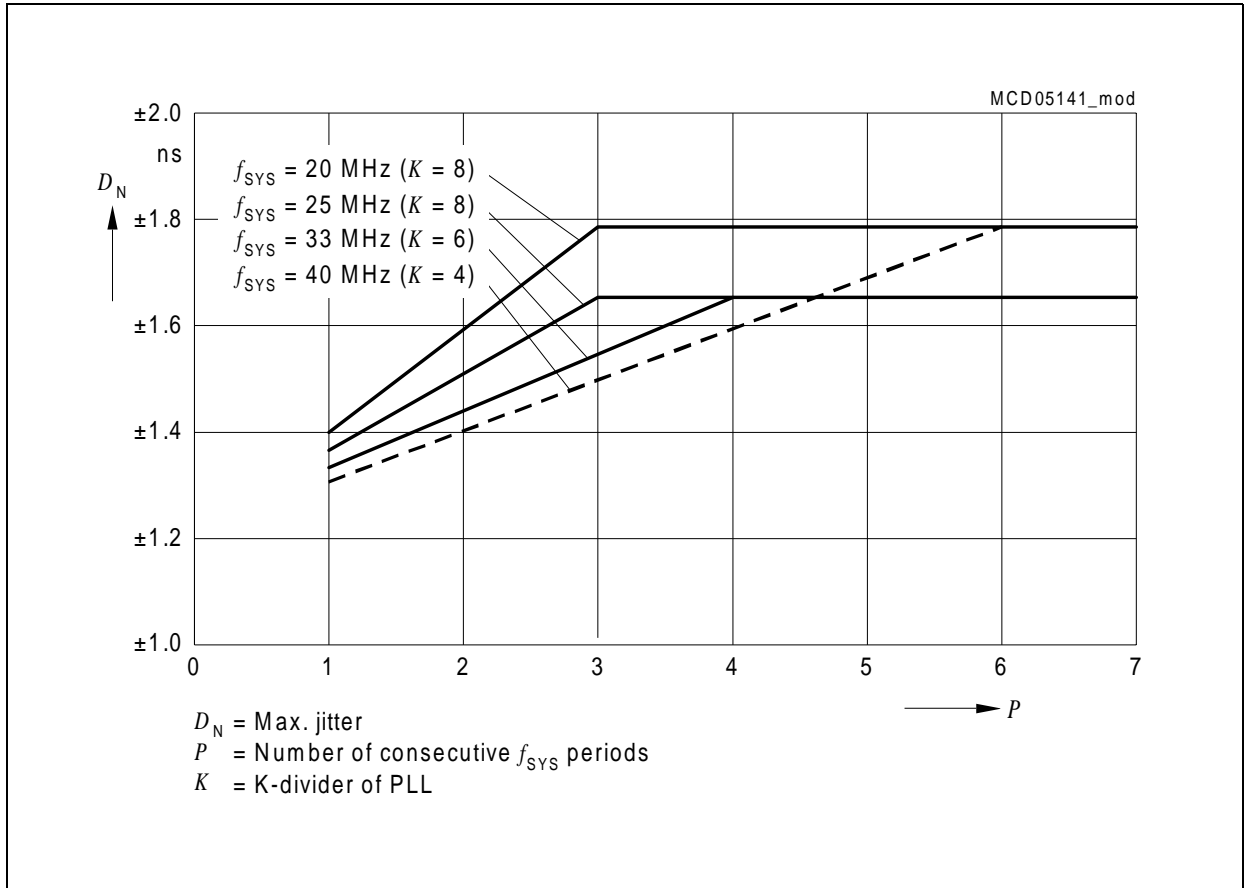
Figure 31 Approximated Maximum Accumulated PLL Jitter for Typical System Clock Frequencies f_{SYS}

Figure 31 must be corrected as shown below.

Caused by the correction of Figure 31 on page 83, the last paragraph must be updated as follows: “Figure 31 gives an example for typical jitter curves with $K = 4$ @40 MHz, $K = 6$ @33 MHz, and $K = 8$ @20/25 MHz.”
