TC1796

32-Bit Single-Chip Microcontroller

TC1796 Documentation Addendum

Revision History: V1.2 2007-04

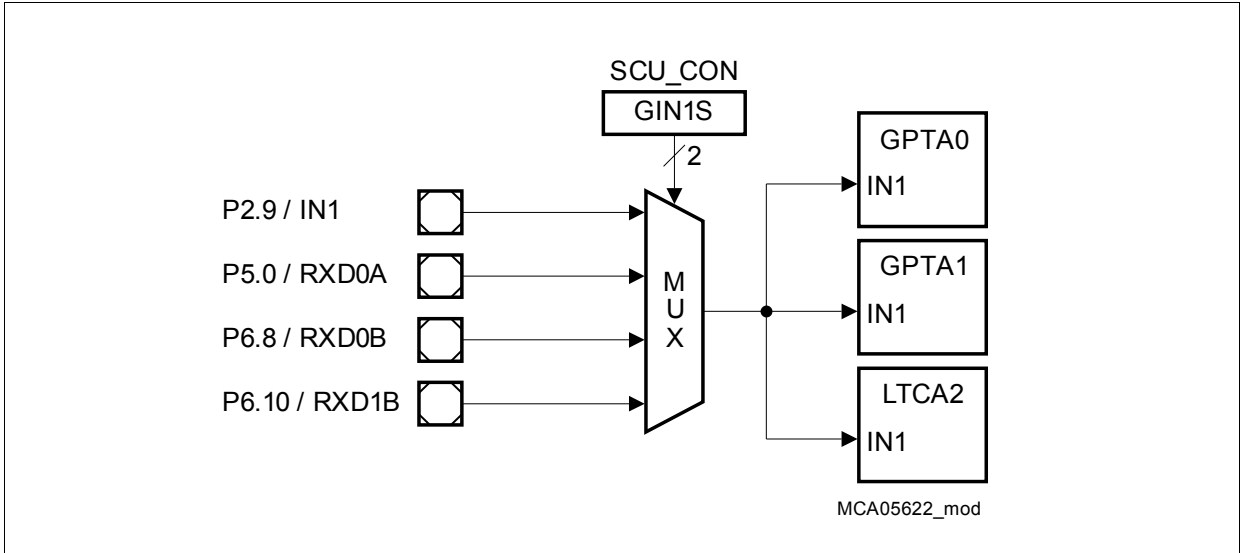
Figure 5-11 GPTA0/GPTA1/LTCA2 Input IN1 Control

The first sentence on the top “In the TC1796, ...” must be replaced by the following sentence: “In the TC1796, the input lines IN1 of the **GPTA0**, **GPTA1**, and **LTCA2** modules can be used to measure the baud rate of an ASC0 or ASC1 receiver input signal.” Additionally, Figure 5-11 must be corrected.

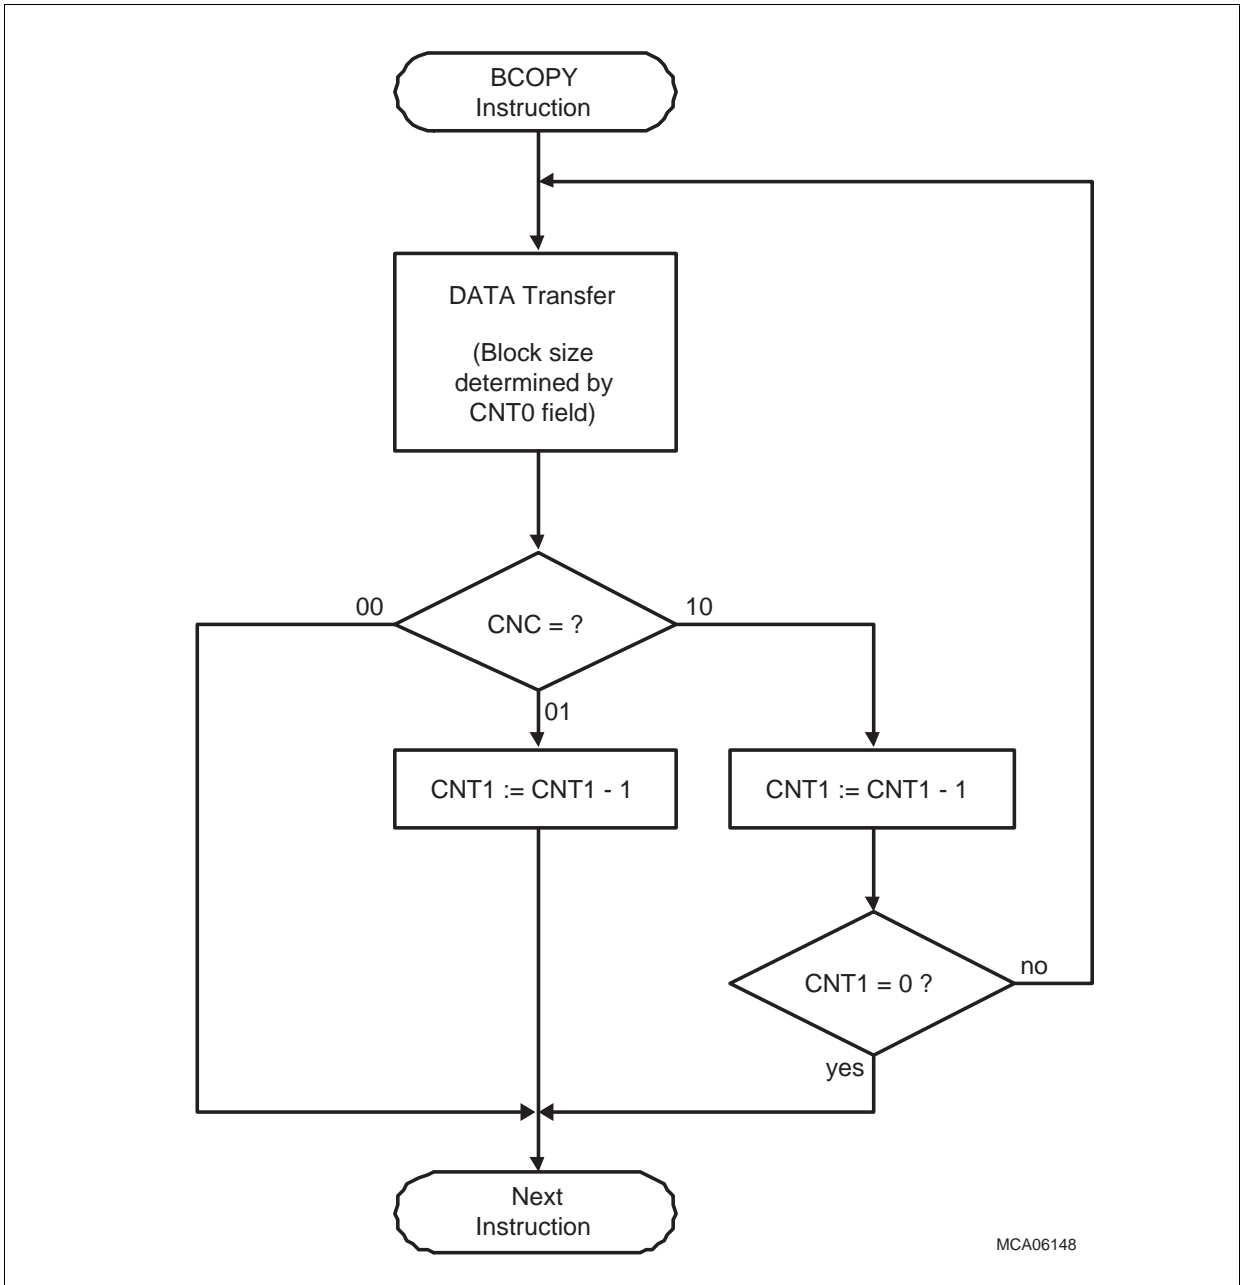
Figure 11-14 Counter Operation for BCOPY Instruction

Figure 11-14 must be replaced by the following figure (block "DATA Transfer" has been changed):

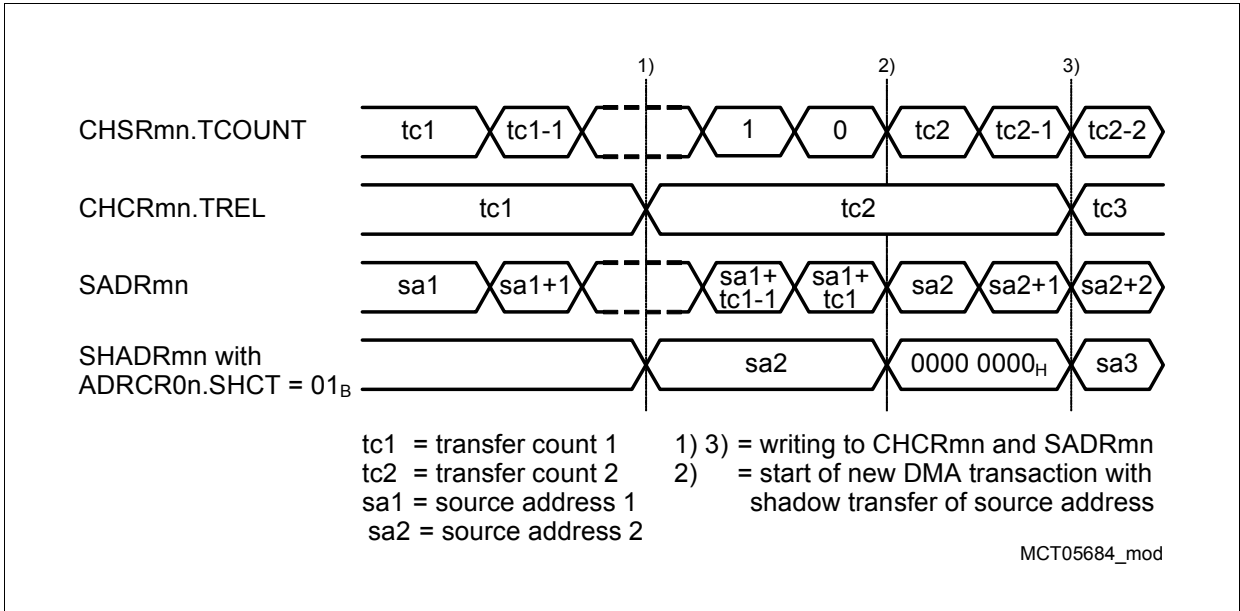
Figure 12-5 Channel Request Control

The wordings “SHADR0n with CHCR0n.SHCT = 01_B” on the left of the first waveform from the bottom of Figure 12-5 must be replaced with “SHADR0n with ADRCR0n.SHCT = 01_B”.

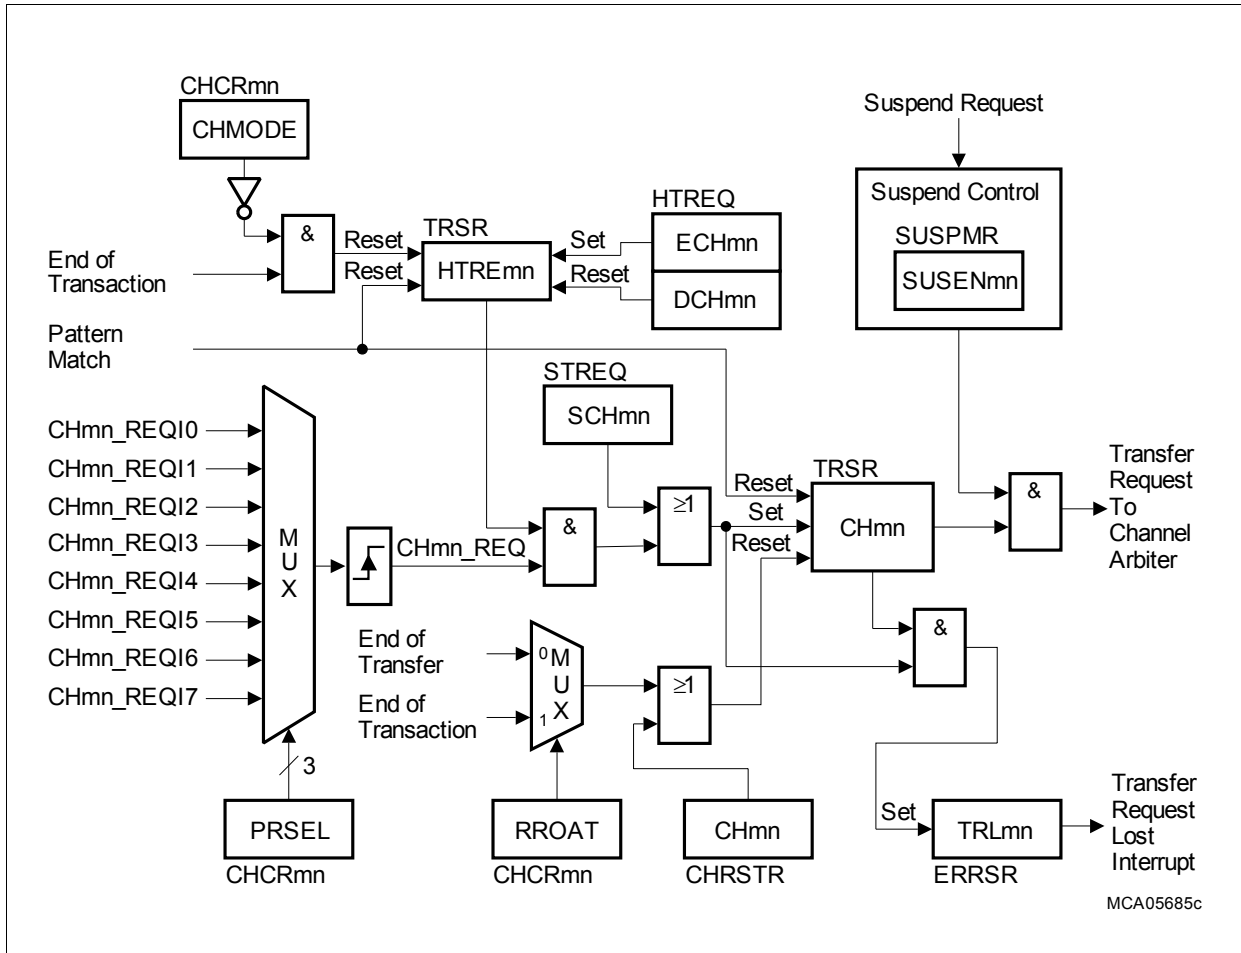
Figure 12-6 Channel Request Control

Figure 12-6 must be updated caused by the changes on pages 12-34 and 12-49.

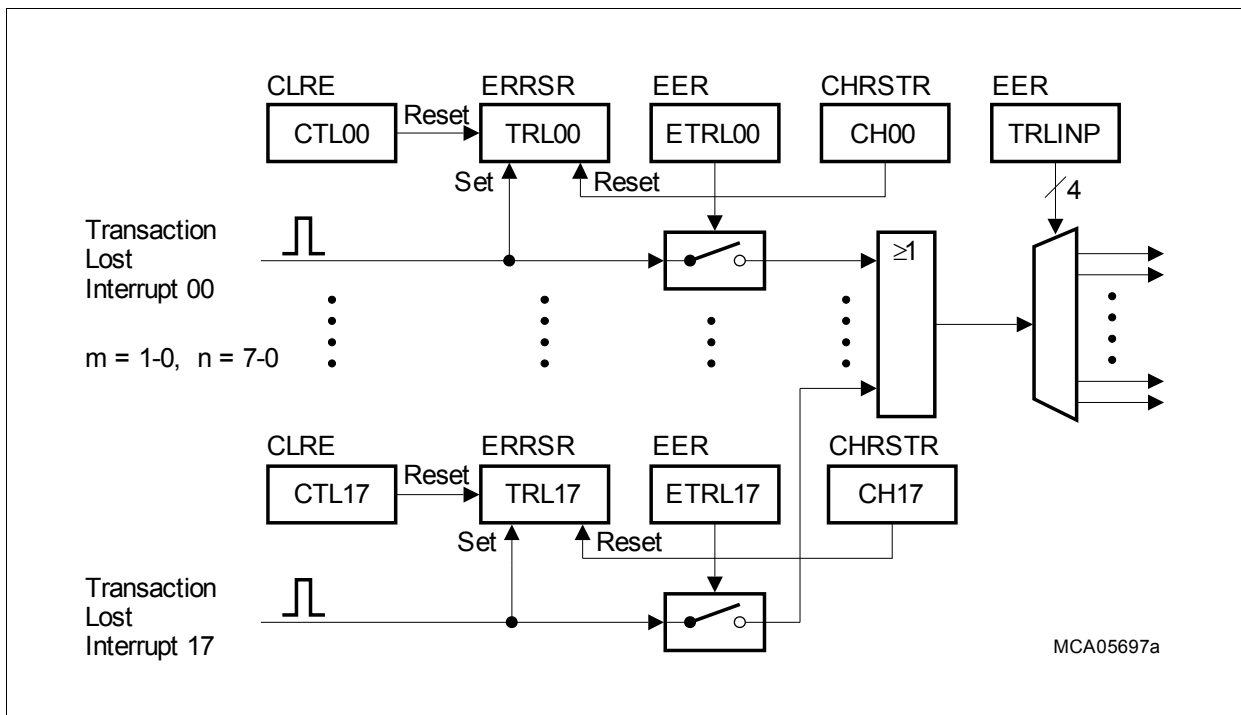
Figure 12-18 Transaction Lost Interrupt

In Section 12.1.8.2, the register name EERSR must be replaced by ERRSR in the third sentence of the first paragraph, first sentence of the second paragraph and within Figure 11-18. The corresponding text must be replaced by :

Figure 12-18 must be replaced by:

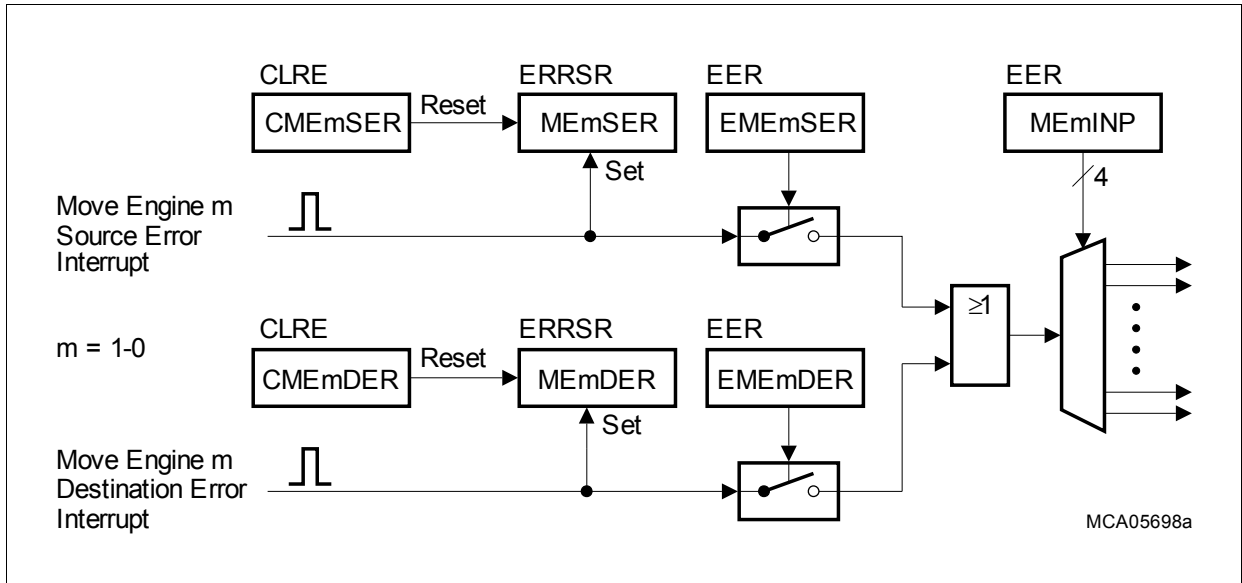
Figure 12-19 Move Engine Interrupts

In Section 12.1.8.3, the register name EERSR must be replaced by ERRSR in the first sentence of the third paragraph and within Figure 11-19. The corresponding text must be replaced by :

Figure 12-19 must be replaced by:

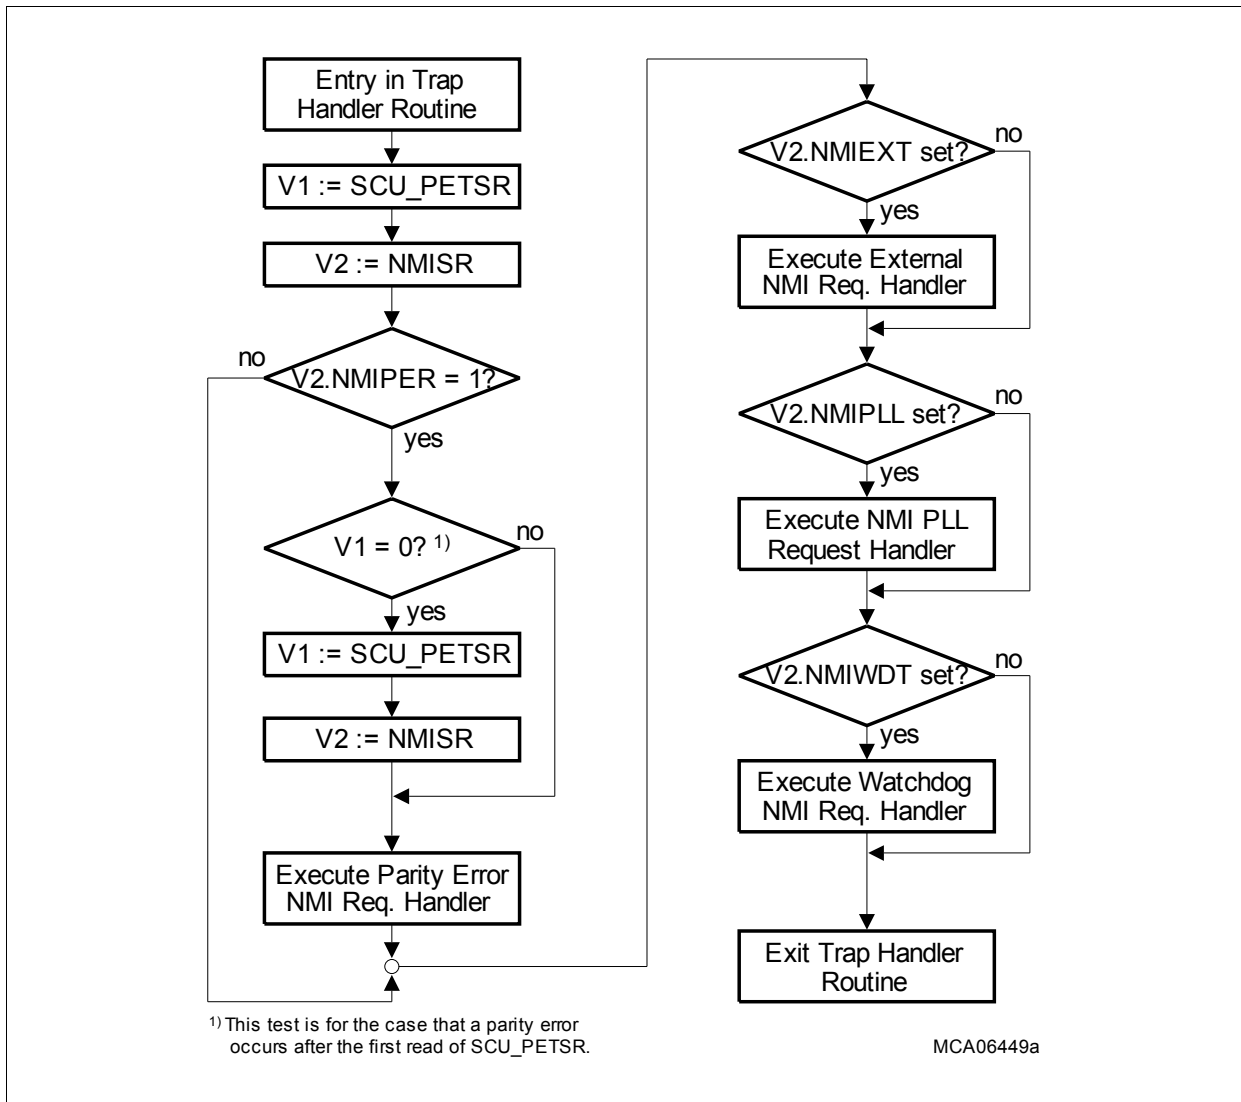
Figure 14-5 NMI Trap Handler Routine for Parity Error Handling

Figure 14-5 must be updated with the following corrected drawing.

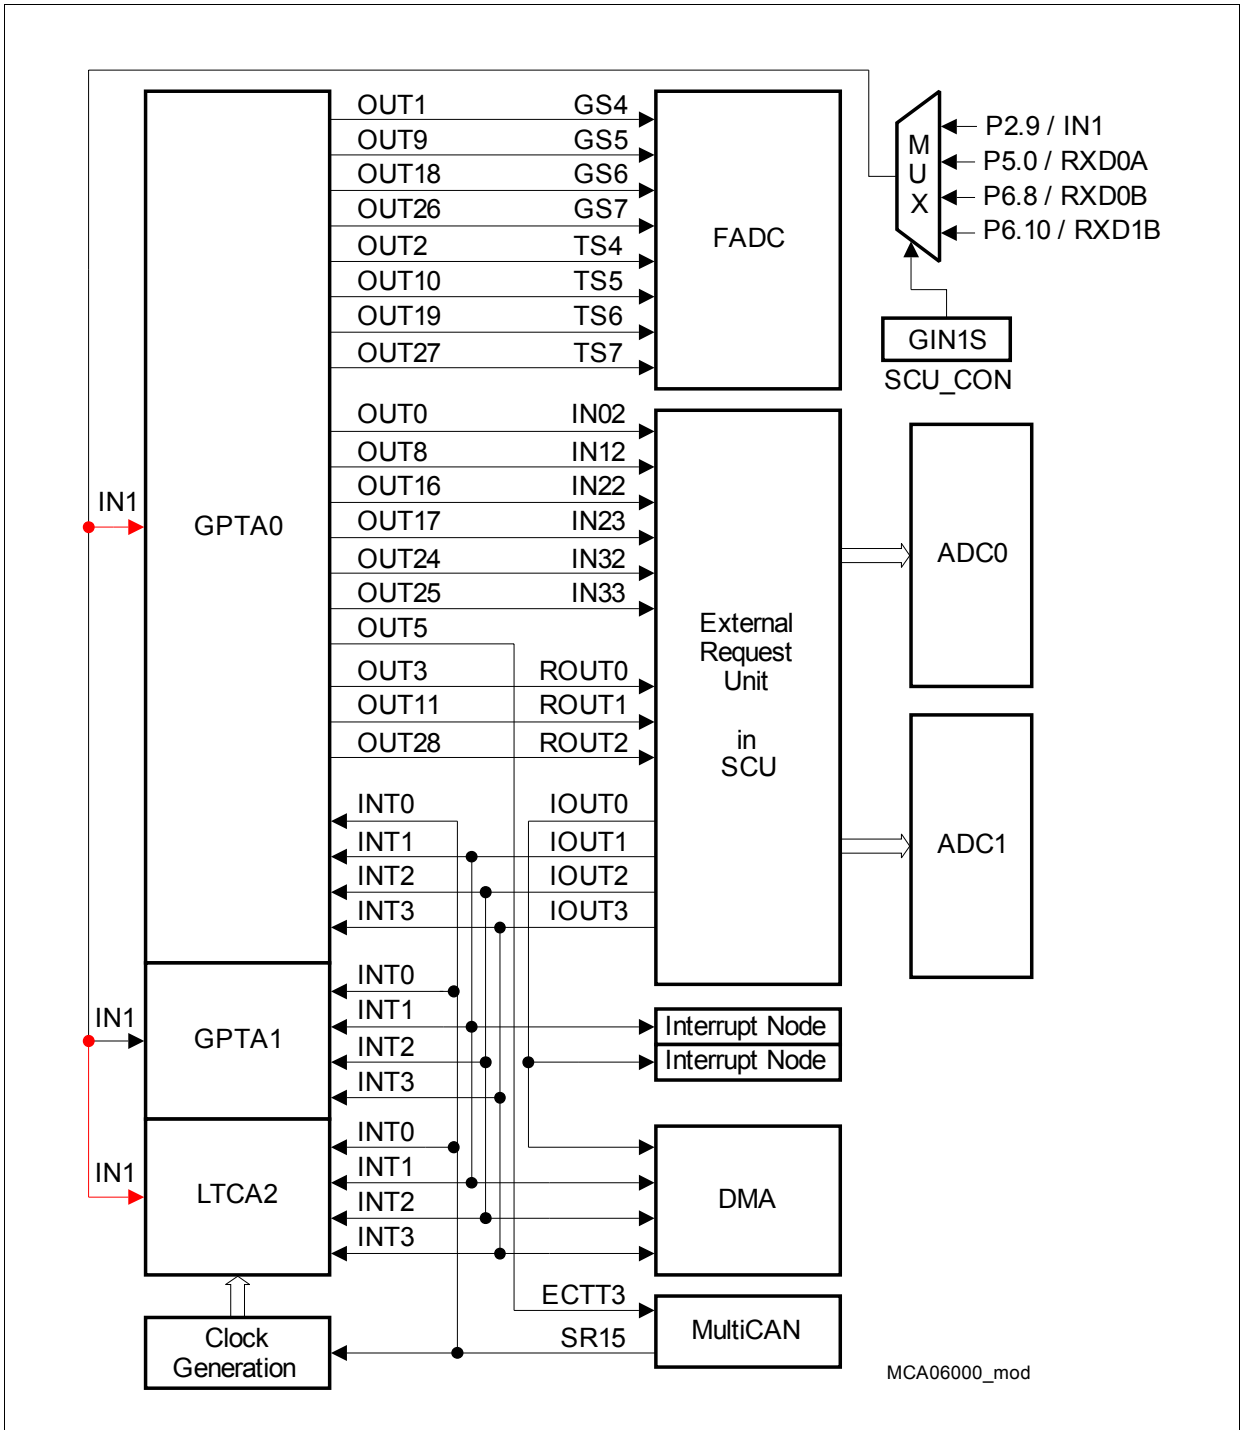
Figure 24-91 Connections of GPTA with On-Chip Modules

Figure 24-91 must be replaced by the following figure: The red marked parts indicate the changes.
