TC1796

32-Bit Single-Chip Microcontroller

TC1796 Documentation Addendum**Revision History: V2.0 2008-04**

Page	Subjects (major changes since last revision)
–	This is the first release that refers to the TC1796 User's Manual V2.0 , July 2007

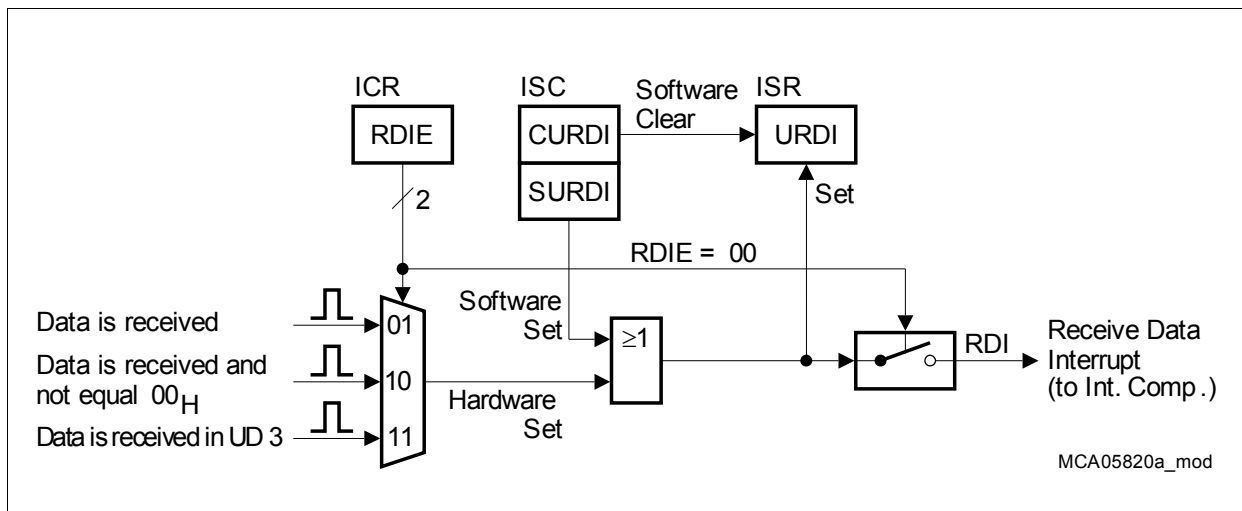
Figure 21-26 Receive Data Interrupt Control

In the paragraph above Figure 21-26 "ISC.SRDI and ISC.CRDI" must be changed into "ISC.SURDI and ISC.CURDI".

Figure 21-26 must be updated with the following figure (output signal on the right side):
