**SEE/SEL Final Report for
Cypress Semiconductor CYRS1061,
16-Mbit SRAMs**

**Fab Lot:
L9903000, Wafer #2**

1.0 Test Overview

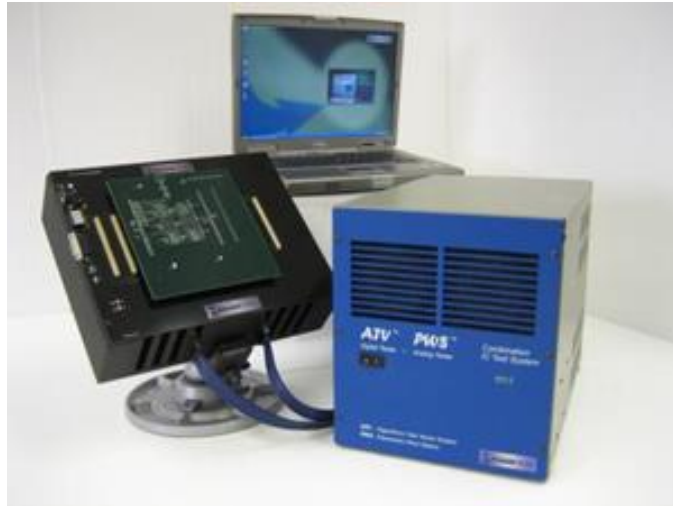
Figure 2. ATV Test System used for SEE Testing

Testing was performed using a JD Instruments Algorithmic Test Vector (ATV) system shown in Figure 2. The main chassis of the tester was located in the SEE irradiation room and connected to the test head mounted on the actuating arm of the chamber. A USB cable connected the tester to a controlling computer located in the experimenter area.

All testing was done with one device at a time inserted into a test card mounted on the ATV test head.

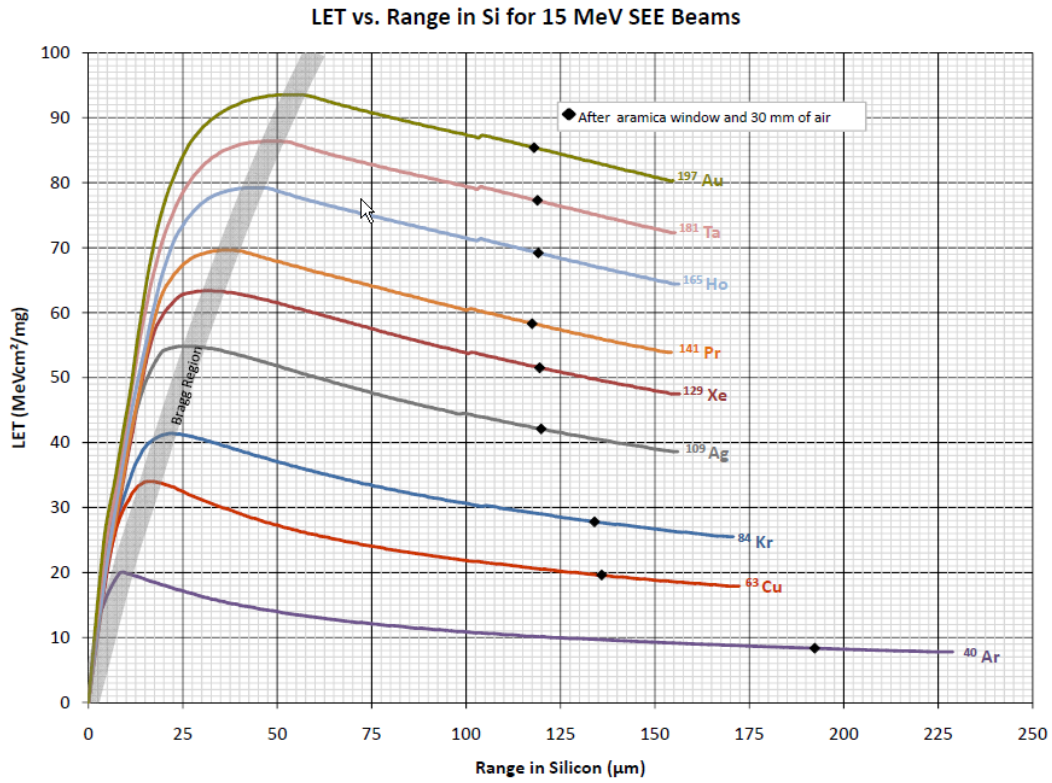
Figure 3. Ion Range vs. LET, Various Ions, 15 MeV beam, Texas A&M Cyclotron

Figures 3 and 4 show ranges vs. LET for various ions available with this set-up. Note that all ions used had a range of at least 100u in silicon

Parts were irradiated in air at a distance of 30mm from the aramica window of the source. Testing was performed using four ion species in the 15 MeV SEE beam. Xenon (^{129}Xe) was used for LETs between 52 and 80 ($\text{MeV}\cdot\text{cm}^2/\text{mg}$), Krypton (^{84}Kr) for LETs of 28 and 38 ($\text{MeV}\cdot\text{cm}^2/\text{mg}$), Argon (^{40}Ar) for an LET of 8.4 ($\text{MeV}\cdot\text{cm}^2/\text{mg}$) and Nitrogen (^{14}N) for LETs of 1.3 and 2.1 ($\text{MeV}\cdot\text{cm}^2/\text{mg}$).

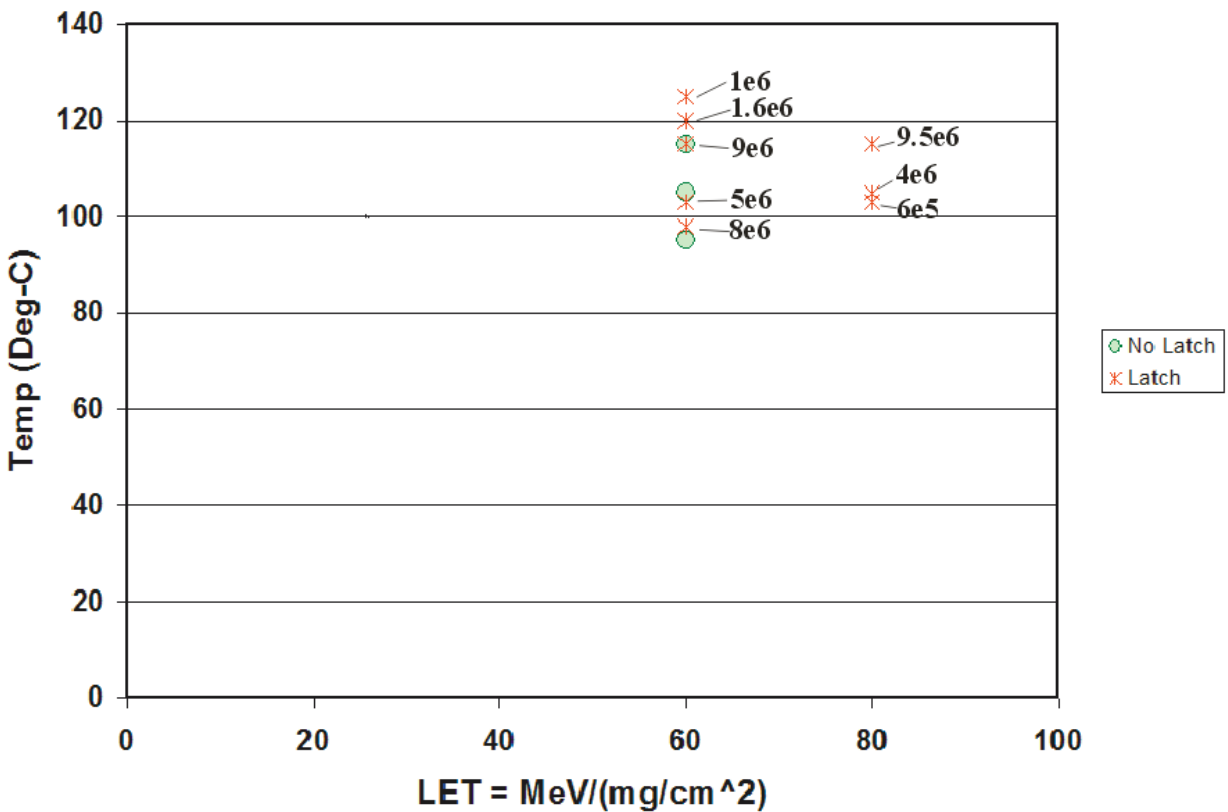
Figure 8. SEL RUN Log for CYRS1061 QDR Memories

A series of LET and temperature conditions were tested to see if a combination could be determined at which no parts would latch. Figure 7 shows the SEL portion of the run log which details the results of these tests. Runs that do not have an entry under “Fluence to Latch” did not latch up to the target fluence of 1.00E+07 ions/cm². Figure 8 plots these results.

The target fluence to demonstrate no SEL is $1e7$ ions/cm². The data show that 3 exposures with an LET of 60 MeV/(mg/cm²) did not latch. Several other exposures at 60 MeV/(mg/cm²) almost made the $1e7$ threshold (e.g. 8e6, 9e6 ions/cm²).

- 1) No latch-up events were observed for devices at 95⁰C and irradiated with ions having an LET of 60MeV(mg/cm²) to a fluence of 1E7 ions/cm².
- 2) Memory cell upset testing was performed on 4 devices in normal operating mode (EDAC ON) and a special test mode (EDAC OFF). Upset cross-sections were very repeatable across all devices for the ECC OFF test mode. In normal operating mode (EDAC ON) random memory upsets were corrected in almost all cases.
- 3) Device level upset cross-sections were measured when devices were operated in a dynamic mode. Dynamic operating error rates were calculated for several orbits and solar conditions.
- 4) No SEFI events were observed up to 80 MeV(mg/cm²)

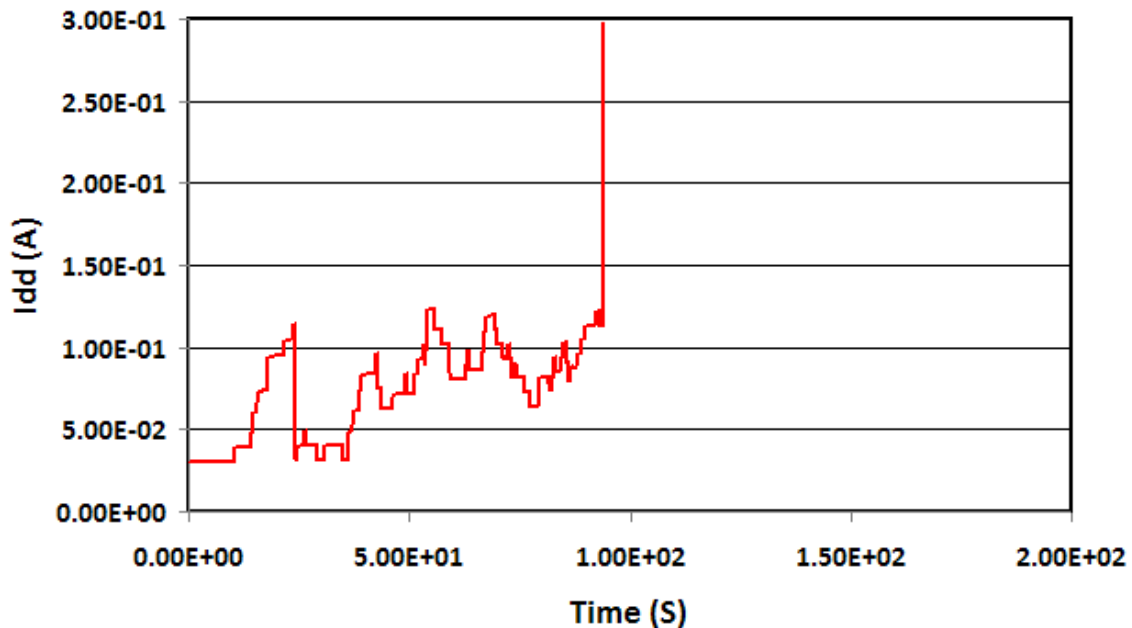
Figure 10. Idd vs Fluence during SEL Exposure, Run 45

The variation of I_{dd} vs. fluence in figure 9 was typical of that seen in most of the SEL exposures. Figure 10 shows a slightly different behavior in run #45 (LET = 60 MeV/(mg/cm²), Temperature 125⁰C).

In run 45 Idd appeared to continuously rise and then stabilize around 100mA. There was some speculation that this higher average current might have caused self heating that made the DUT more susceptible to latchup resulting in latchup at the relatively low fluence of $1e6$ ions/cm².

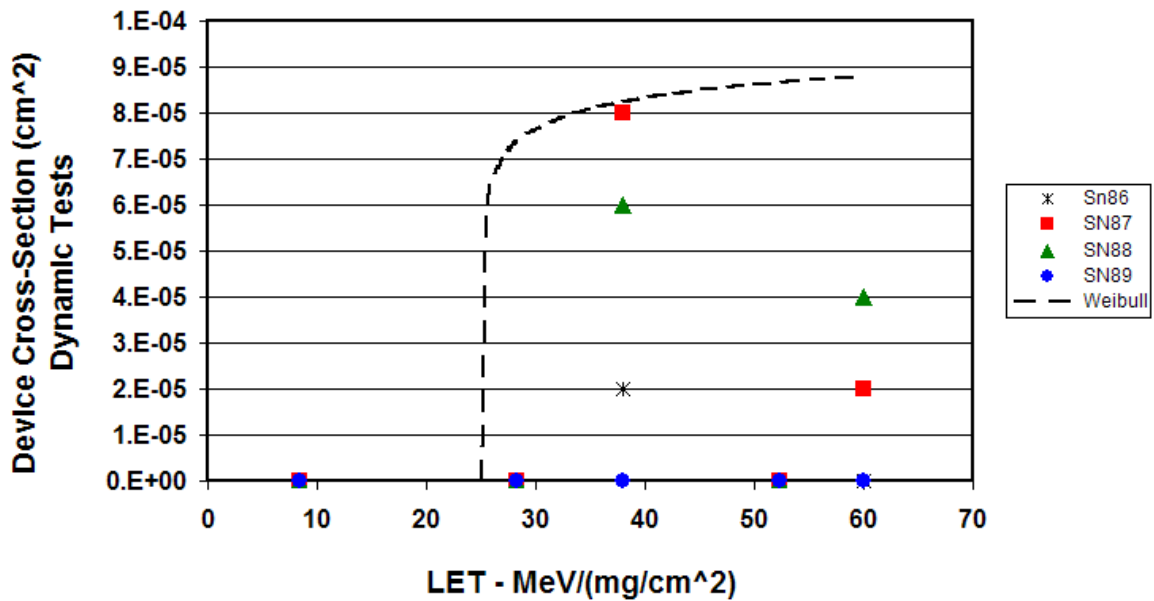
Figure 19. Device Level Upsets Cross-Sections, Dynamic Testing

Figure 19 is a plot of the device level upset cross-sections for dynamic errors along with a Weibull curve that encloses all detected failures.

Weibull parameters for the curve in Figure 19 are as follows:

OnSet LET = 25 MeV/(mg/(cm²))
 Width = 0.7
 Exponent = 0.2
 Saturated X-Section = $9.9e3 \text{ u}^2 = 9.9e-5 \text{ cm}^2$

Using these parameters figure 20 shows the device level upset rates for these devices in a selection of conditions
