Errata Sheet

V 1.2, 2002-02-22

Device	**SAF-C161JI-32RF, SAK-C161JI-32RF, SAF-C161JC-32RF, SAF-C161JC-32RF, SAF-C161CS-32RF, SAF-C161CS-32RF**
Marking/Step	**Step (E)ES-AB, AB**
Package	**P-TQFP-128-2**

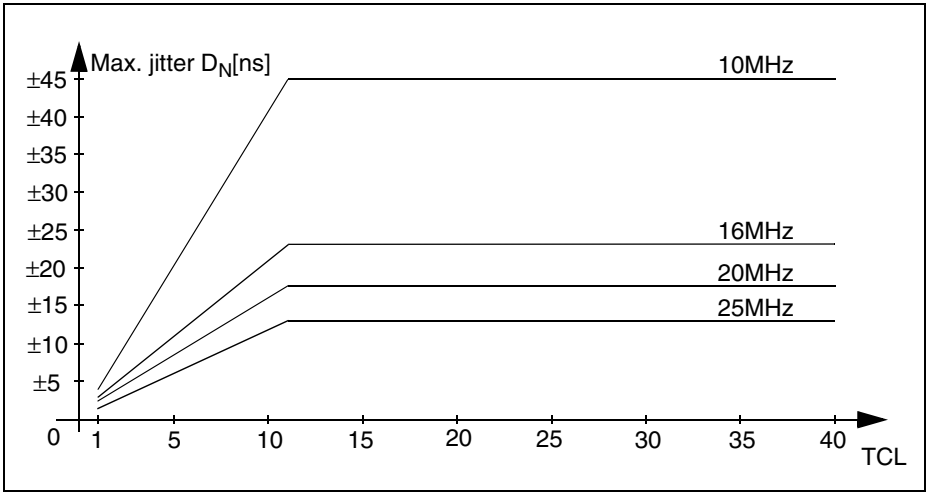
The additional jitter has the maximum effect if only one TCL is considered (period jitter). This can have an influence to the bus timings with one TCL.

The additional jitter decreases with the number of consecutive TCLs (accumulated jitter). The accumulated jitter has an effect on timings with more than one TCL (certain bus timings, CAN bus timing, Serial interface).

New value of the additional jitter.

IIn case that the additional jitter causes problems in the system which cannot be relaxed with software adapted timing parameters, then direct drive or prescaler mode can be used. If the maximum frequency of the on-chip oscillator (16 MHz) is not sufficient then an external clock generator can be used.
