Errata Sheet

August 8, 2003 / Release 1.0

Device:	**SAB-C161PI-LM, -L25M** **SAF-C161PI-LM, -L25M** **SAB-C161PI-LM3V** **SAF-C161PI-LM3V** **SAB-C161PI-LF, -L25F** **SAF-C161PI-LF, -L25F** **SAB-C161PI-LF3V** **SAF-C161PI-LF3V**
Stepping Code / Marking:	**ES-CA, CA**
Package:	**P-MQFP-100-2, P-TQFP-100-1**

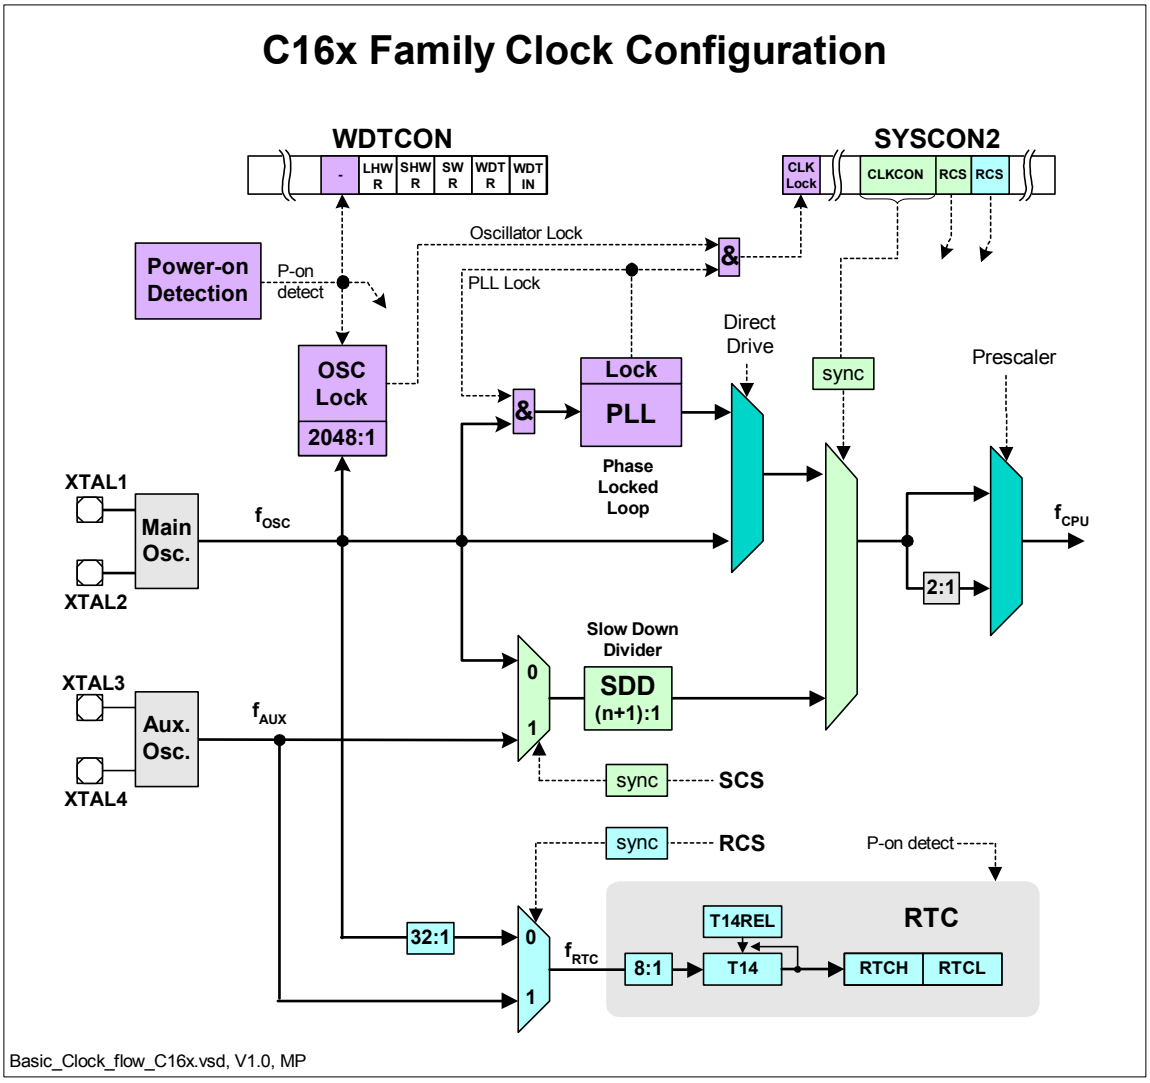
Case 4: NO Clock @ XTAL1 and Power-on Detection FAIL

If the system gets no clock at XTAL1 during power-on and the power-on detection fails then the following settings can be found:

- The real time clock registers are undefined (T14, T14REL, RTCH, RTCL).
- The slow down divider (SDD) may be selected as f_{CPU} clock source (no oscillator watchdog function possible). In that case the system will stop.

Consider the conditions to get a defined clock configuration at power-on.

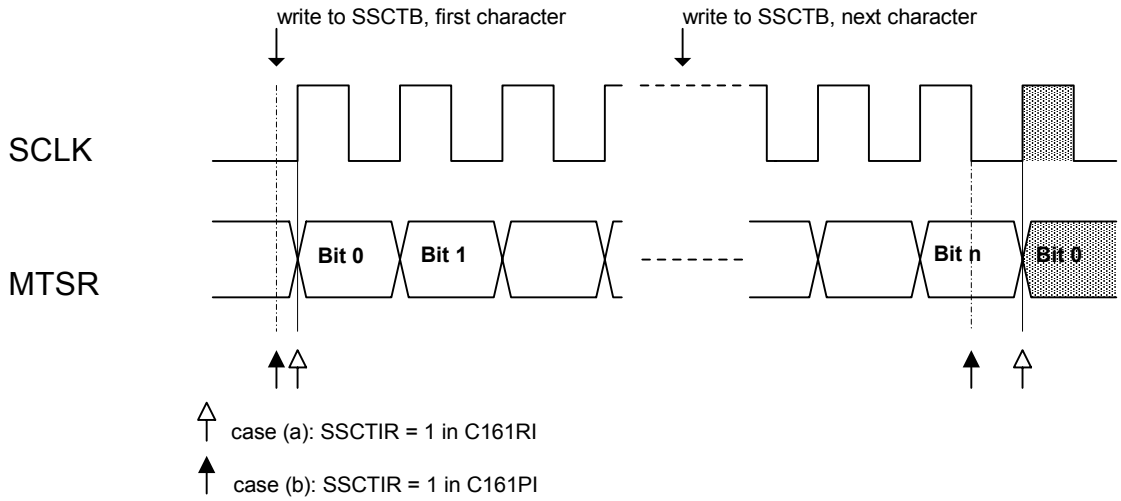
(b) in the **C161PI**, when SSCTB has been written while the transmit shift register was empty (and the SSC is enabled), flag SSCTIR is set to '1' directly after completion of the write operation, independent of the selected baud rate. When the transmit shift register is not empty when SSCTB was written, SSCTIR is set to '1' after the last latching edge of SCLK (= 1/2 bit time before the first shifting edge of the next character). See also e.g. C167CR User's Manual V3.1, p. 12-5.

The following diagram shows these relations in an example for a data transfer in master mode with SSCPO = 0 and SSCPH = 0. It is assumed that the transmit shift register is empty at the time the first character is written to SSCTB:

Typically, in interrupt driven systems, no problems are expected from the modified timing of flag SSCTIR. However, when flag SSCTIR is polled by software in combination with other flags which are set/cleared at the end or at the beginning of a transfer (e.g. SSCBSY), the modified timing may have an effect.
