Errata Sheet

V 1.1, 2006-03

Device	**C505A-4E**
	C505CA-4E
Marking/Step	**Step CA**
Package	**P-MQFP-44**

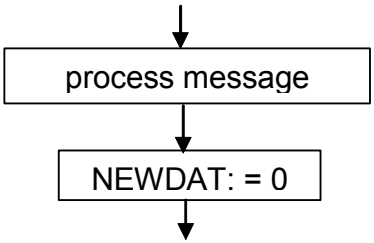
CAN.4: Flowchart sequence in figure in User's Manual regarding Micro-controller handling of the Last Message Object is partly incorrect (C505CA only)

For the software flowchart figure 6-37 in User's Manual 08.97, the correct would be to first 'process message contents' and then to 'clear bit NEWDAT'.
