AURIX™ TC36x errata sheet

Marking/Step: (E)ES-AA, AA

About this document

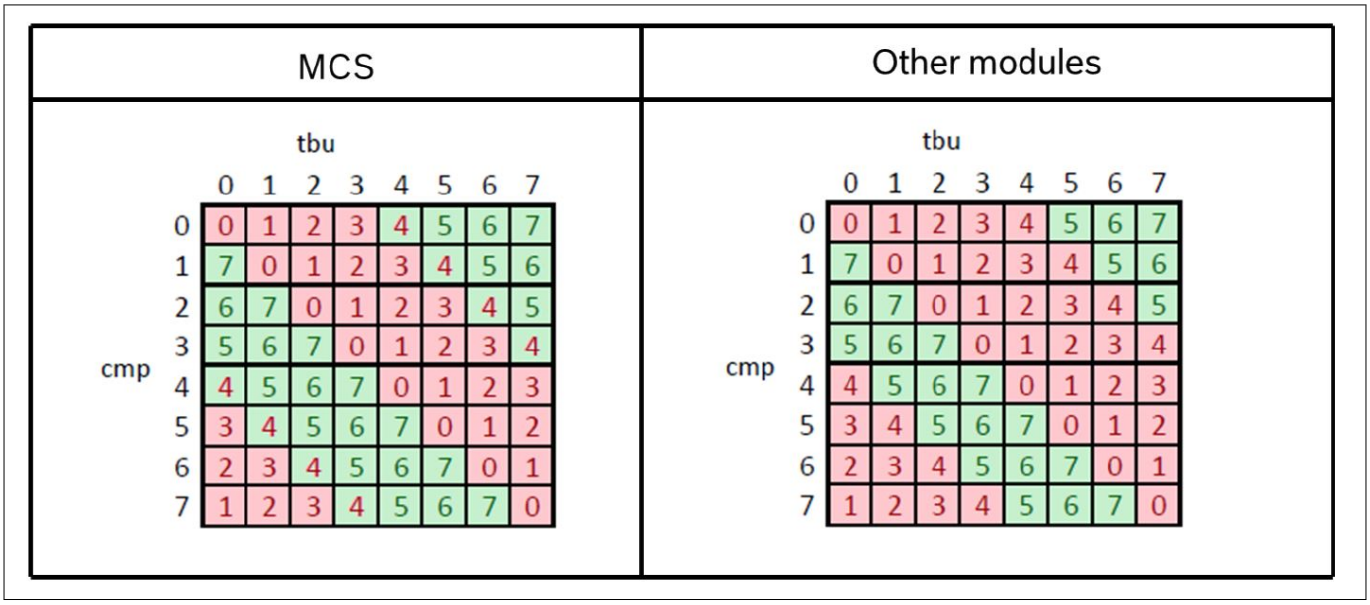
Figure 8 TBU value evaluation MCS against other modules. Red (past) and green (future).

With the revised specification of GTM 4.1 it was revealed that the implementation for the WUCE instruction is not correct for the boundaries. The implementation of the WUCE instruction has an inverted behavior for both boundaries between future and past.

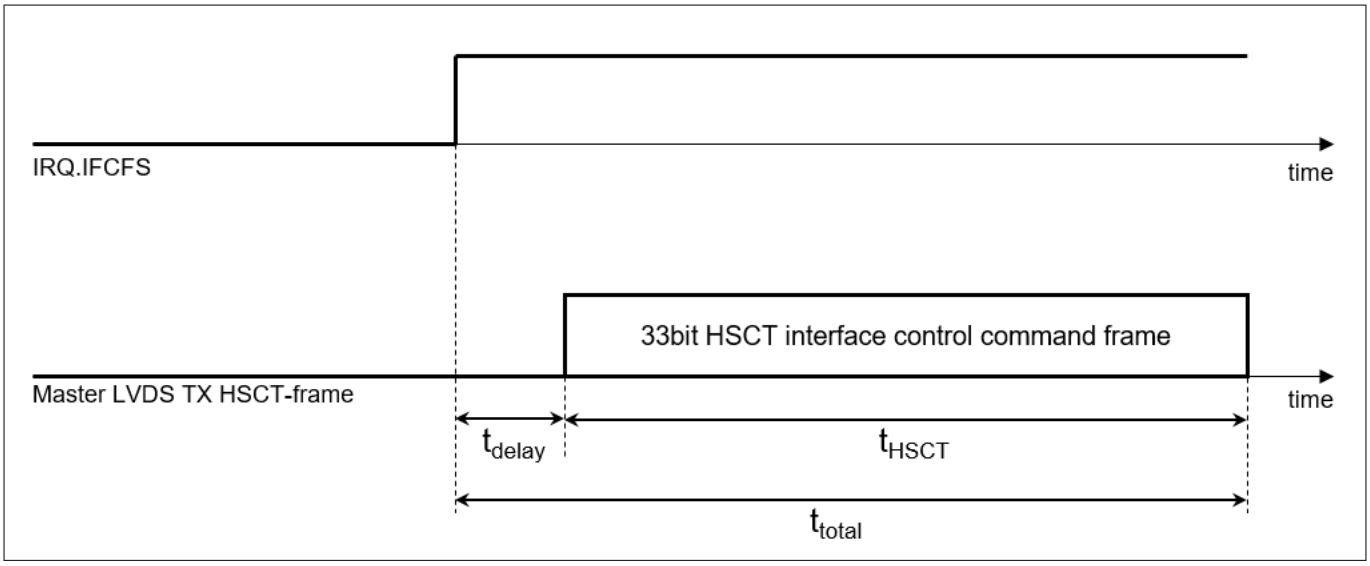
Figure 12 Timing of LVDS TX interface command sending in relation to IRQ.IFCFS

the user might falsely assume that also the actual sending on the LVDS TX port has already occurred once the IRQ.IFCFS flag is set, which is not true.

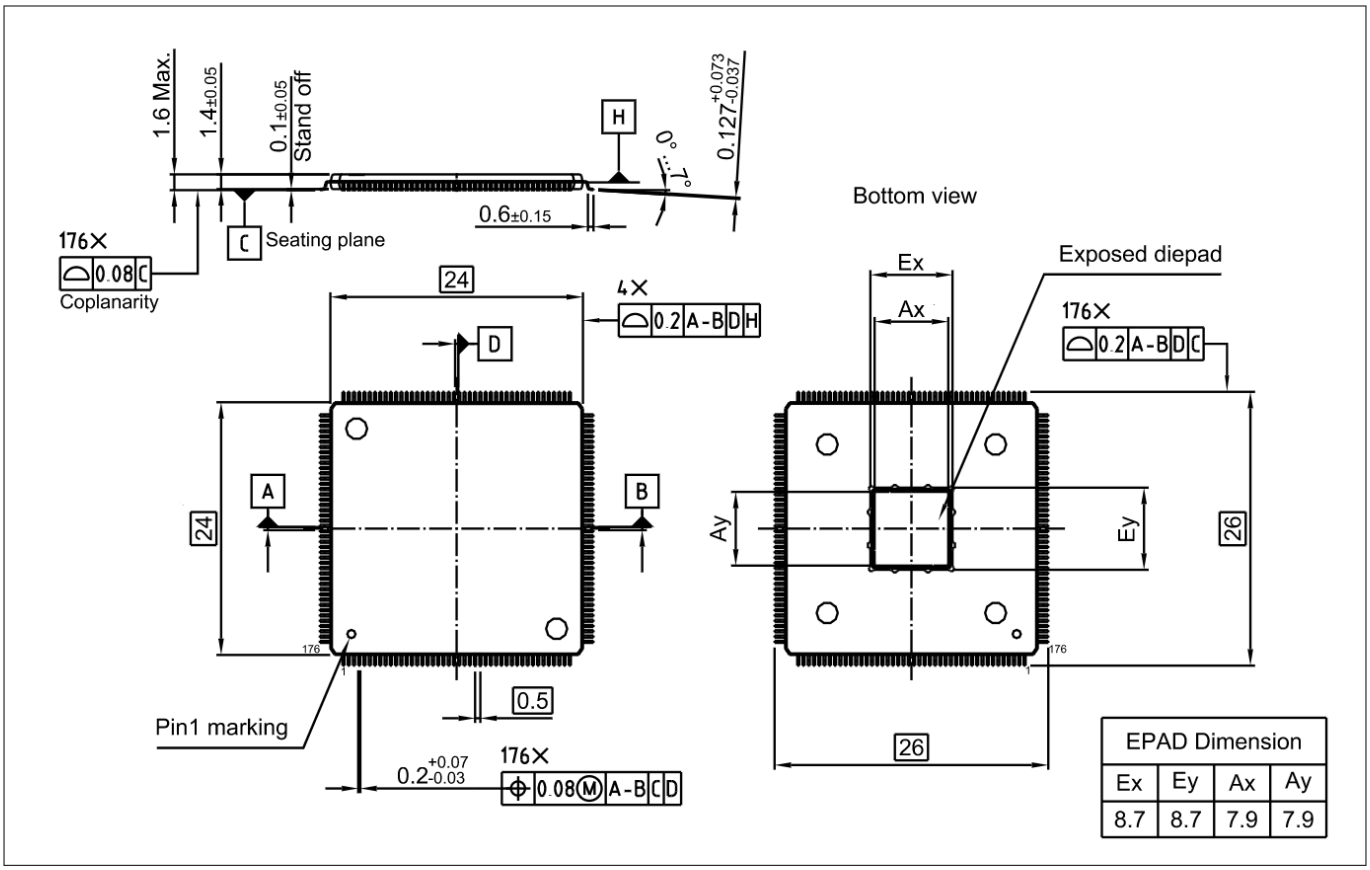
Figure 13 Package Outlines LQFP-176 for TC36x

***Note**: For the exposed diepad of the LQFP-176 package of the TC36x, structural corner protrusions have to be considered for purposes of system design and integration with a maximum boundary of 9.4 mm.*

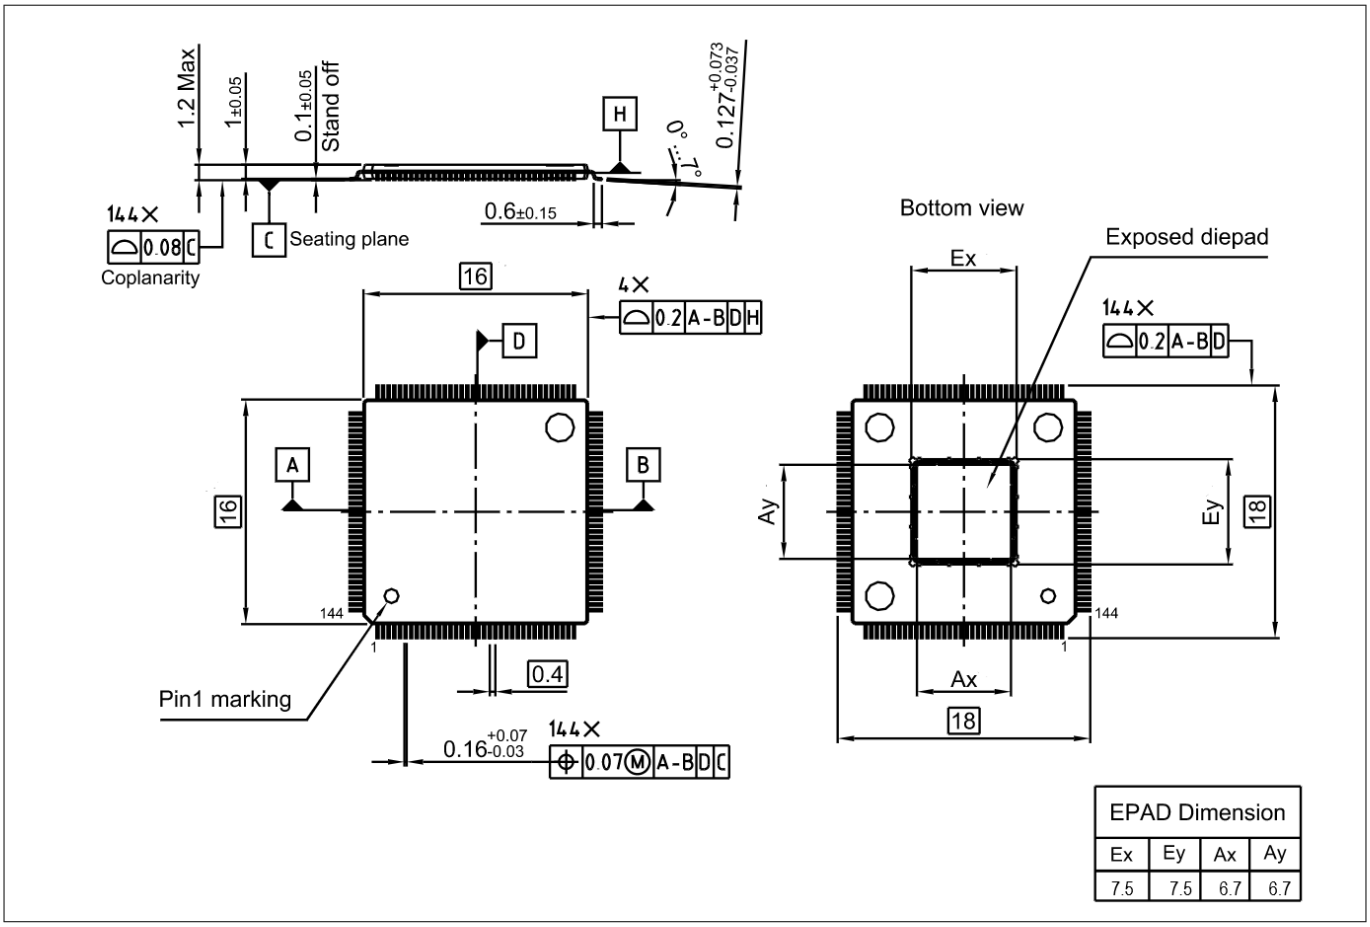
Figure 15 Package Outlines TQFP-144 for TC36x

***Note**: For the exposed diepad of the TQFP-144 package of the TC36x, structural corner protrusions have to be considered for purposes of system design and integration with a maximum boundary of 8.0 mm.*
