AURIX™ TC37x errata sheet

Marking/Step: (E)ES-AA, AA

10615AERRA

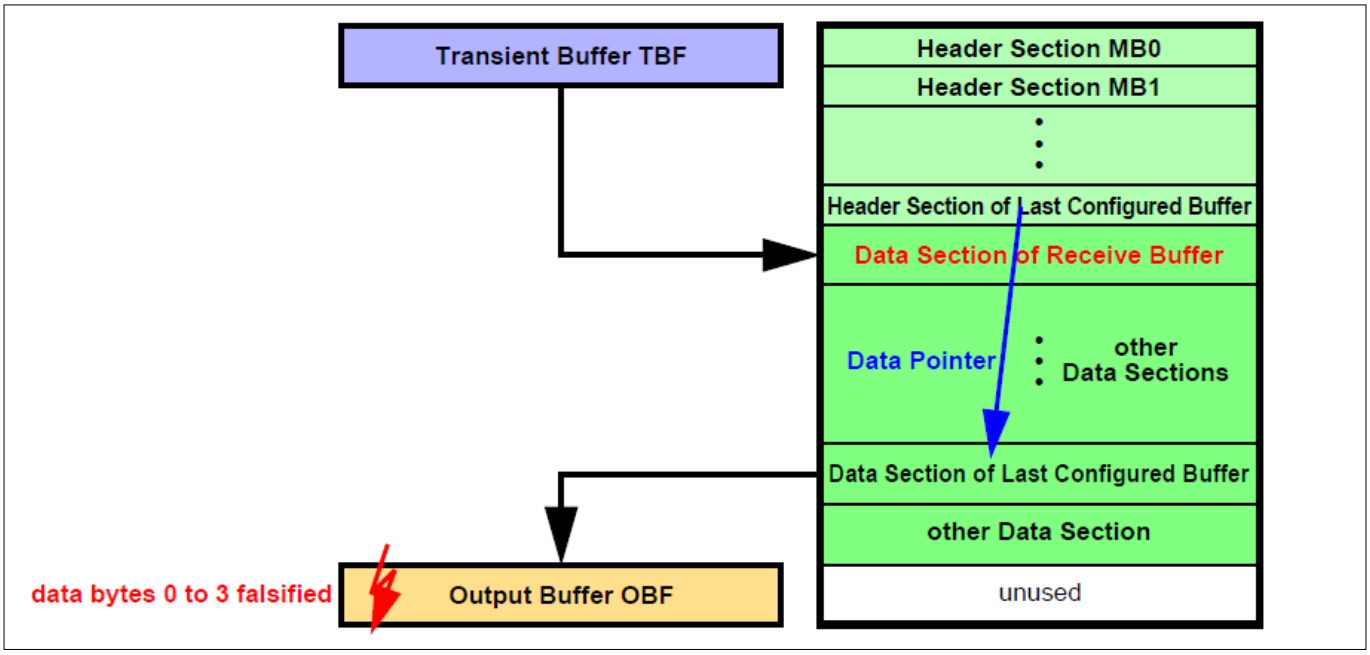
Figure 1 Message buffer transfer from Message RAM to OBF

When the message buffer has its payload configured to maximum length (PLC = 127), the OBF word on address 00h (payload data bytes 0 to 3) is overwritten with unexpected data at the end of the transfer.

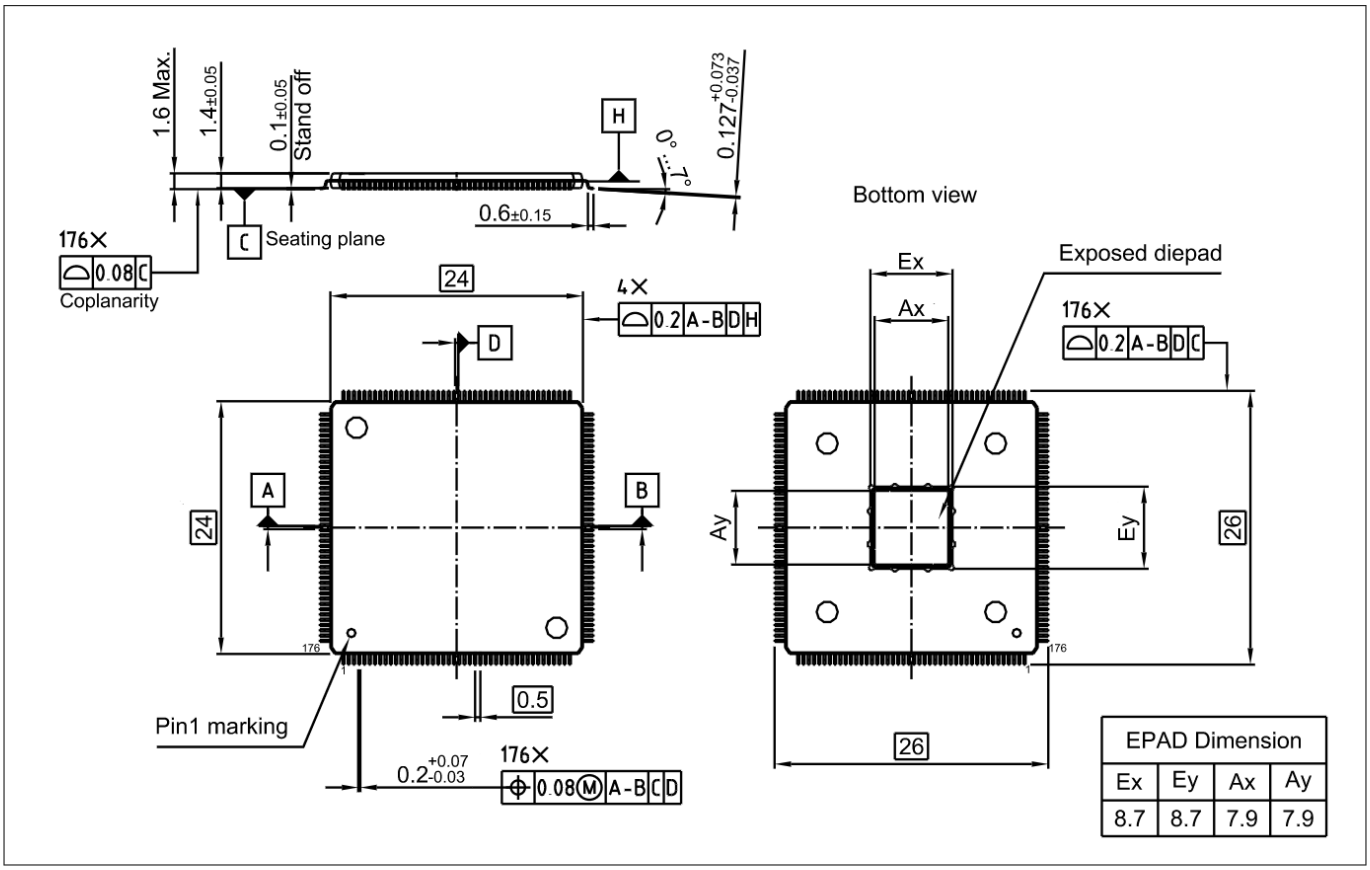
Figure 13 Package Outlines LQFP-176 for TC37x

Furthermore, for the exposed die pad, the maximum boundary of the structural corner protrusions to be considered during system design and integration has been added.

***Note**: For the exposed diepad of the LQFP-176 package of the TC37x, structural corner protrusions have to be considered for purposes of system design and integration with a maximum boundary of 9.4 mm.*

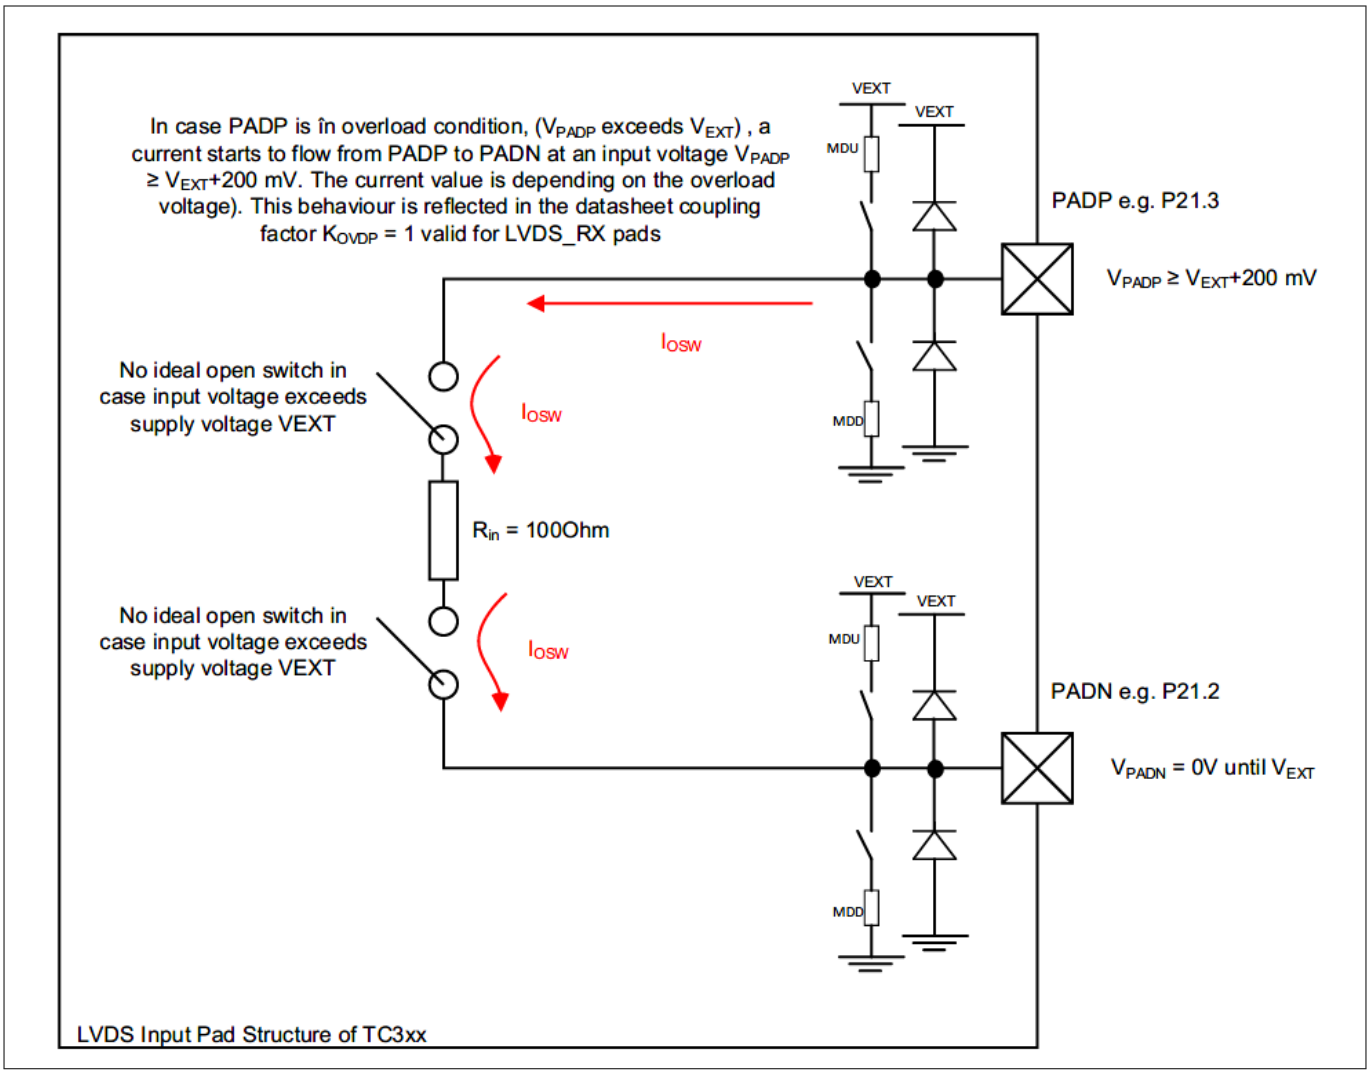
Figure 14 Positive overload on P-pad of a LVDS RX pin pair (both used as inputs)

The following figure illustrates the effect for a positive overload condition ($V_{PADP} > V_{EXT}$) on the P-pad (PADP) of a pin pair where both the P-pad and the corresponding N-pad (NPAD, with $0V \le V_{NPAD} \le V_{EXT}$) are used as digital CMOS inputs.

The overload current I_{OSW} through the non-ideal open switch significantly increases when $V_{PADP} \ge V_{EXT}$ + 200 mV.

***Note**: In general, the effect will also occur if the N-pad is used as output, or for a negative overload condition on either the P-pad or the N-pad.*
