AURIX™ TC37xEXT errata sheet

Marking/Step: (E)ES-AB, AB

10616AERRA

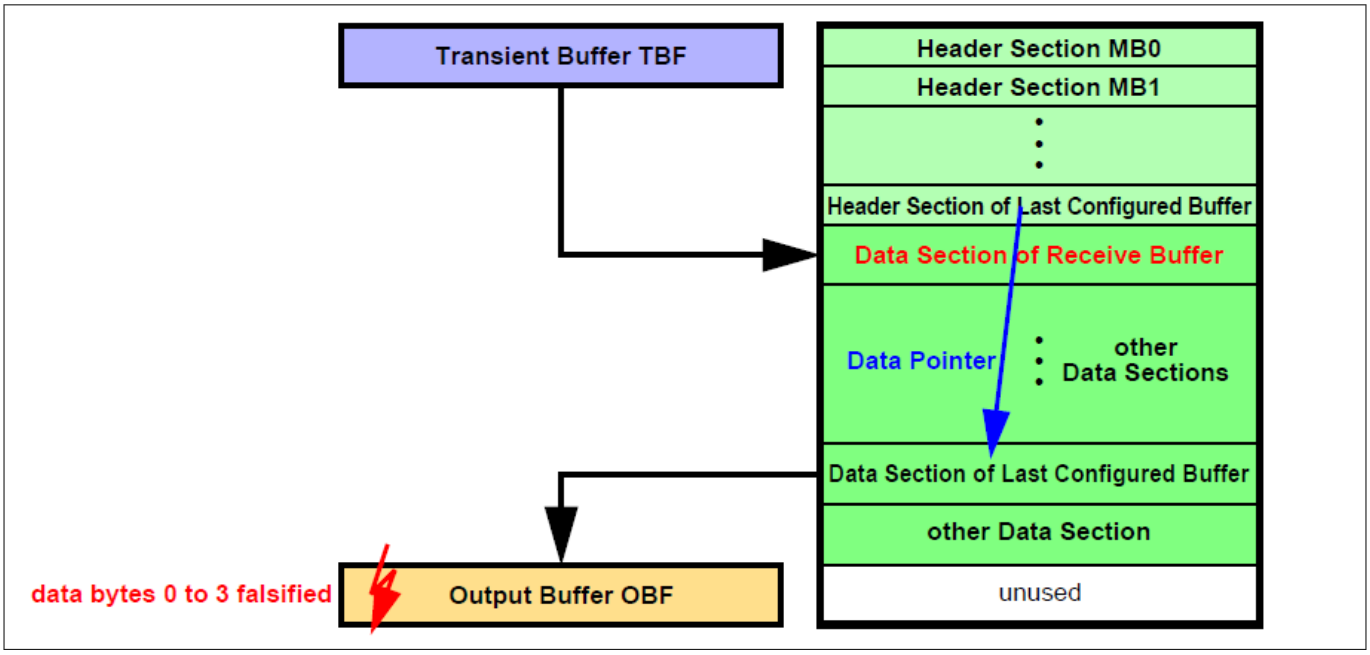
Figure 1 Message buffer transfer from Message RAM to OBF

When the message buffer has its payload configured to maximum length (PLC = 127), the OBF word on address 00h (payload data bytes 0 to 3) is overwritten with unexpected data at the end of the transfer.

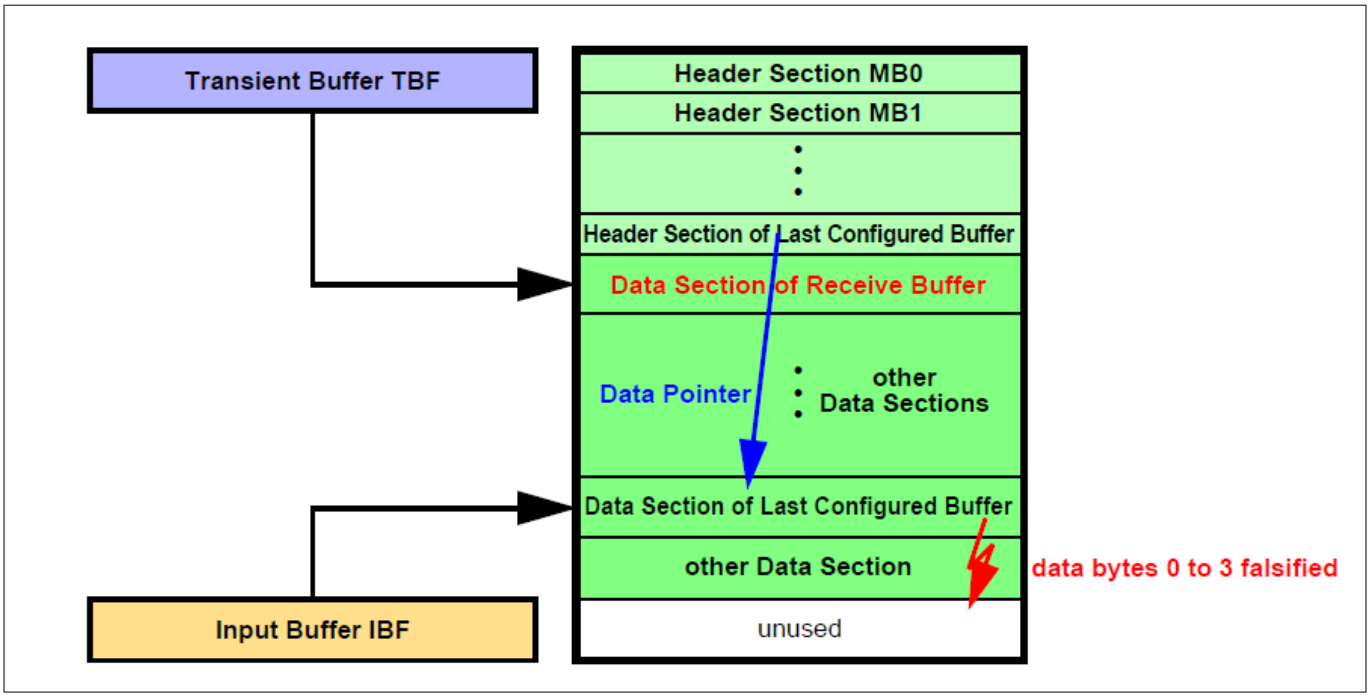
Figure 2 Message buffer transfer from IBF to Message RAM

After the Data Section of the selected message buffer in the Message RAM has been written, one additional write access overwrites the following word in the Message RAM which might be the first word of the next Data Section.

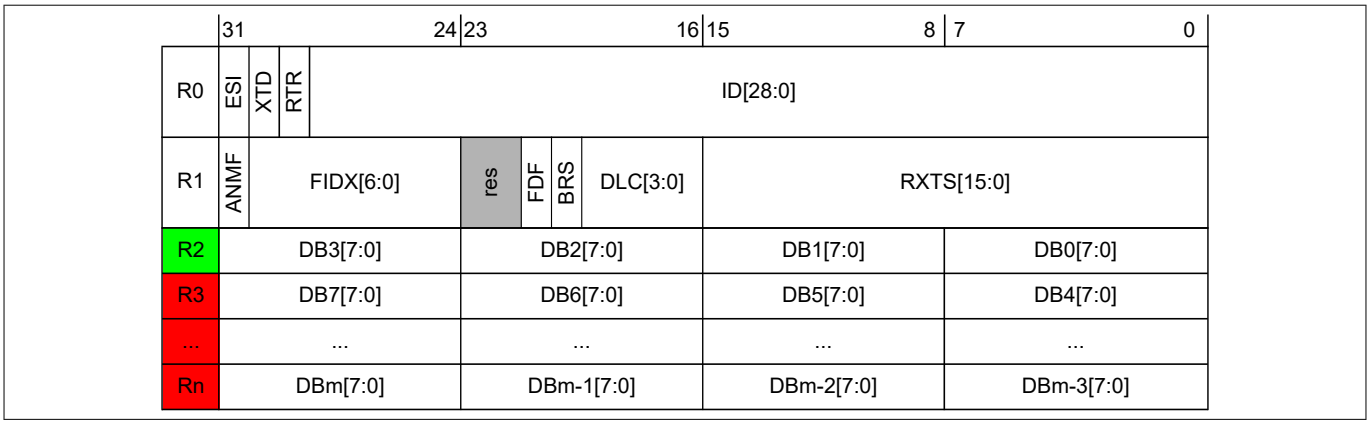
Under the following conditions a received message will have corrupted data while the received message is signaled as valid to the host.

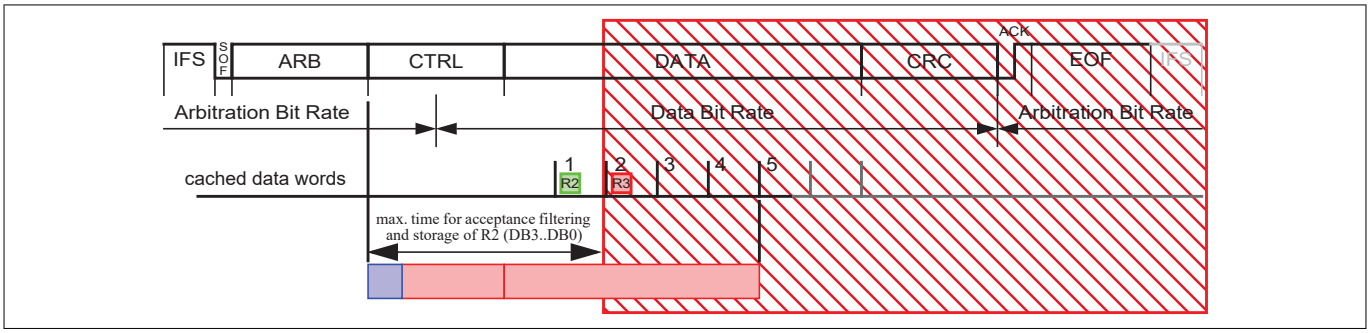
Figure 10 CAN Frame with DLC > 4

The figure that follows shows how the available time for acceptance filtering and storage is reduced.

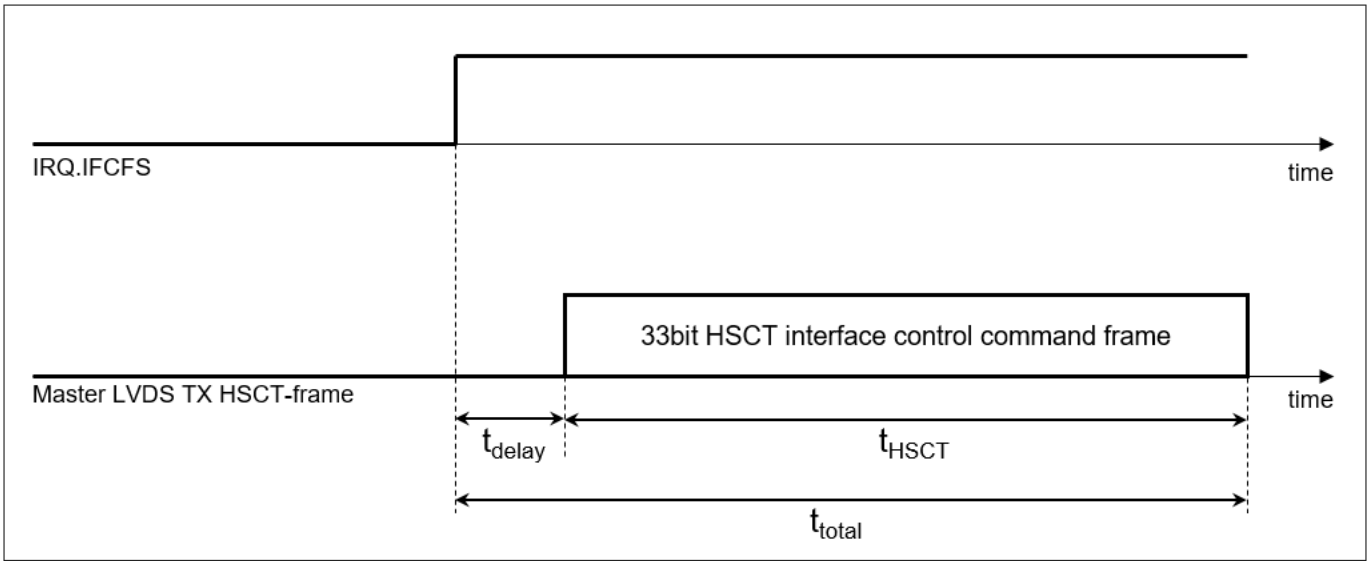
Figure 12 Timing of LVDS TX interface command sending in relation to IRQ.IFCFS

the user might falsely assume that also the actual sending on the LVDS TX port has already occurred once the IRQ.IFCFS flag is set, which is not true.

Instead the timing shown in the following figure applies.

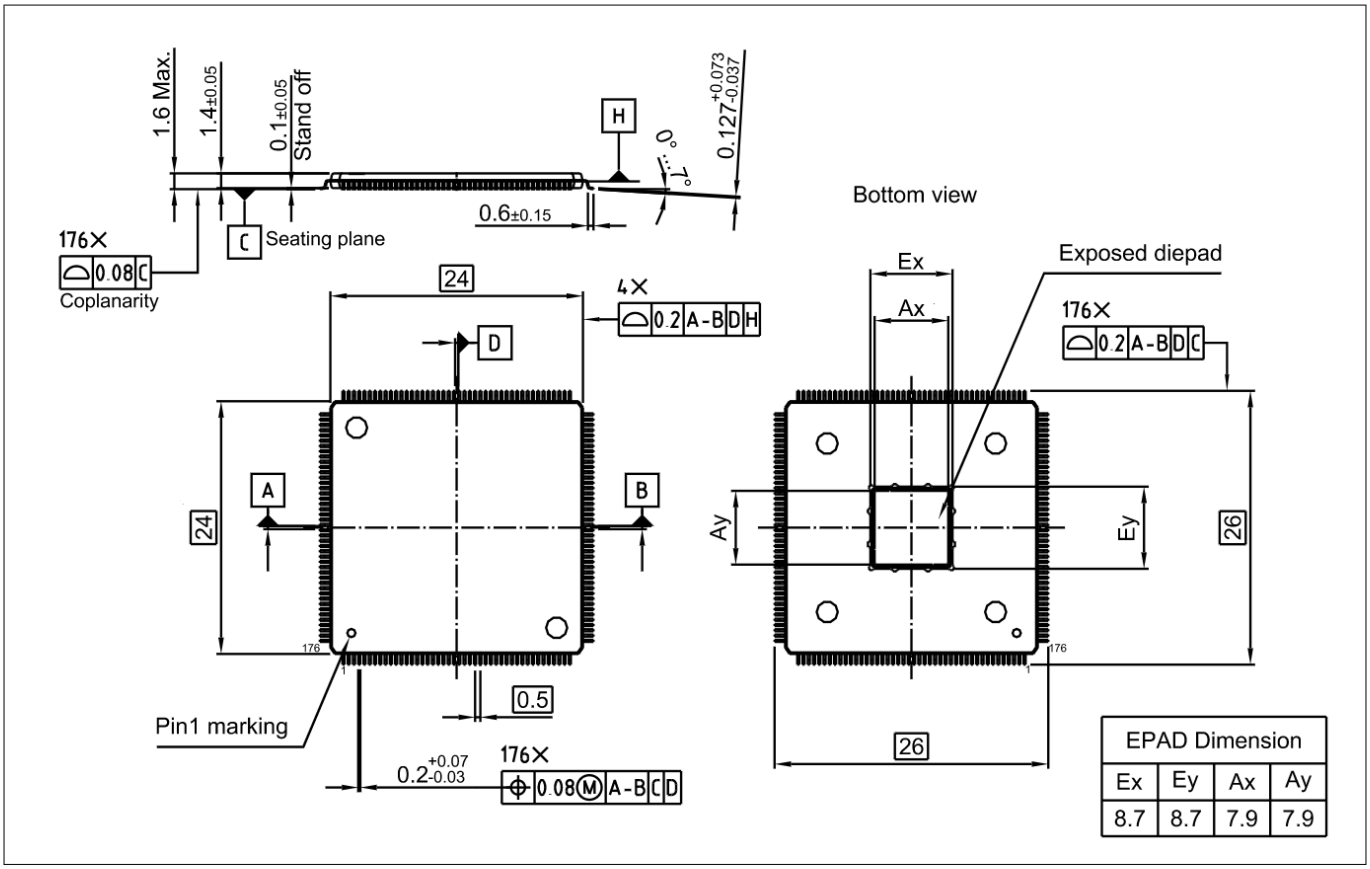
Figure 13 Package Outlines LQFP-176 for TC37xEXT

***Note**: For the exposed diepad of the LQFP-176 package of the TC37xEXT, structural corner protrusions have to be considered for purposes of system design and integration with a maximum boundary of 9.4 mm.*

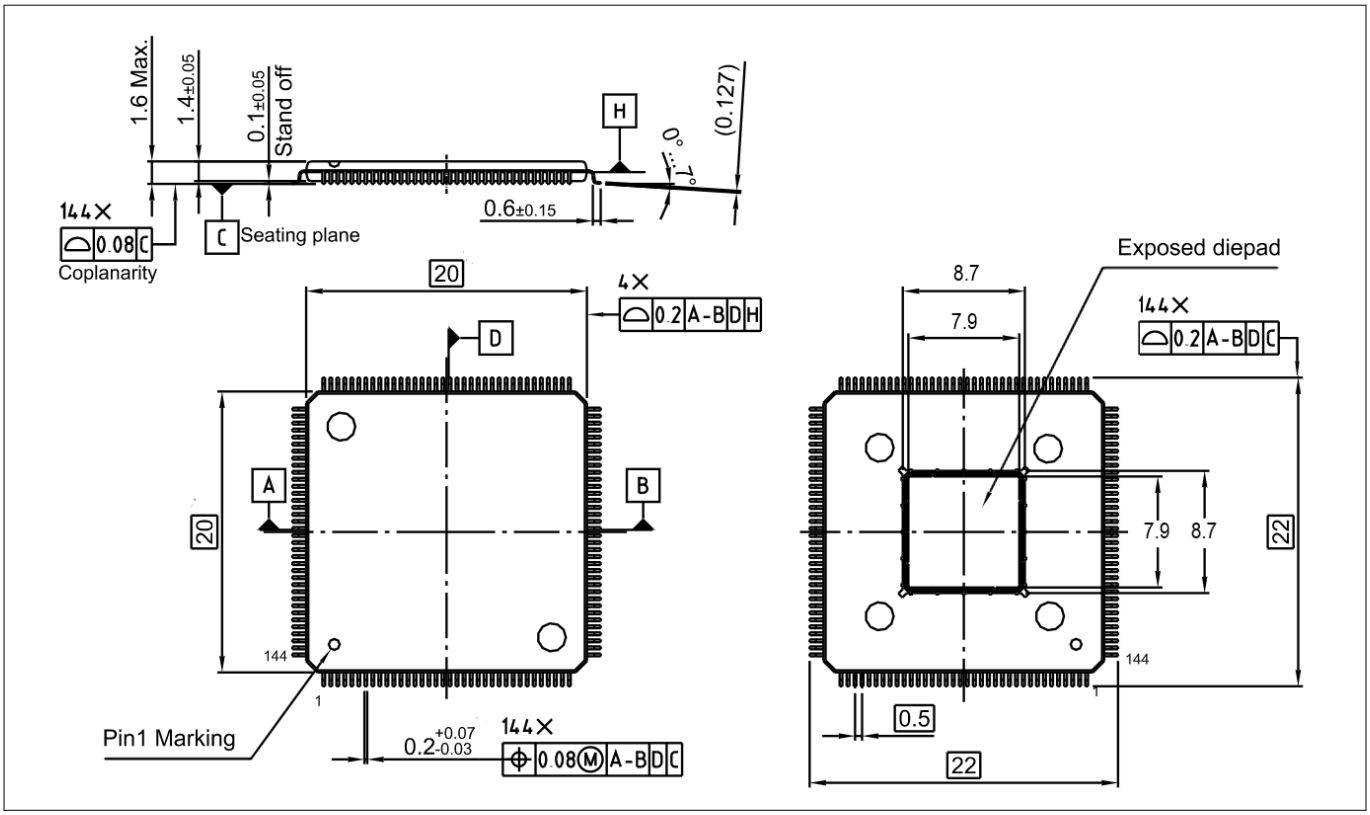
Figure 14 Package Outlines LQFP-144 for TC37xEXT

***Note**: For the exposed diepad of the LQFP-144 package of the TC37xEXT, structural corner protrusions have to be considered for purposes of system design and integration with a maximum boundary of 9.4 mm.*

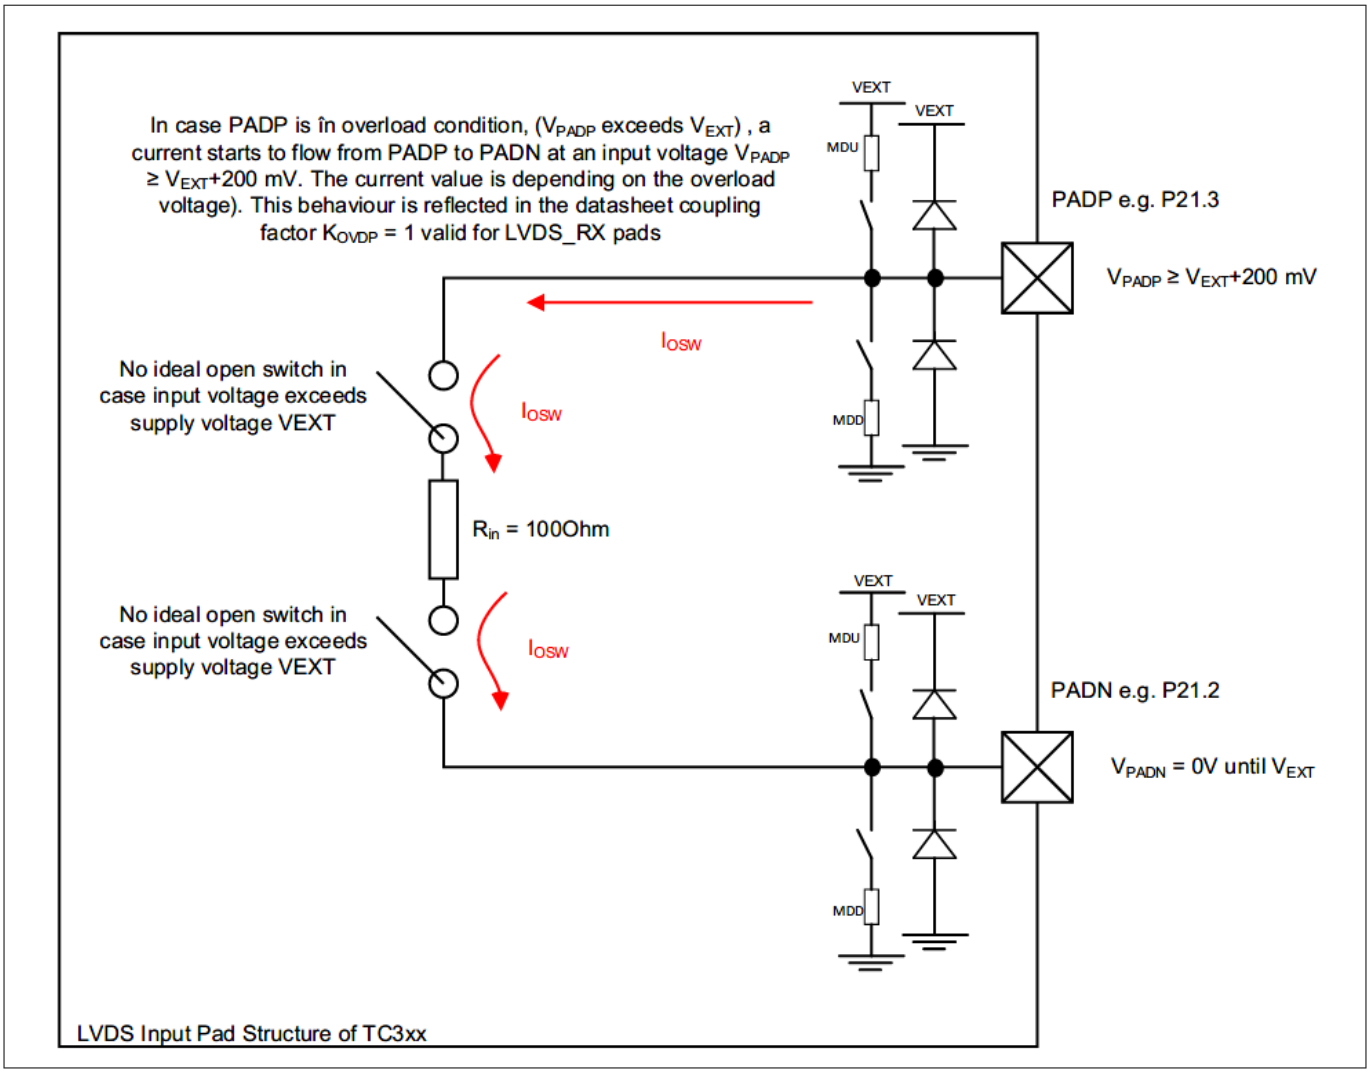
Figure 15 Positive overload on P-pad of a LVDS RX pin pair (both used as inputs)

The following figure illustrates the effect for a positive overload condition ($V_{PADP} > V_{EXT}$) on the P-pad (PADP) of a pin pair where both the P-pad and the corresponding N-pad (NPAD, with $0V \le V_{NPAD} \le V_{EXT}$) are used as digital CMOS inputs.

The overload current I_{OSW} through the non-ideal open switch significantly increases when $V_{PADP} \ge V_{EXT}$ + 200 mV.

***Note**: In general, the effect will also occur if the N-pad is used as output, or for a negative overload condition on either the P-pad or the N-pad.*
