AURIX™ TC38x errata sheet

Marking/Step: (E)ES-AE, AE

About this document

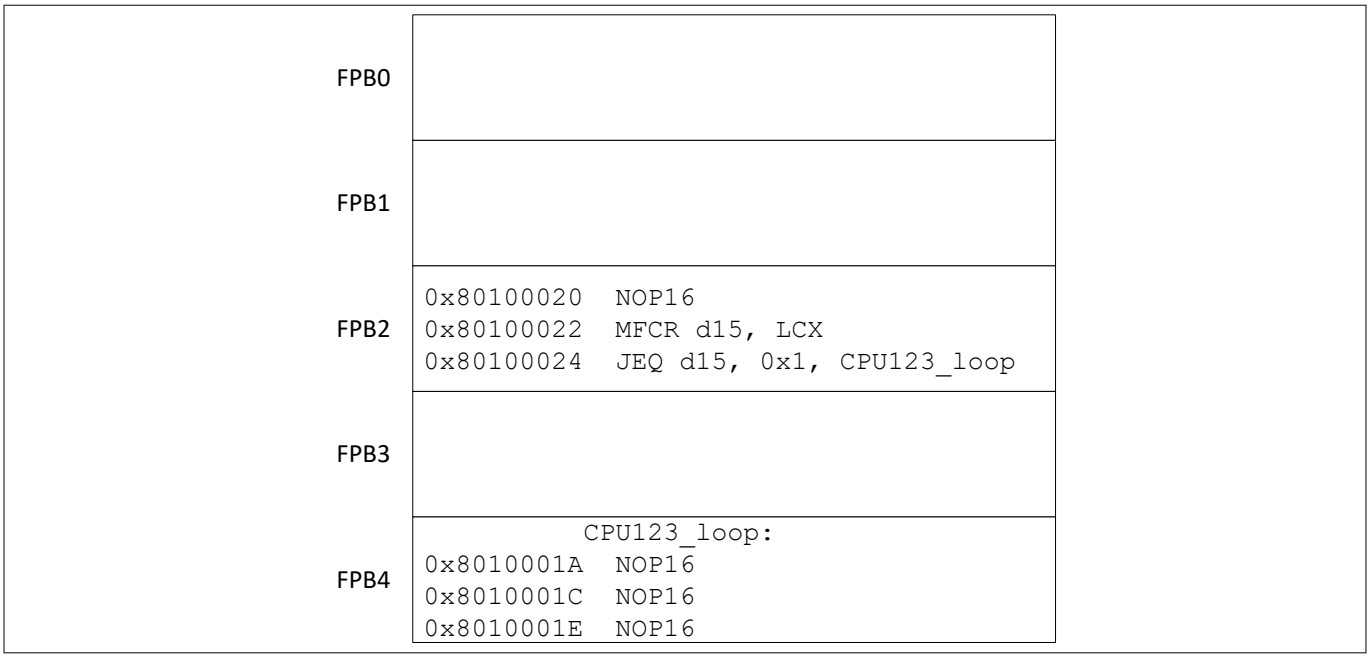
Figure 1 Example of CPUx flash prefetch buffer allocation

Under specific conditions, a CPU (CPUx) may stall indefinitely waiting for an access to its own local PFLASH (PFx) when at least 3 other masters constantly and concurrently request from PFx. When the other masters access the same address range, CPUx may be prevented from accessing its local PFLASH memory. The rate from the remote masters which prevents the local access (the **stalling rate**) is one burst transaction (BTR4) every 4 cycles [1)] at CPUx's PFLASH SRI Slave interface (CPUxP). In this case, while the slave interface remains continuously busy, the CPUx is stalled indefinitely, preventing the running application from making forward progress. Any lower rate of remote accesses; for example two BTR4 every 9 cycles, would allow CPUx to make progress and would not result in a live-lock. The slave interface CPUxP can only supply responses at this rate when the PFLASH data is being serviced directly from the CPUx flash prefetch buffers (FPB - See User manual section "Program Flash Interface").

While the loop condition remains true (d15==1), the 3 remote CPUs will continue fetching and sustaining the critical access rate causing a CPUx to potentially live-lock if all remote CPUs are running concurrently.

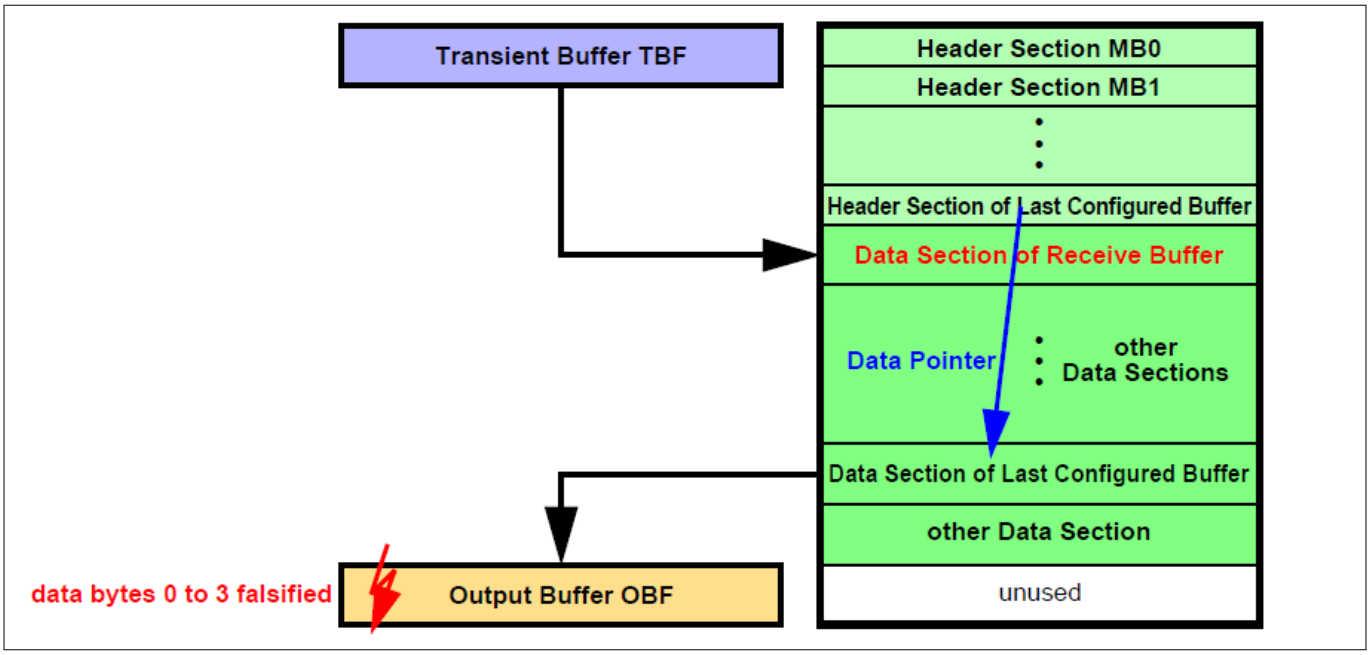
Figure 2 Message buffer transfer from Message RAM to OBF

When the message buffer has its payload configured to maximum length (PLC = 127), the OBF word on address 00h (payload data bytes 0 to 3) is overwritten with unexpected data at the end of the transfer.

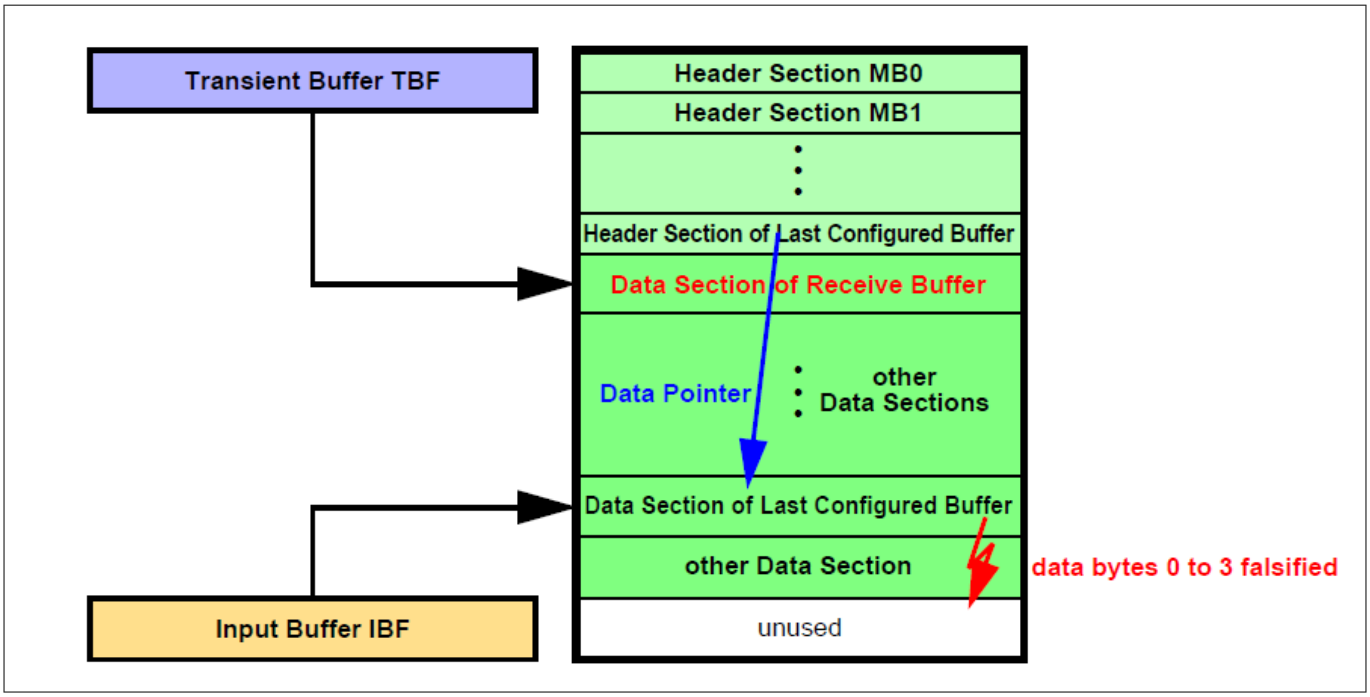
Figure 3 Message buffer transfer from IBF to Message RAM

After the Data Section of the selected message buffer in the Message RAM has been written, one additional write access overwrites the following word in the Message RAM which might be the first word of the next Data Section.

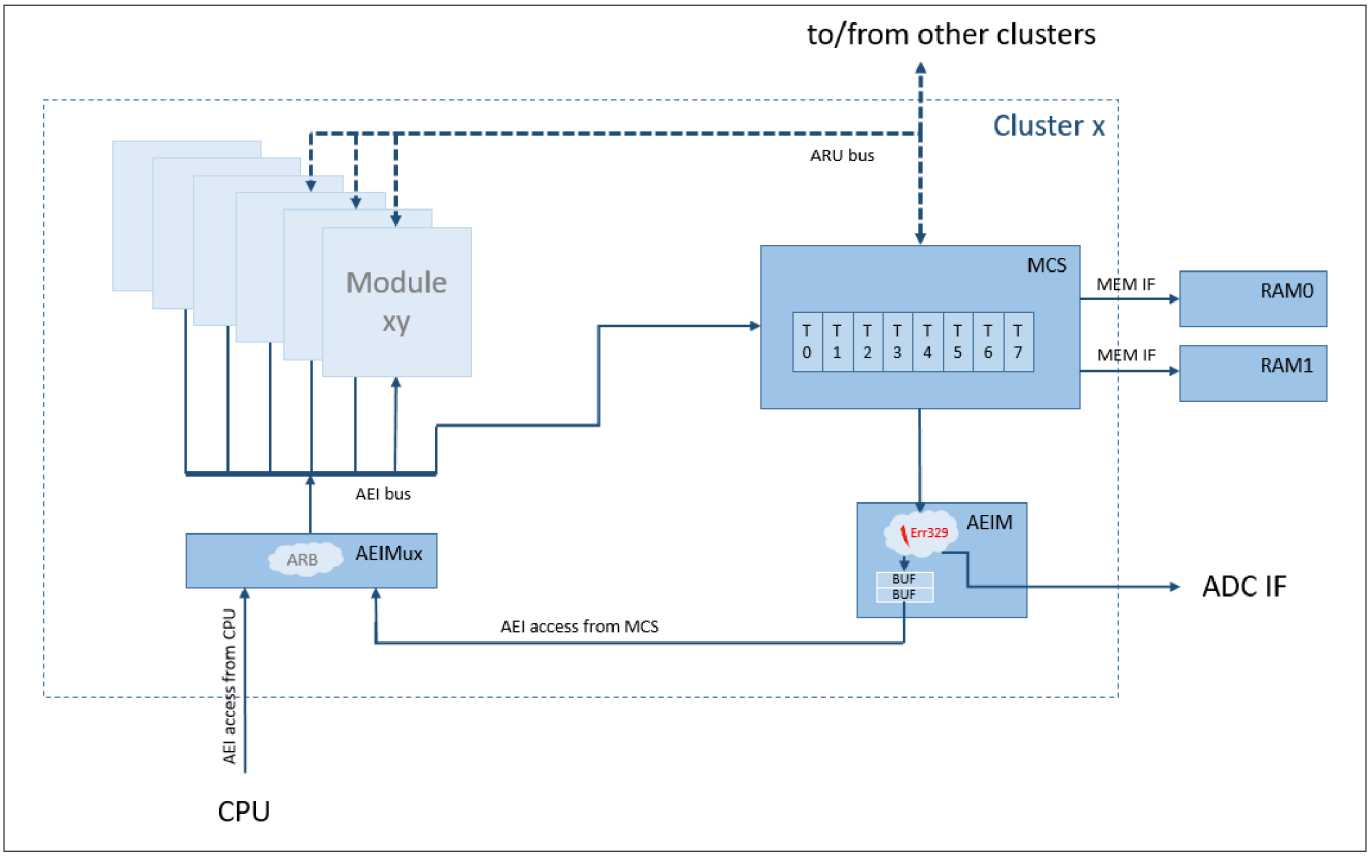
Figure 5 Cluster-internal AEI network

Problem GTM_AI.329 is related to a potential incorrect handling of MCS access requests to the AEI bus at the AEIM entry stage in case that one AEIM buffer is already filled. If in such a case a new access request from MCS enters the AEIM logic during a very specific time window (related to progress on the AEI bus), the AEIM logic might signalize incorrect parameters back to MCS that could result in incorrect data, the loss of data or a repetitive execution of MCS accesses to AEI.

To avoid the potential occurrence of problem GTM_AI.329 it has to be ensured that not more than 1 AEIM buffer gets filled due to backpressure in the AEI bus system.

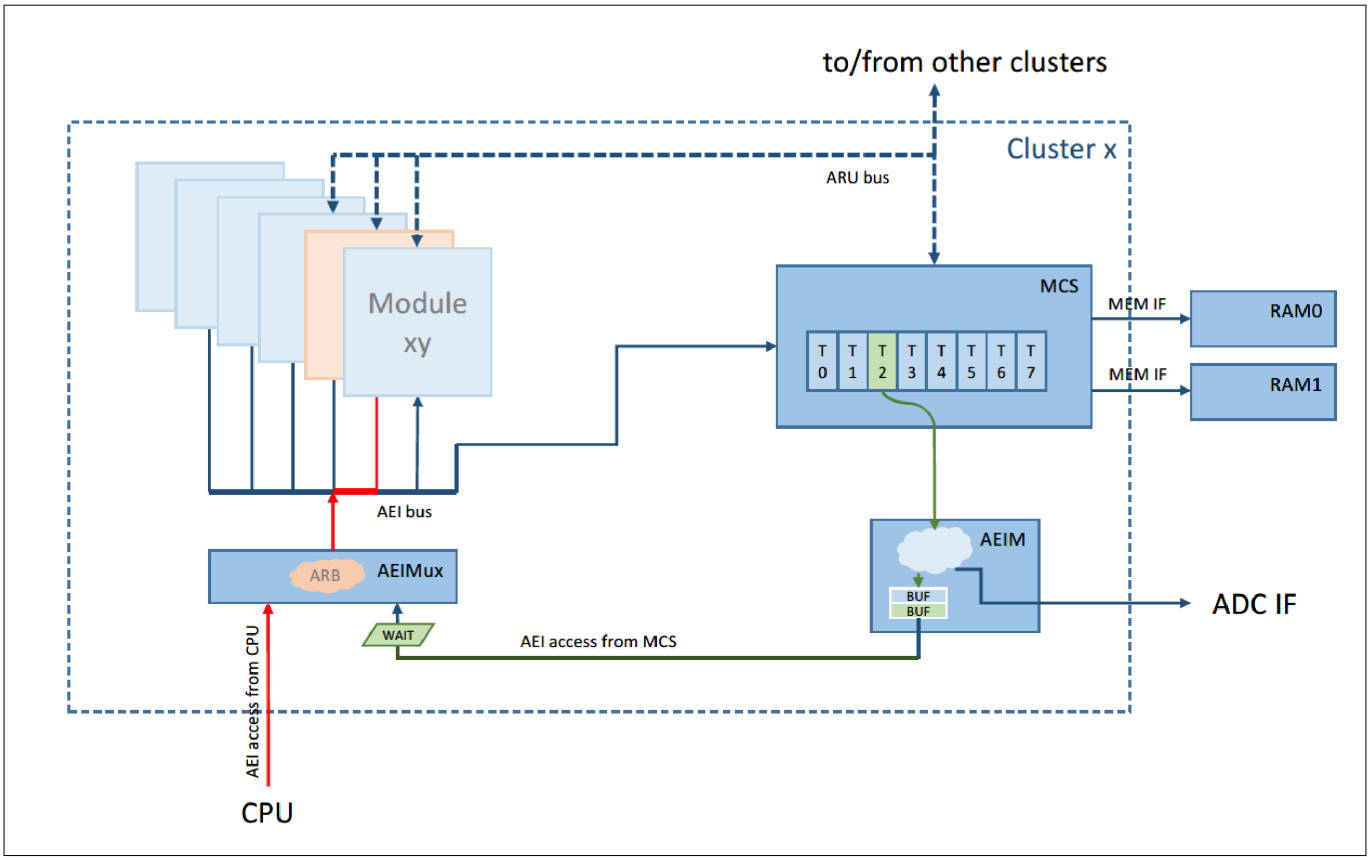
Figure 6 MCS AEI master access path

Figure 6 shows an uncritical traffic situation. Here an access of a MCS thread to the AEI bus (green access path) is temporary delayed due to an ongoing AEI bus access from the CPU (red access path). The MCS access to the AEI bus will be safely buffered at the AEIM (green buffer). As soon as the CPU access to the AEI bus completes, the buffered AEI bus access from MCS will be executed.

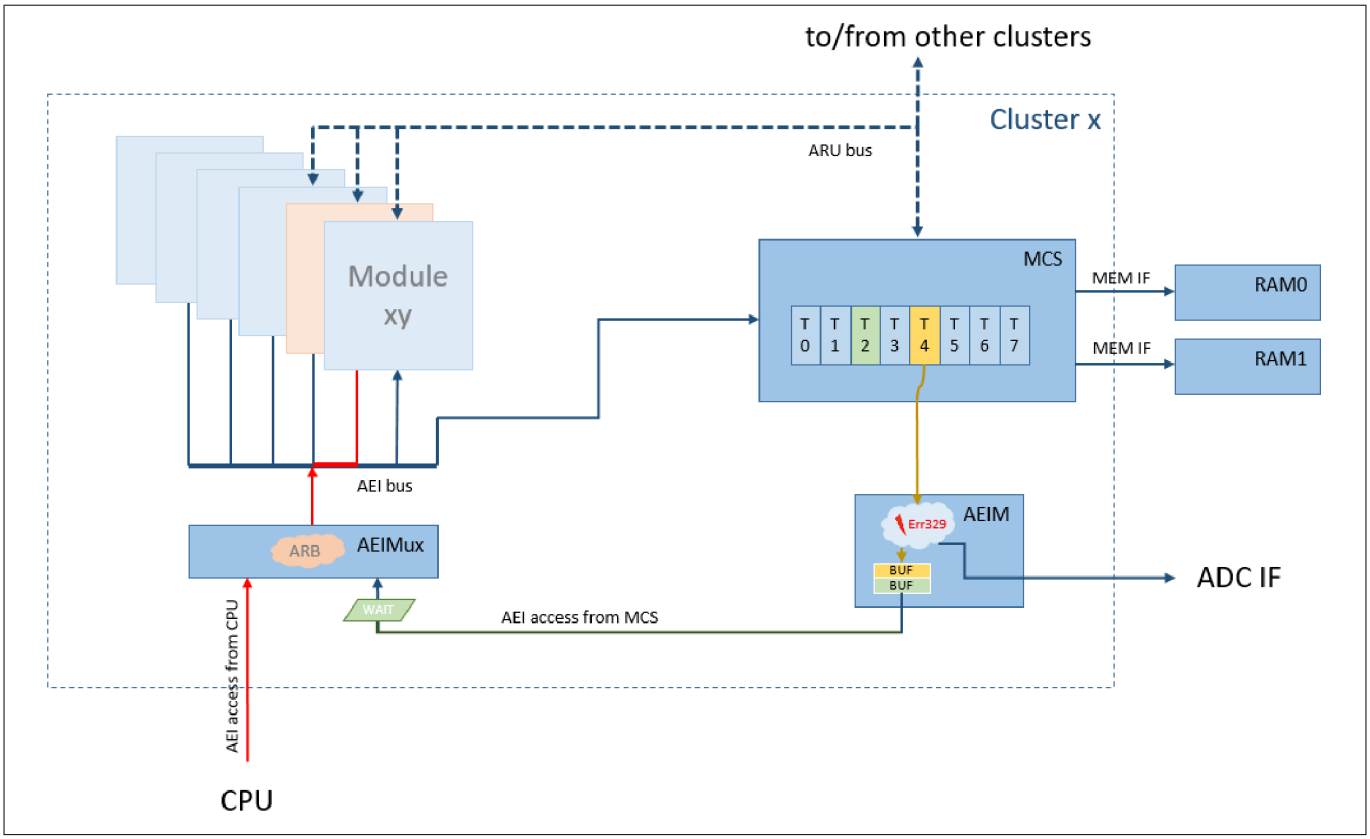
Figure 7 Critical MCS AEI master scenario

In Figure 7, a potential risk for the occurrence of problem GTM_AI.329 is illustrated. Here the first buffer of the AEIM (green) is still waiting for the access to the AEI bus while a second AEI bus access from MCS arrives at the AEIM (yellow access path). Under certain, but for the user unpredictable timing conditions, this second AEI bus access arriving at the AEIM can trigger the misbehavior described in problem GTM_AI.329.

The workarounds described in the 'Workaround' section will ensure that not more than one AEIM buffer will be filled and therefore the occurrence of problem GTM_AI.329 is avoided. All workarounds have been tested and proven correct.

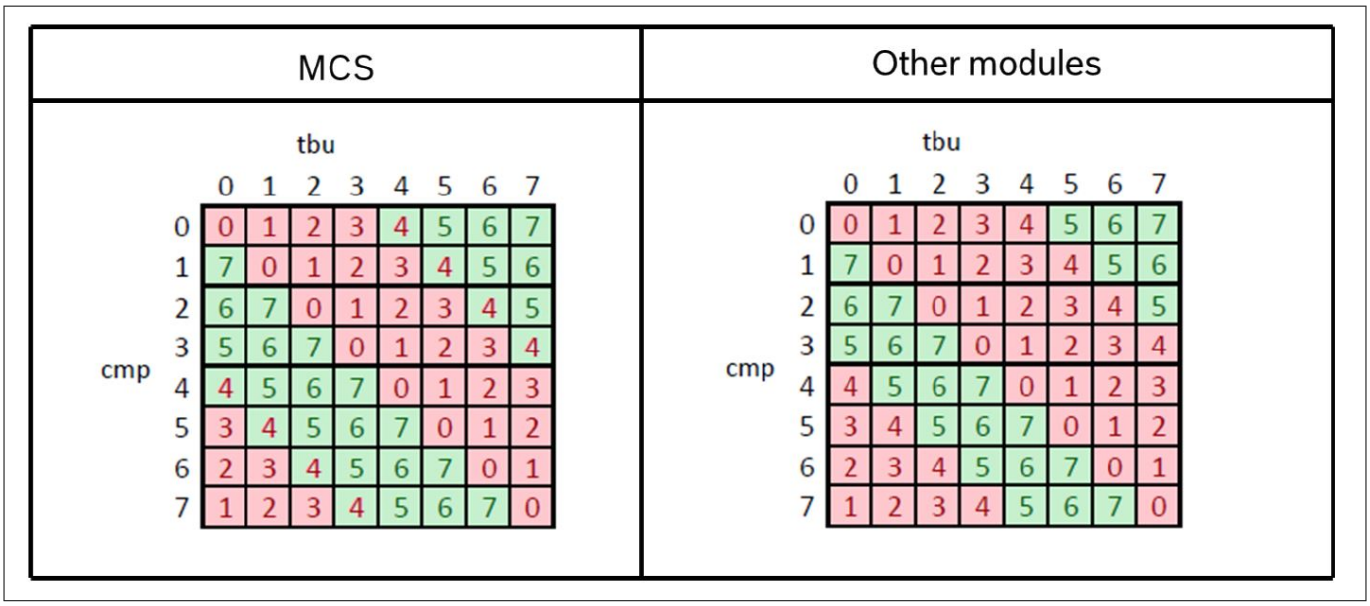
Figure 9 TBU value evaluation MCS against other modules. Red (past) and green (future).

With the revised specification of GTM 4.1 it was revealed that the implementation for the WUCE instruction is not correct for the boundaries. The implementation of the WUCE instruction has an inverted behavior for both boundaries between future and past.

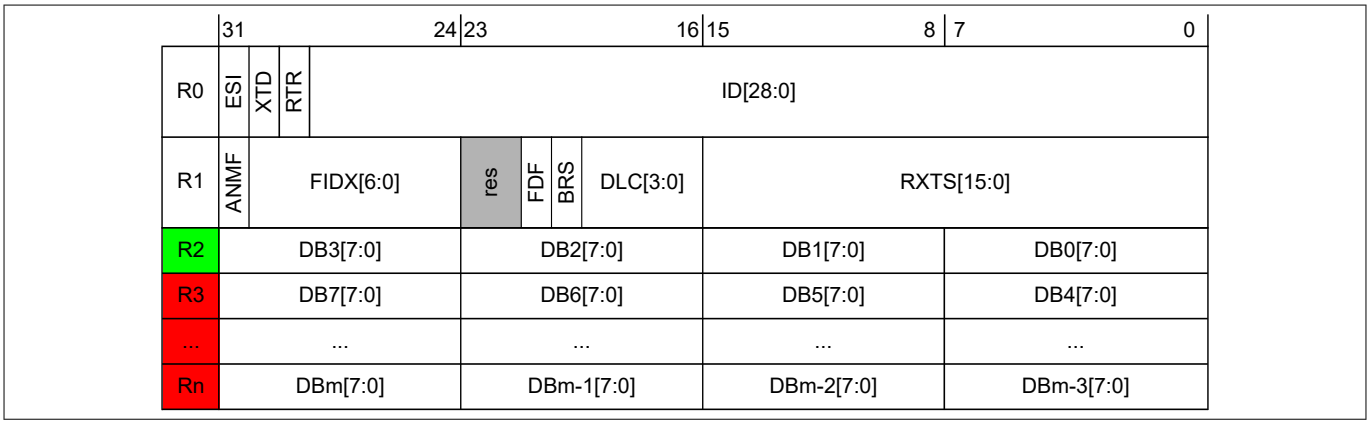
In down-counting phase the output signals has to be set to !SL when CN0 < CM1/CM0.

Received data bytes (DB0..DBm) from the CAN Core are buffered in the cache of the Rx Handler before they are written to the Message RAM (in words of 4 byte). Data words inside the Message RAM are numbered from R2 to Rn (n ≤ 17).

Under the following conditions a received message will have corrupted data while the received message is signaled as valid to the host.

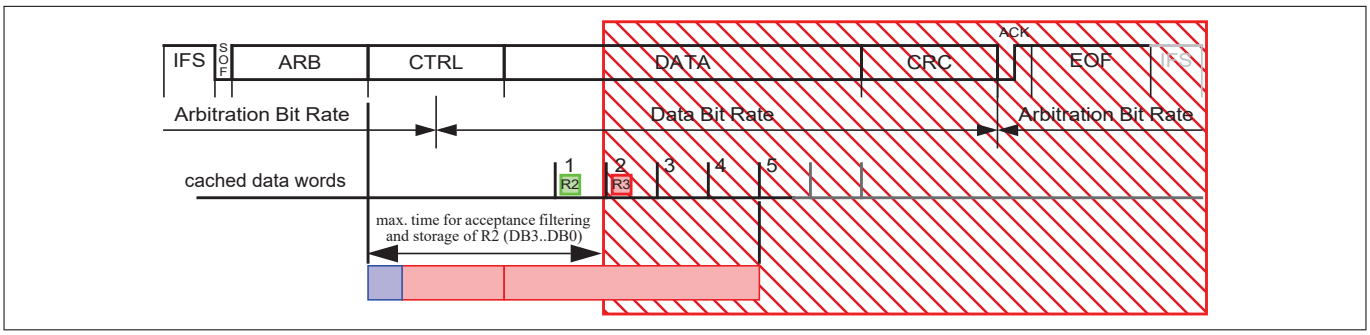
Figure 11 CAN Frame with DLC > 4

The issue may occur in FD Frame Format as well as in Classic Frame Format.
The figure that follows shows how the available time for acceptance filtering and storage is reduced.

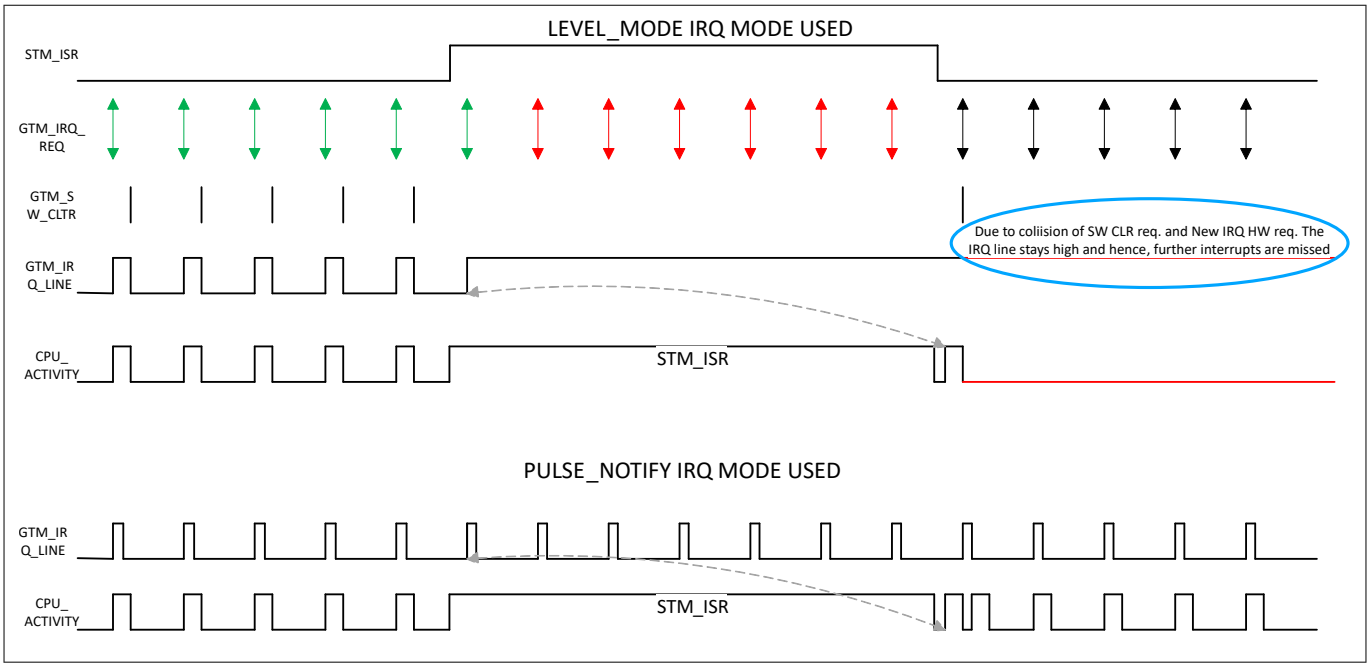
Figure 12 Interrupt Level vs. Pulse-Notify mode - Corner Case Example

interrupt and clear events), GTM_IRQ_XXX is not cleared and remains high. As a consequence, the IR observes no transition on GTM_IRQ_XX. Thus, any forthcoming interrupt events in this scenario are lost as there is no chance to release the CPU IRQ when a collision happens as shown in Figure below.

If Pulse-Notify mode is selected, every internal trigger will be forwarded to the IR, irrespective of the time of occurrence and the clear event, as the pulse-notify leads to set and reset of GTM_IRQ_XXX as compared to only setting of the GTM_IRQ_XXX line in Level mode.

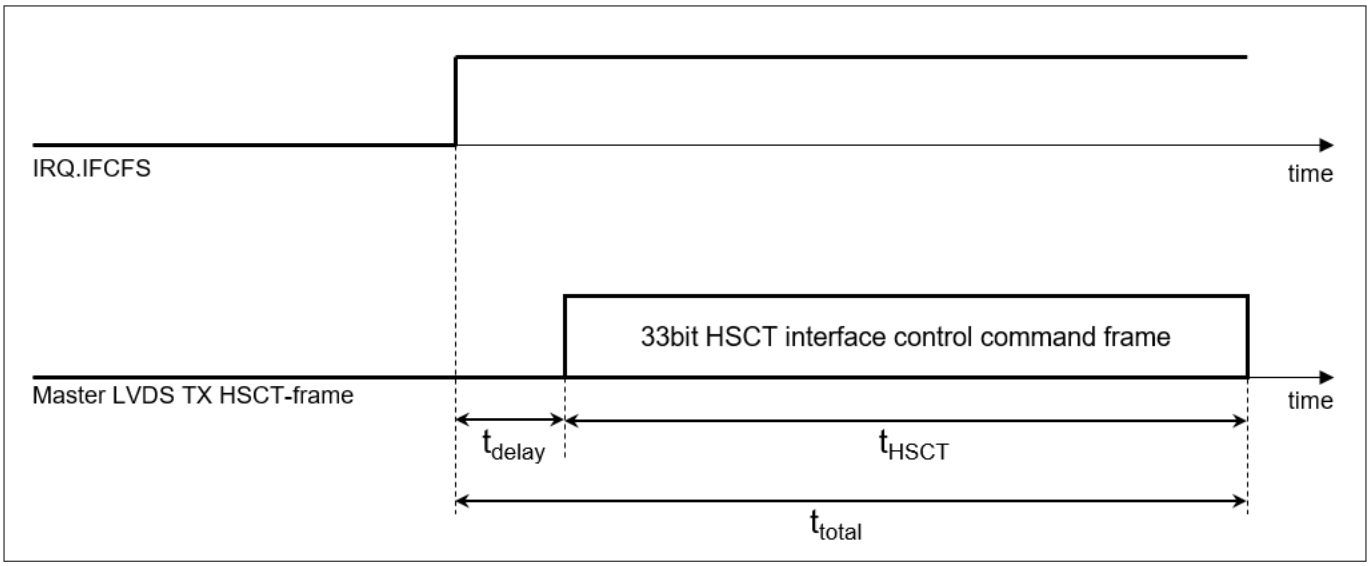
Figure 13 Timing of LVDS TX interface command sending in relation to IRQ.IFCFS

the user might falsely assume that also the actual sending on the LVDS TX port has already occurred once the IRQ.IFCFS flag is set, which is not true.

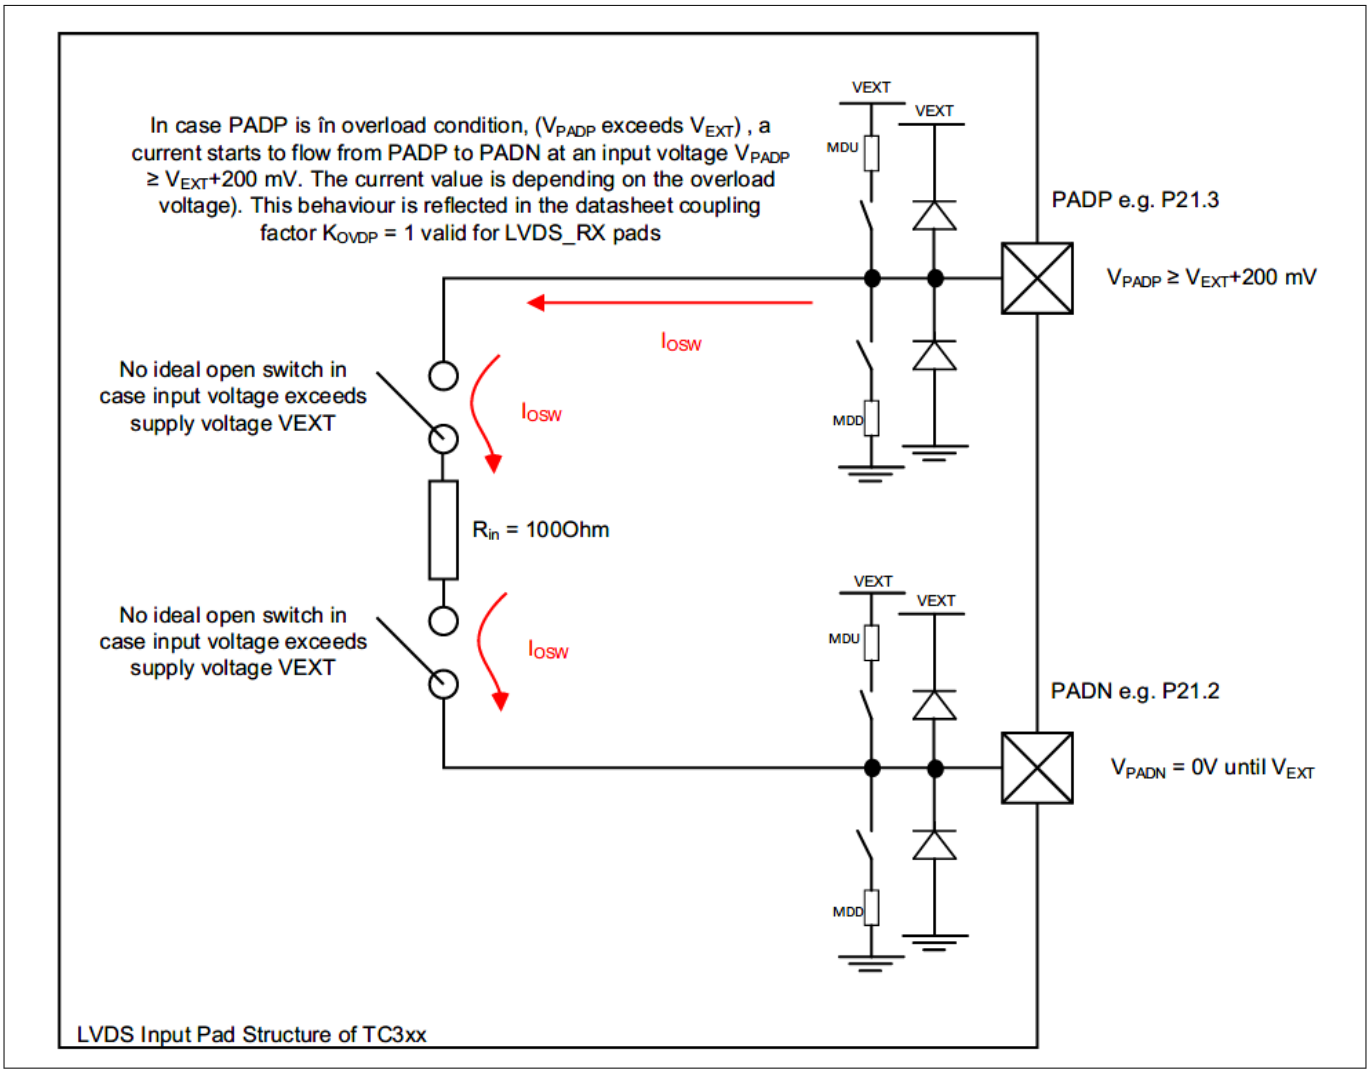
Figure 14 Positive overload on P-pad of a LVDS RX pin pair (both used as inputs)

The following figure illustrates the effect for a positive overload condition ($V_{PADP} > V_{EXT}$) on the P-pad (PADP) of a pin pair where both the P-pad and the corresponding N-pad (NPAD, with $0V \le V_{NPAD} \le V_{EXT}$) are used as digital CMOS inputs.

The overload current I_{OSW} through the non-ideal open switch significantly increases when $V_{PADP} \ge V_{EXT}$ + 200 mV.
