AURIX™ TC39x errata sheet

Marking/Step: (E)ES-BD, BD

10610AERRA

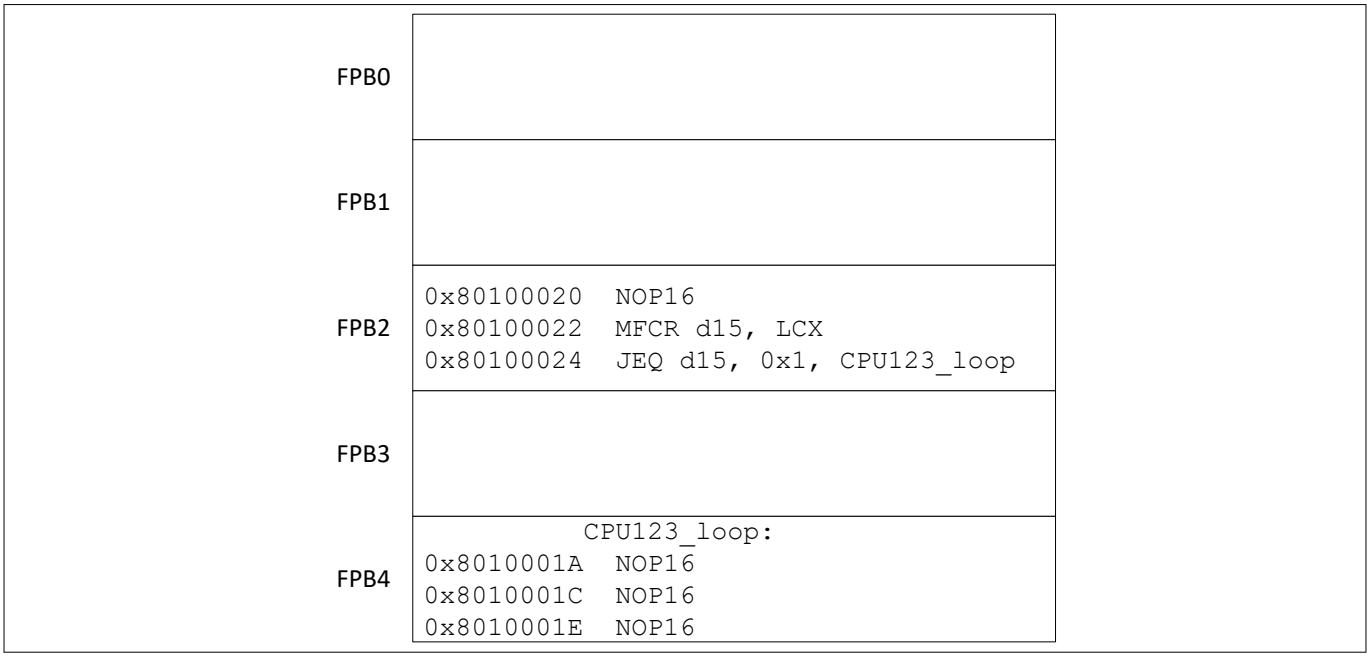
Figure 1 Example of CPUx flash prefetch buffer allocation

Under specific conditions, a CPU (CPUx) may stall indefinitely waiting for an access to its own local PFLASH (PFx) when at least 3 other masters constantly and concurrently request from PFx. When the other masters access the same address range, CPUx may be prevented from accessing its local PFLASH memory. The rate from the remote masters which prevents the local access (the **stalling rate**) is one burst transaction (BTR4) every 4 cycles [1)] at CPUx's PFLASH SRI Slave interface (CPUxP). In this case, while the slave interface remains continuously busy, the CPUx is stalled indefinitely, preventing the running application from making forward progress. Any lower rate of remote accesses; for example two BTR4 every 9 cycles, would allow CPUx to make progress and would not result in a live-lock. The slave interface CPUxP can only supply responses at this rate when the PFLASH data is being serviced directly from the CPUx flash prefetch buffers (FPB - See User manual section "Program Flash Interface").

While the loop condition remains true (d15==1), the 3 remote CPUs will continue fetching and sustaining the critical access rate causing a CPUx to potentially live-lock if all remote CPUs are running concurrently.

The erratum is limited to the specific scenario where other masters access the same NVM bank as that of CPUx. In this case, the CPUx can be locked out of its own NVM interface, causing it to stall indefinitely. It's important to note that this issue only occurs under above listed specific conditions.

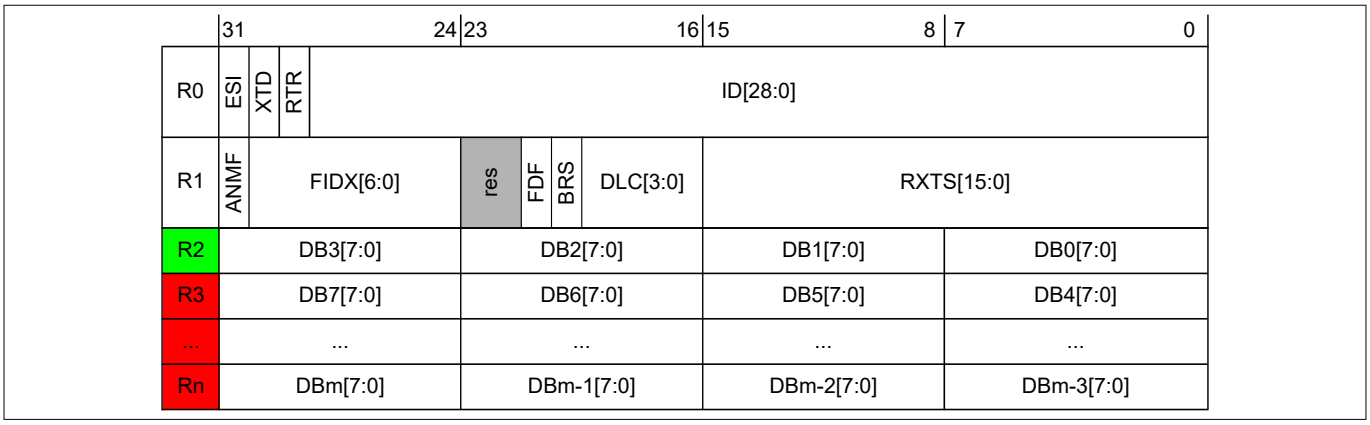
Figure 10 TC3xx - Rx Buffer and FIFO Element (R_i holds Data Byte DB(x+3)..DBx (with x=4*(i-2)))

Under the following conditions a received message will have corrupted data while the received message is signaled as valid to the host.

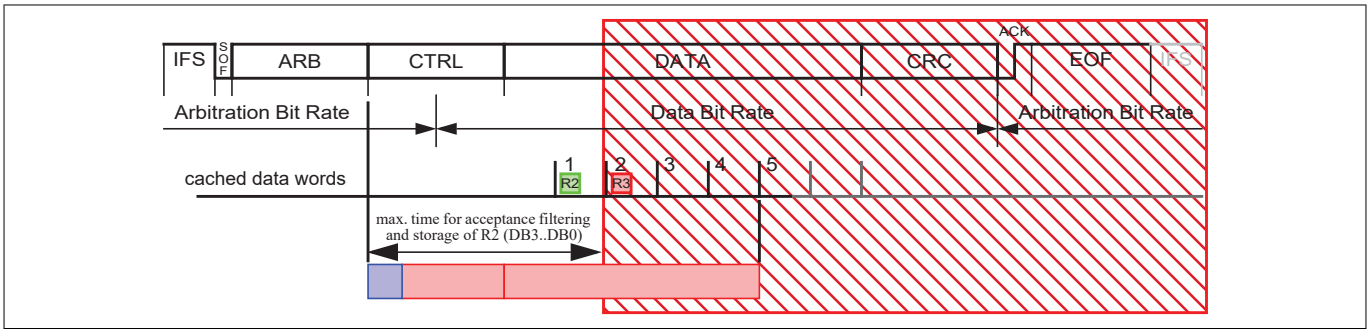
Figure 11 CAN Frame with DLC > 4

The figure that follows shows how the available time for acceptance filtering and storage is reduced.
