TRAVEO™ T2G CYT2B7 errata sheet

Marking/Step: Rev. D

32-bit single-chip microcontroller

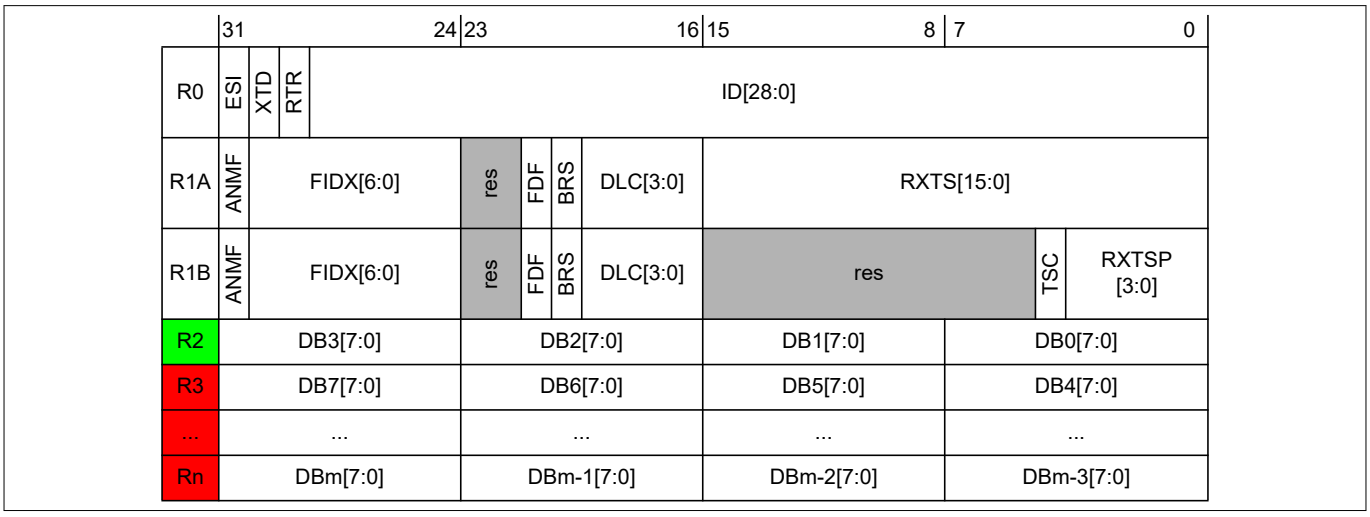
Figure 1 Rx Buffer and FIFO Element

Received data bytes (DB0..DBm) from the CAN Core are buffered in the cache of the Rx Handler before they are written to the Message RAM (in words of 4 byte). Data words inside the Message RAM are numbered from R2 to Rn (n ≤ 17).

Under the following conditions a received message will have corrupted data while the received message is signaled as valid to the host.

1. The data length code (DLC) of the received Message is greater than 4 (DLC > 4)
2. The storage of Ri of a received message into the Message RAM (after acceptance filtering is done) has not completed before R(i+1) is transferred from the CAN Core into the cache of the Rx Handler (where 2 ≤ i ≤ 5)
3. While condition 1 and 2 apply, a concurrent read of data word Ri from the cache and write of data word R(i+1) into the cache of the Rx handler happens

Due to condition 3 the issue occurs only sporadically. Use an end-to-end (E2E) protection (for example, checksum or CRC covering the data field) and add it to all messages in the CAN system, to detect data corruption in received frames.

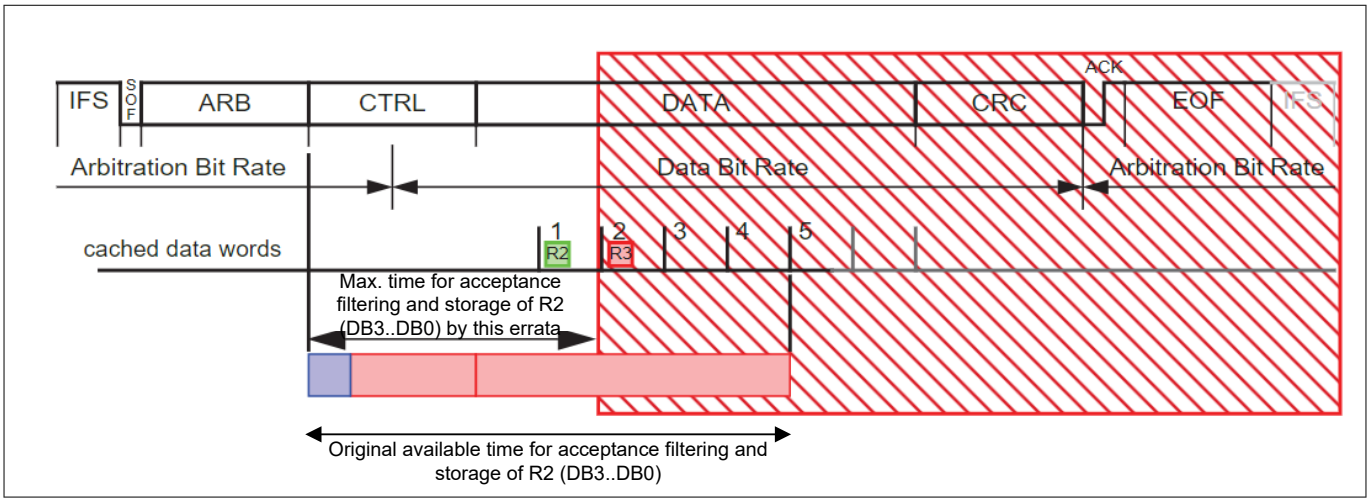
Figure 2 CAN frame with DLC > 4

The issue may occur in FD Frame Format as well as in Classic Frame Format.

Figure 2 shows how the available time for acceptance filtering and storage is reduced.
