TRAVEO™ T2G CYT2B9 errata sheet

Marking/Step: Rev. C

32-bit single-chip microcontroller

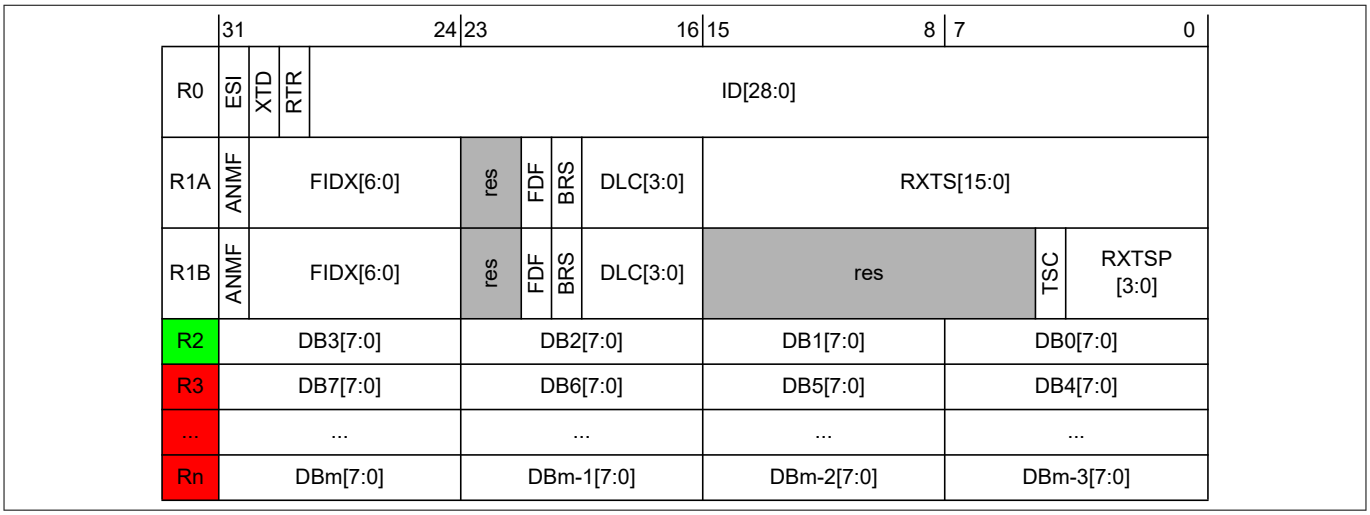
Figure 1 Rx Buffer and FIFO Element

Received data bytes (DB0..DBm) from the CAN Core are buffered in the cache of the Rx Handler before they are written to the Message RAM (in words of 4 byte). Data words inside the Message RAM are numbered from R2 to Rn (n ≤ 17).

Under the following conditions a received message will have corrupted data while the received message is signaled as valid to the host.

1. The data length code (DLC) of the received Message is greater than 4 (DLC > 4)
2. The storage of Ri of a received message into the Message RAM (after acceptance filtering is done) has not completed before R(i+1) is transferred from the CAN Core into the cache of the Rx Handler (where 2 ≤ i ≤ 5)
3. While condition 1 and 2 apply, a concurrent read of data word Ri from the cache and write of data word R(i+1) into the cache of the Rx handler happens

Due to condition 3 the issue occurs only sporadically. Use an end-to-end (E2E) protection (for example, checksum or CRC covering the data field) and add it to all messages in the CAN system, to detect data corruption in received frames.

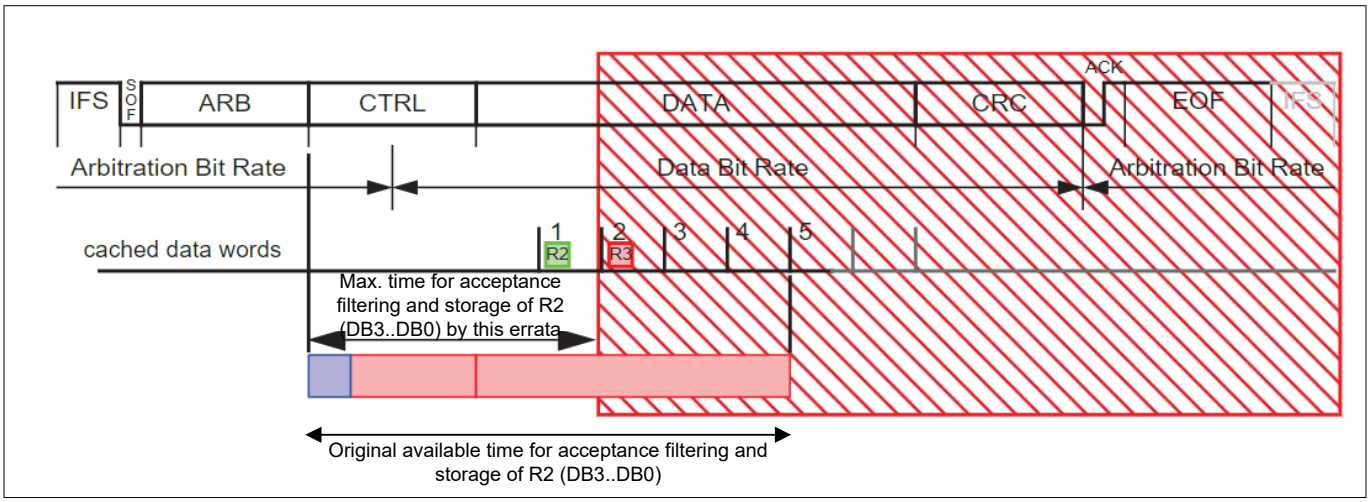
Figure 2 CAN frame with DLC > 4

Figure 2 shows how the available time for acceptance filtering and storage is reduced.
