TRAVEO™ T2G CYT2BL errata sheet

Marking/Step: Rev. A

32-bit single-chip microcontroller

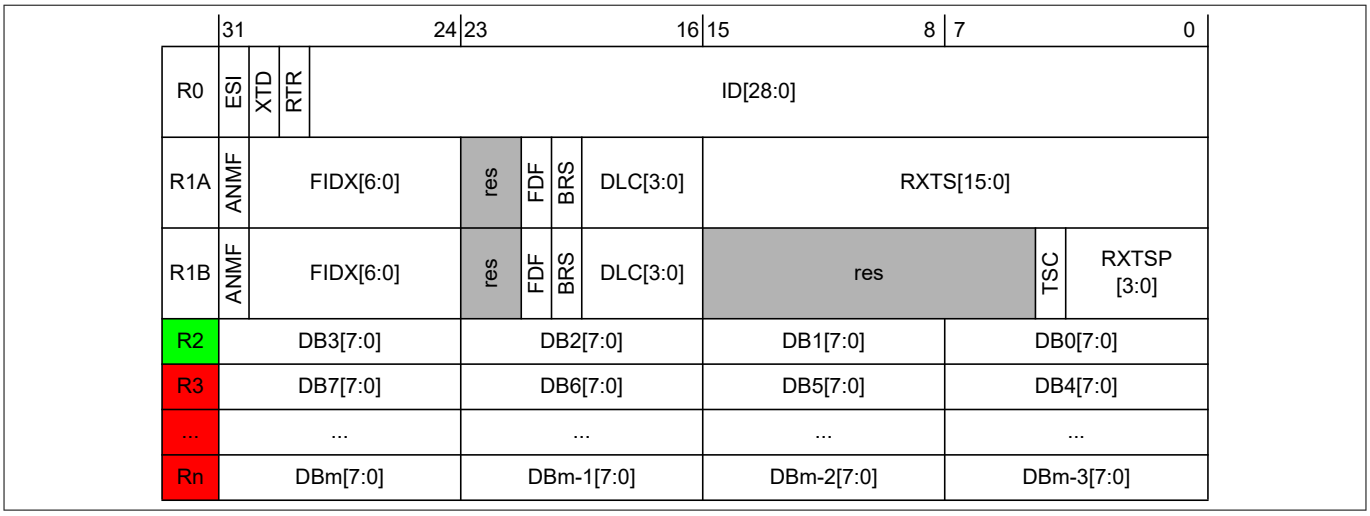
Figure 1 Rx Buffer and FIFO Element

Received data bytes (DB0..DBm) from the CAN Core are buffered in the cache of the Rx Handler before they are written to the Message RAM (in words of 4 byte). Data words inside the Message RAM are numbered from R2 to Rn (n ≤ 17).

Under the following conditions a received message will have corrupted data while the received message is signaled as valid to the host.

1. The data length code (DLC) of the received Message is greater than 4 (DLC > 4)
2. The storage of Ri of a received message into the Message RAM (after acceptance filtering is done) has not completed before R(i+1) is transferred from the CAN Core into the cache of the Rx Handler (where 2 ≤ i ≤ 5)
3. While condition 1 and 2 apply, a concurrent read of data word Ri from the cache and write of data word R(i+1) into the cache of the Rx handler happens

Due to condition 3 the issue occurs only sporadically. Use an end-to-end (E2E) protection (for example, checksum or CRC covering the data field) and add it to all messages in the CAN system, to detect data corruption in received frames.

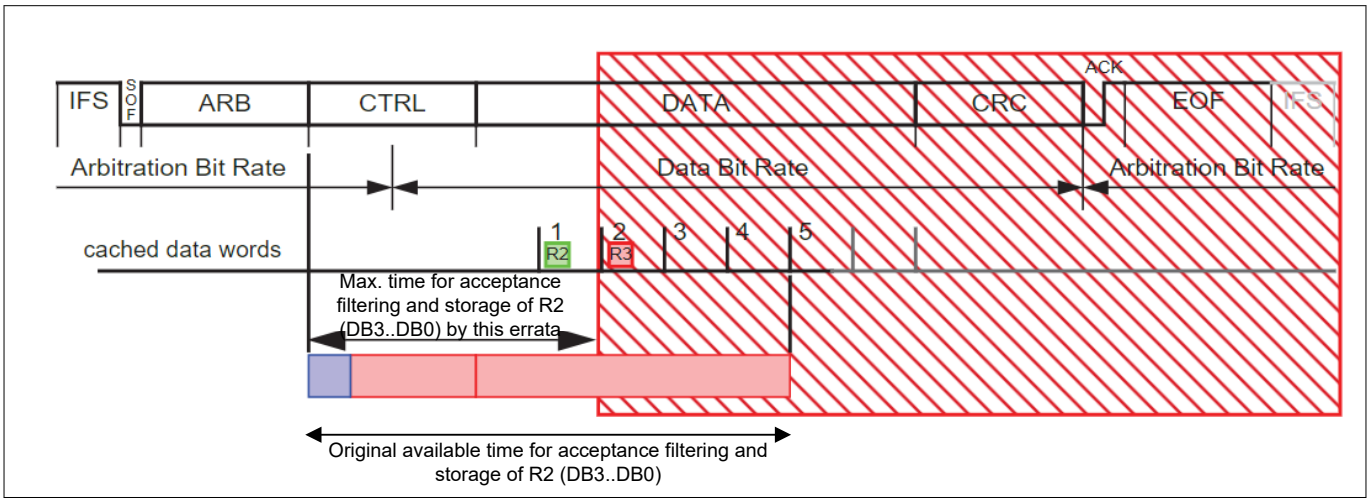
Figure 2 CAN frame with DLC > 4

The issue may occur in FD Frame Format as well as in Classic Frame Format.

Figure 2 shows how the available time for acceptance filtering and storage is reduced.
