TRAVEO™ T2G CYT4DN errata sheet

Marking/Step: Rev. C

32-bit single-chip microcontroller

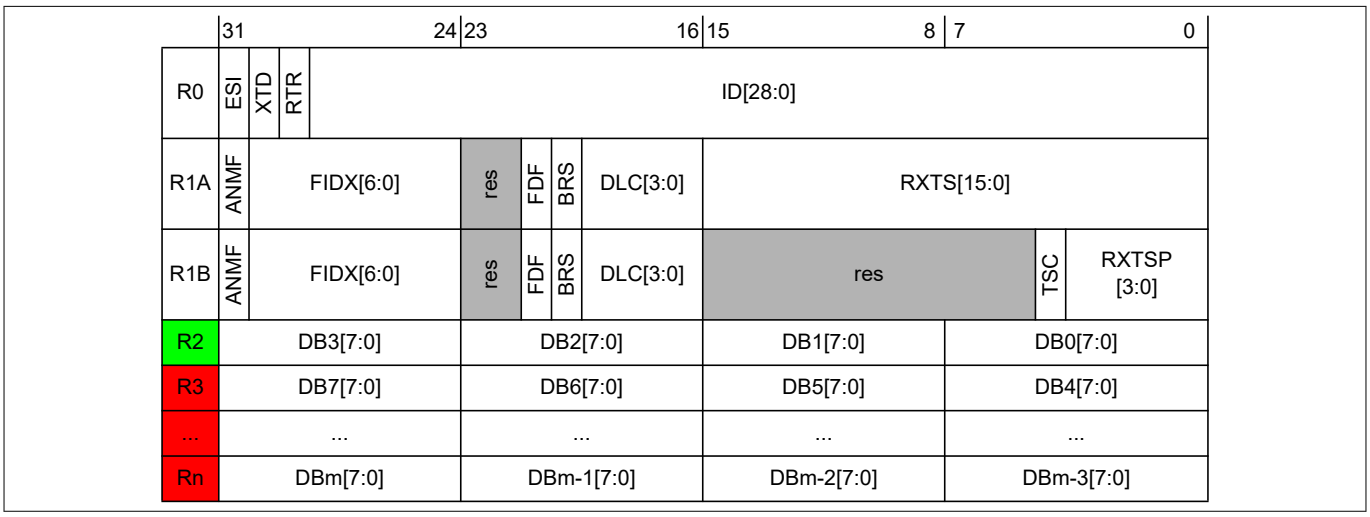
Figure 1 Rx Buffer and FIFO Element

Received data bytes (DB0..DBm) from the CAN Core are buffered in the cache of the Rx Handler before they are written to the Message RAM (in words of 4 byte). Data words inside the Message RAM are numbered from R2 to Rn (n ≤ 17).

Under the following conditions a received message will have corrupted data while the received message is signaled as valid to the host.

1. The data length code (DLC) of the received Message is greater than 4 (DLC > 4)
2. The storage of Ri of a received message into the Message RAM (after acceptance filtering is done) has not completed before R(i+1) is transferred from the CAN Core into the cache of the Rx Handler (where 2 ≤ i ≤ 5)
3. While condition 1 and 2 apply, a concurrent read of data word Ri from the cache and write of data word R(i+1) into the cache of the Rx handler happens

Due to condition 3 the issue occurs only sporadically. Use an end-to-end (E2E) protection (for example, checksum or CRC covering the data field) and add it to all messages in the CAN system, to detect data corruption in received frames.

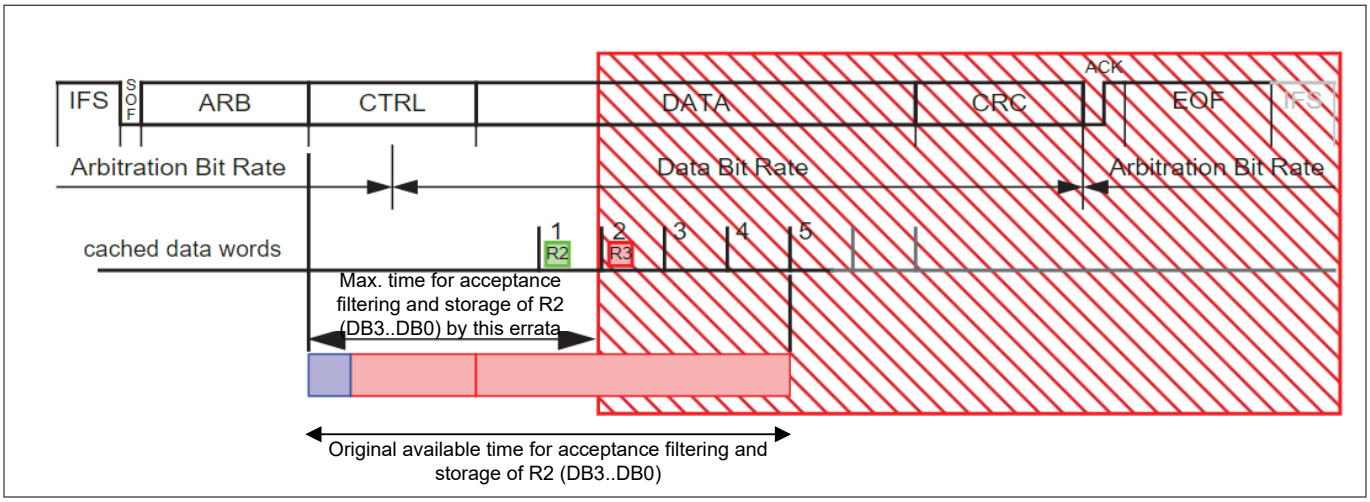
Figure 2 CAN frame with DLC > 4

The issue may occur in FD Frame Format as well as in Classic Frame Format.

Figure 2 shows how the available time for acceptance filtering and storage is reduced.
