AURIX™ TC22x/TC21x errata sheet

Marking/Step: ES-AC, AC

10679AERRA

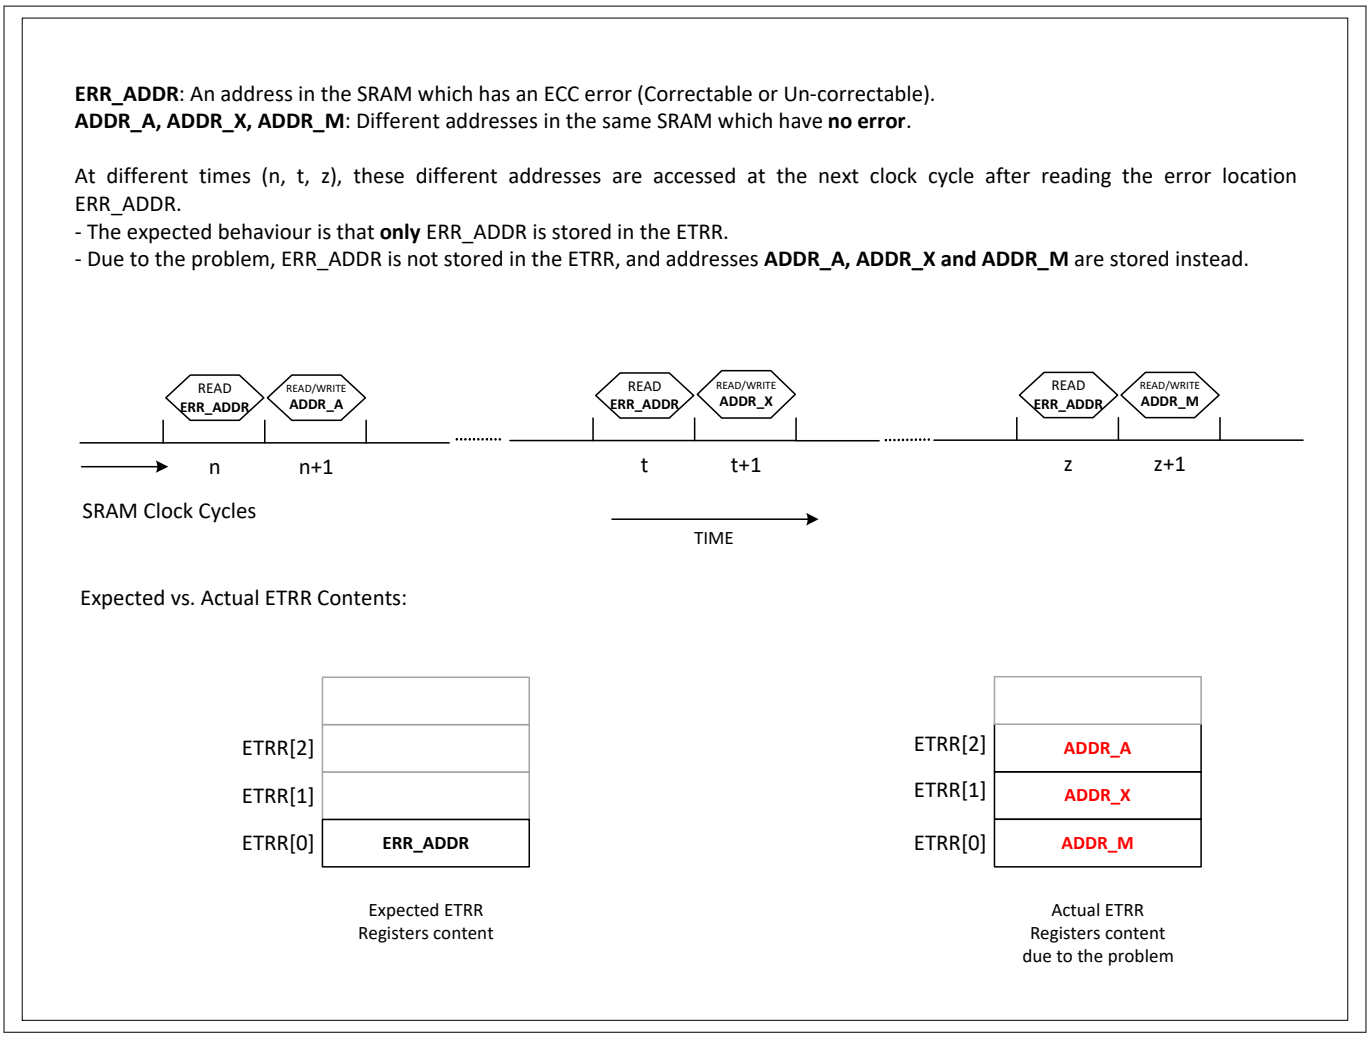
Figure 1 Example sequence showing how registers ETRRx may be filled with "Error Free" addresses

When such a consecutive access sequence (read from ERR_ADDR followed by read/write of different address(es)) happens multiple times, registers ETRRx are filled with addresses that have actually no error – and the SRAM address which actually has an error is not stored indeed. Figure 1 shows such an example scenario.

The consequence of the scenario explained in Figure 1 is that a single error in the SRAM – example just one correctable error at a location ERR_ADDR – can result in registers ETRRx getting filled with fault-free address, and thus potentially even triggering an ETRR overflow.

If there is at least one valid ETRR entry (i.e. MCx.ECCD.VAL ≠ 0) then the software shall run a Non-Destructive-Inversion (NDI) Test on the affected SRAM. Please refer to application note AP32197 (AURIX™ Memory tests using the MTU) for an example regarding running this test.

At the end of this test, if an ETRR overflow is detected (MCx.ECCD.EOV = 1_B) then the MCU shall be considered non-operational. Refer to section on Correctable SRAM Error handling in the Safety Manual.

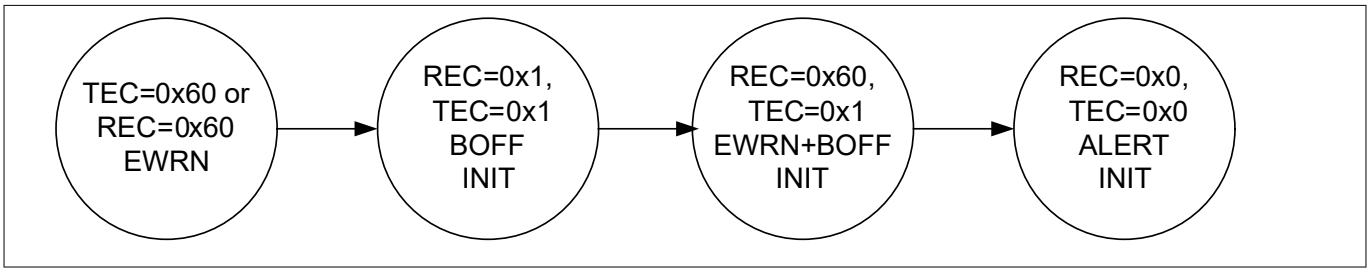
Figure 4 Alert Interrupt Behavior in case of Bus-Off

The MultiCAN module shows the following behavior in case of a bus-off status:

When the threshold for error warning (EWRN) is reached (default value of Error Warning Level EWRN = 0x60), then the EWRN interrupt is issued. The bus-off (BOFF) status is reached if TEC > 255 according to CAN specification, changing the MultiCAN module with REC and TEC to the same value 0x1, setting the INIT bit to 1_B, and issuing the BOFF interrupt. The bus-off recovery phase starts automatically. Every time an idle time is seen, REC is incremented. If REC = 0x60, a combined status EWRN+BOFF is reached. The corresponding interrupt can also be seen as a pre-warning interrupt, that the bus-off recovery phase will be finished soon. When the bus-off recovery phase has finished (128 times idle time have been seen on the bus), EWRN and BOFF are cleared, the ALERT interrupt bit is set and the INIT bit is still set.

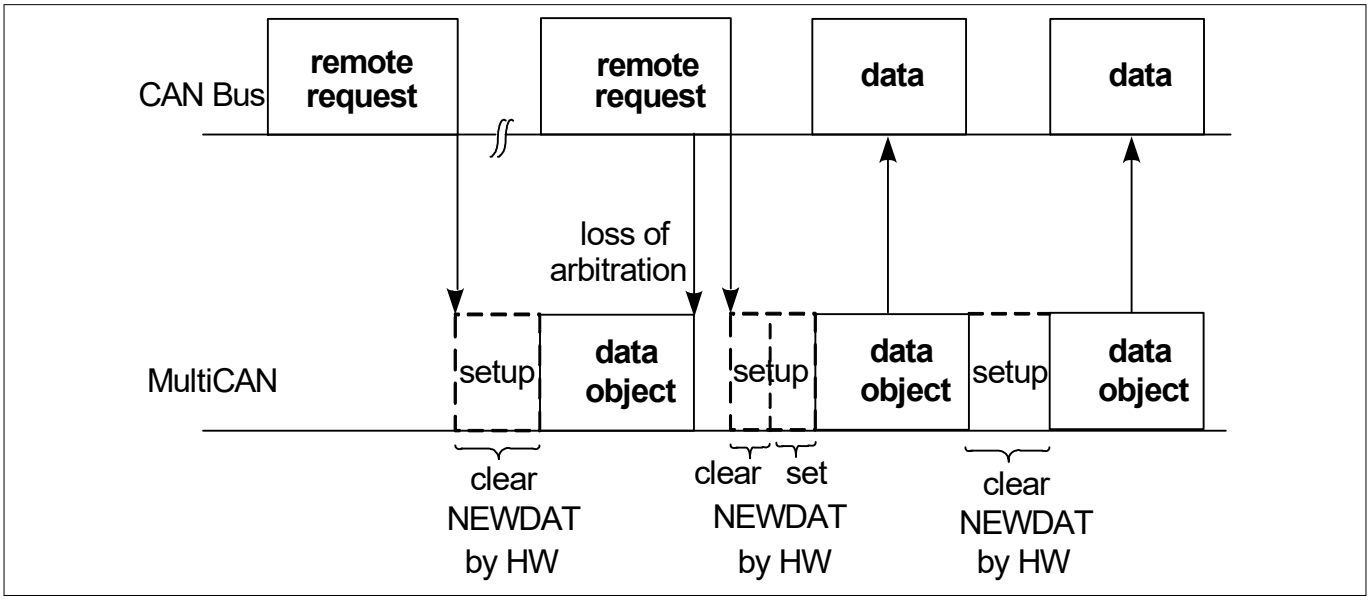
Figure 5 Loss of Arbitration

When the appropriate message object (data frame) triggered by the first remote frame wins the arbitration, it will be sent out and NEWDAT is not reset. This leads to an additional data frame, that will be sent by this message object (clearing NEWDAT).

There will, however, not be more data frames than there are corresponding remote requests.

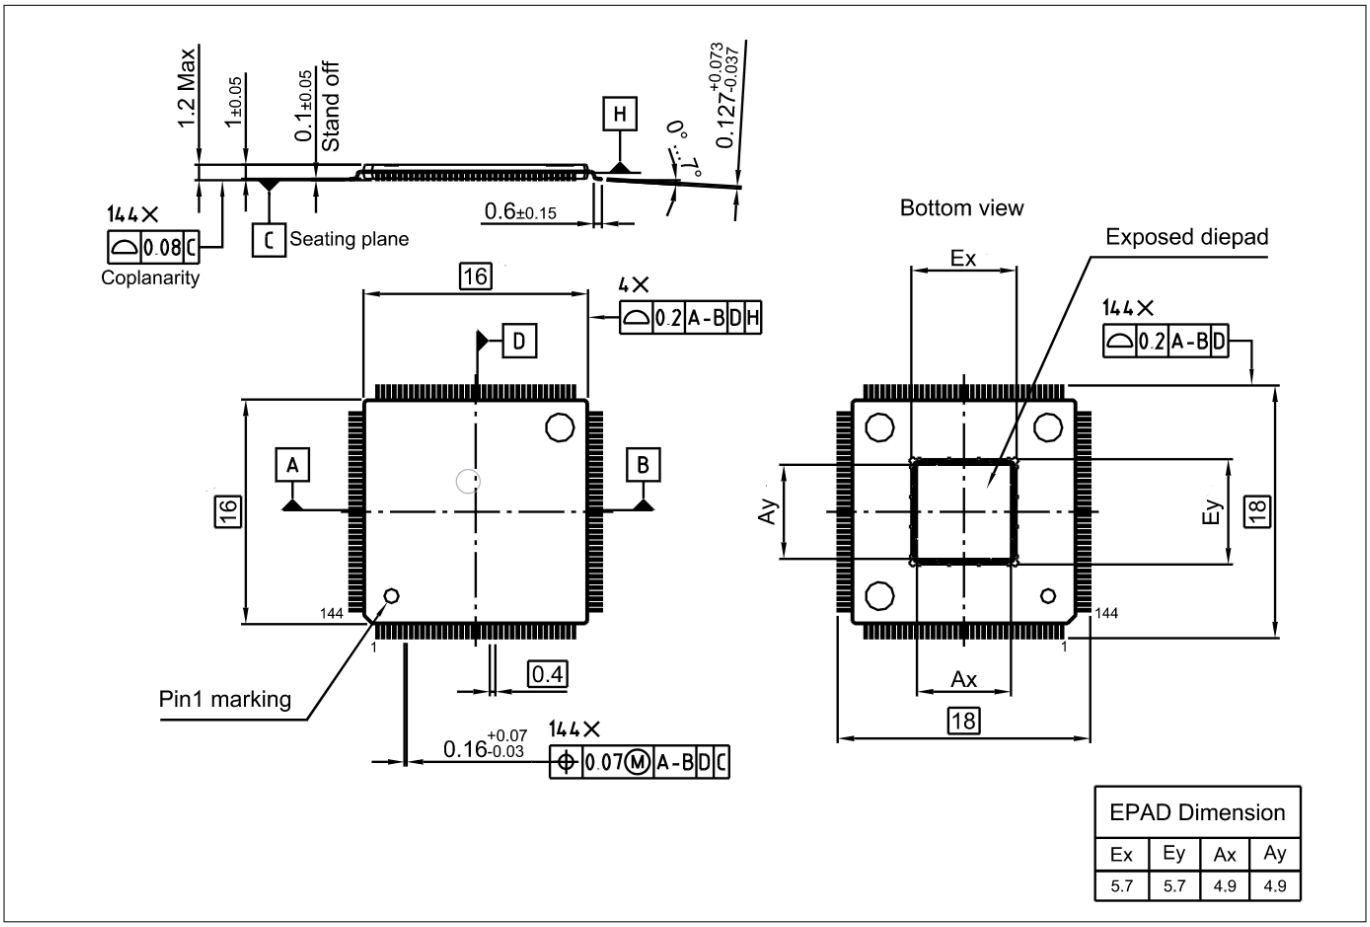
Figure 8 Package Outlines TQFP-144 for TC22x/TC21x

***Note**: For the exposed pad of the TQFP-144 package of the TC22x/TC21x, structural corner protrusions have to be considered for purposes of system design and integration with a maximum boundary of 6.2 mm.*

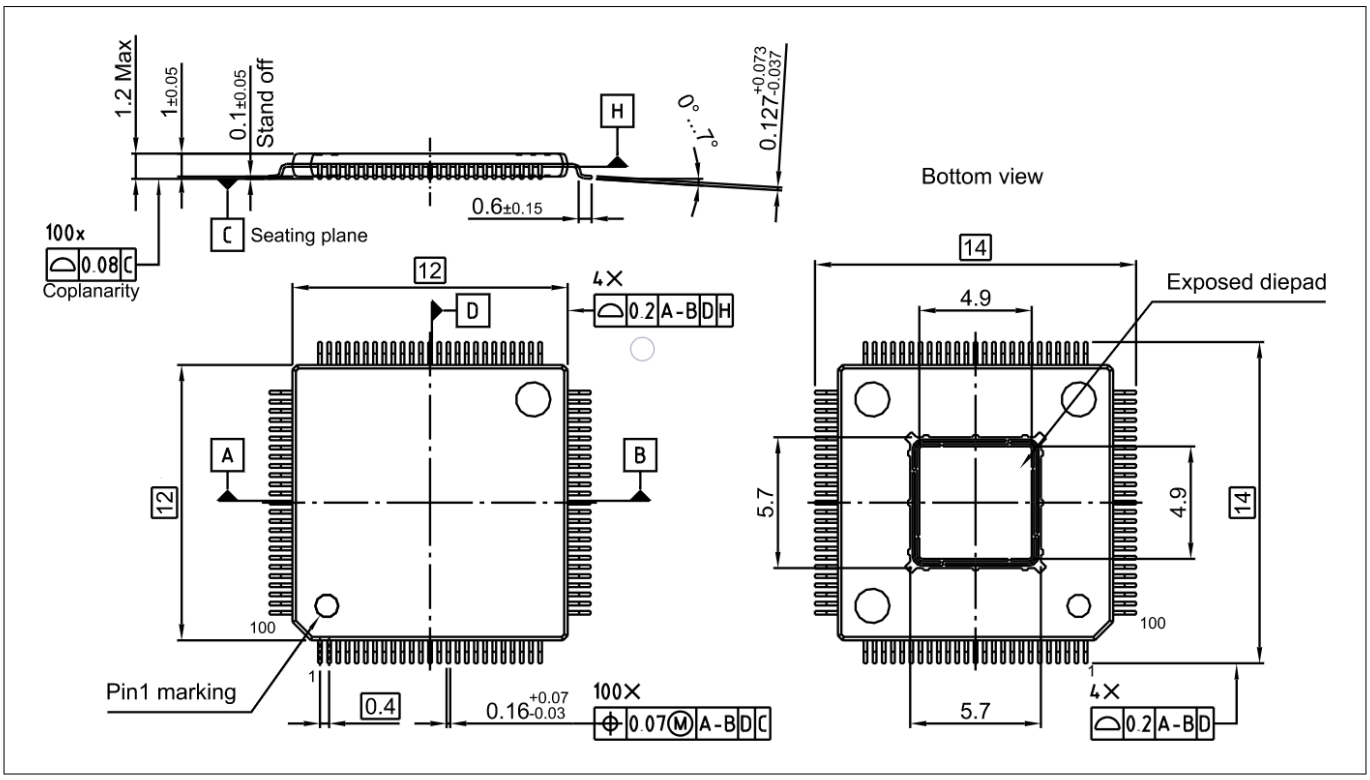
Figure 9 Package Outlines TQFP-100 for TC22x/TC21x

***Note**: For the exposed pad of the TQFP-100 package of the TC22x/TC21x, structural corner protrusions have to be considered for purposes of system design and integration with a maximum boundary of 6.3 mm.*

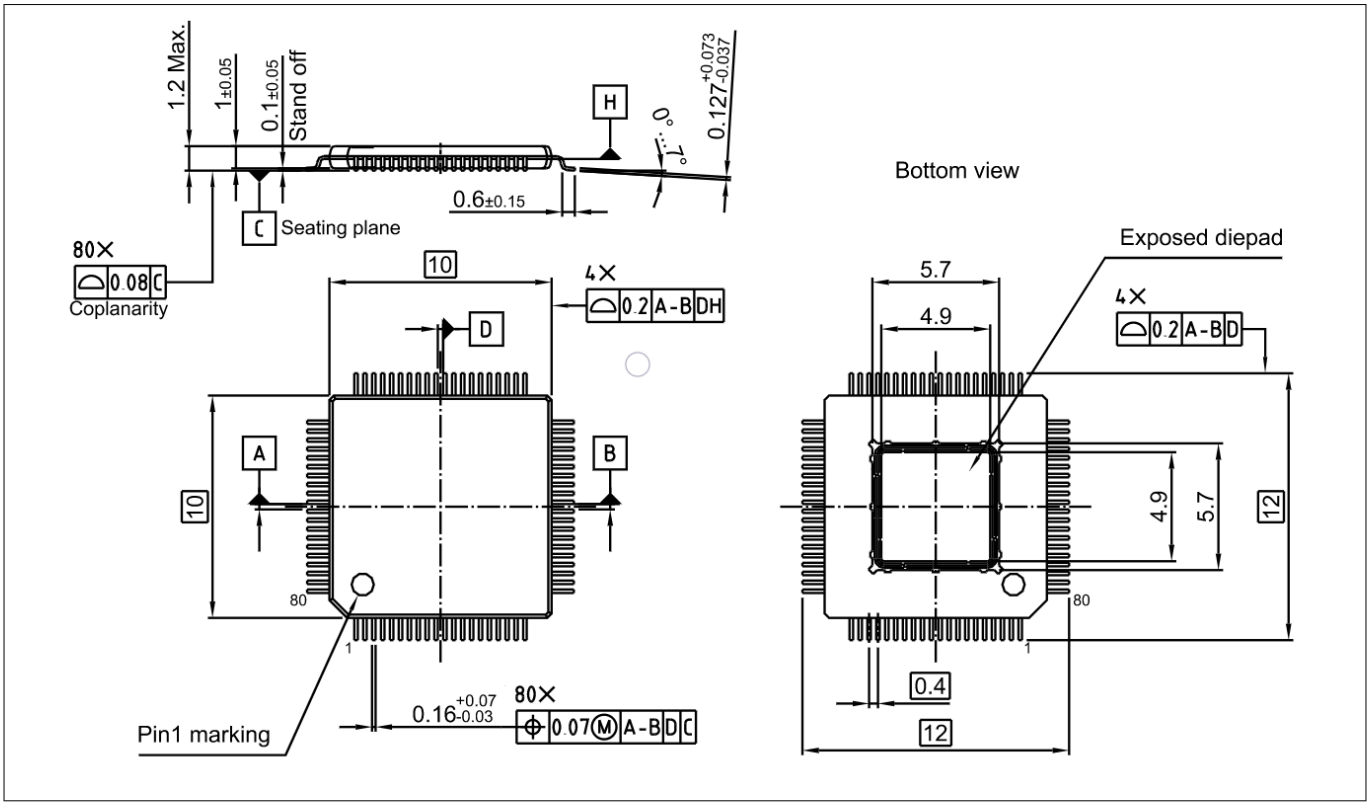
Figure 10 Package Outlines TQFP-80 for TC22x/TC21x

***Note**: For the exposed pad of the TQFP-80 package of the TC22x/TC21x, structural corner protrusions have to be considered for purposes of system design and integration with a maximum boundary of 6.2 mm.*

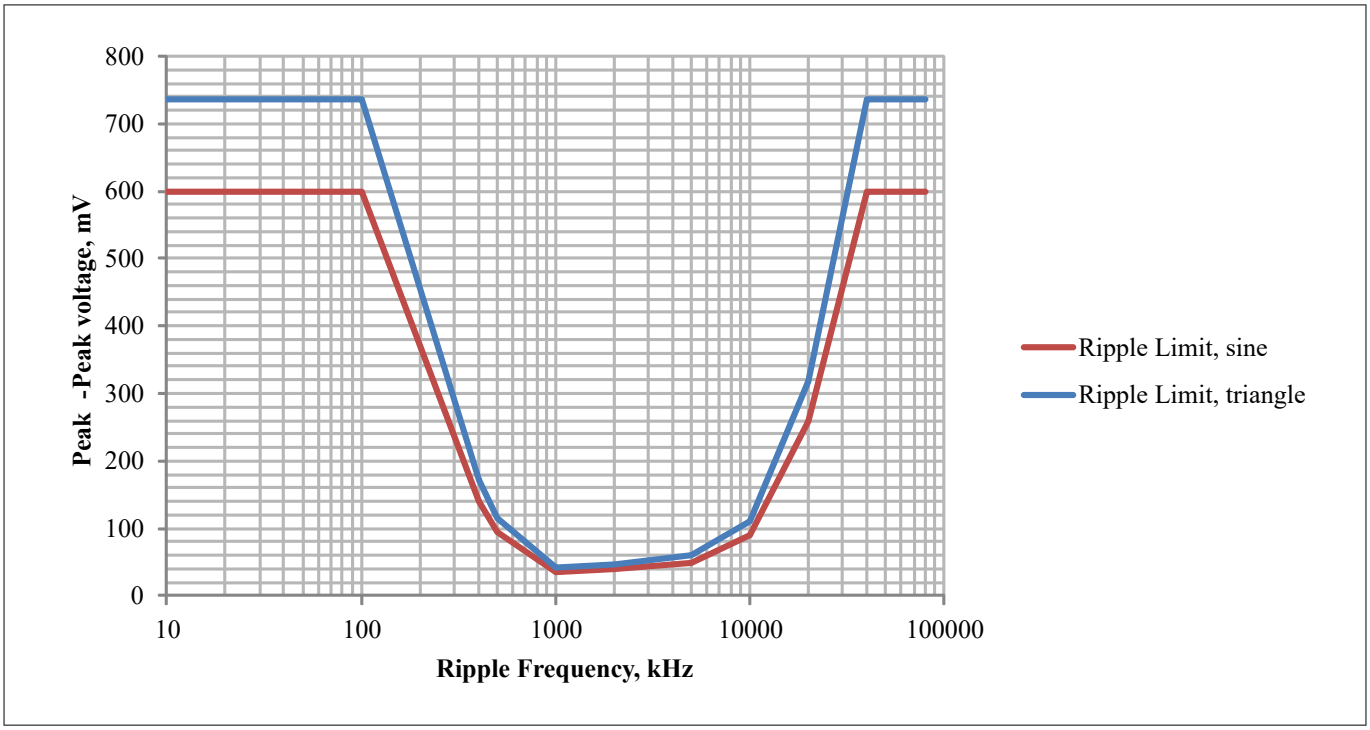
Figure 11 Ripple Voltage vs. Frequency Characteristic

The internal back-up clock is sensitive to specific power supply voltage disturbance/ripple caused by a voltage ripple intrinsic to DC-DC converters. Specific conditions such as insufficient filtering of the ripple may lead to improper behavior of the start-up scheme of the back-up clock, and thus stuck-at state during the start-up of the microcontroller until this condition is removed.
The acceptable voltage vs. frequency characteristic is portrayed below on the chart:

The diagram reflects acceptable ripple level during the cold start of the microcontroller at the respective VDDP3/VEXT/VEVRSB supply of the PMS subsystem, depending on the device and package type, as shown in the following table.

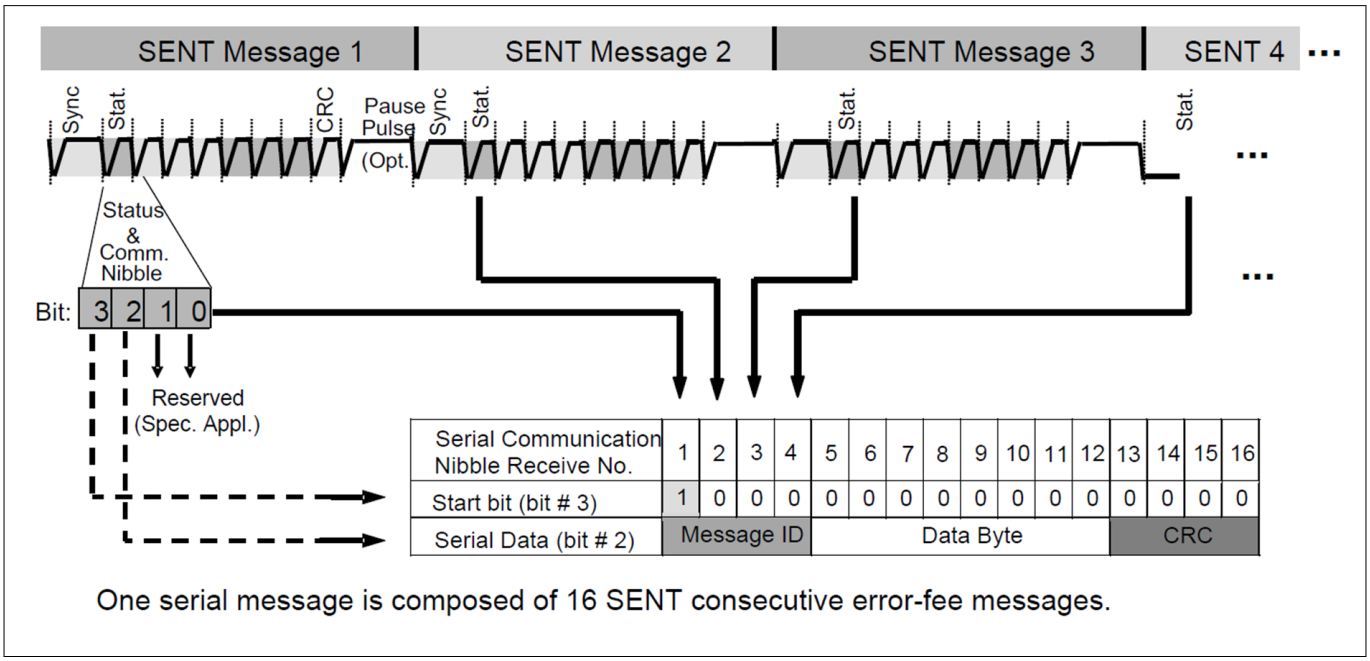
Figure 12 Short Serial Message, Serial Data Encoding over 16 messages

Figure 12 shows a corrected version of this figure.
