AURIX™ TC23x errata sheet

Marking/Step: ES-AB, AB

10680AERRA

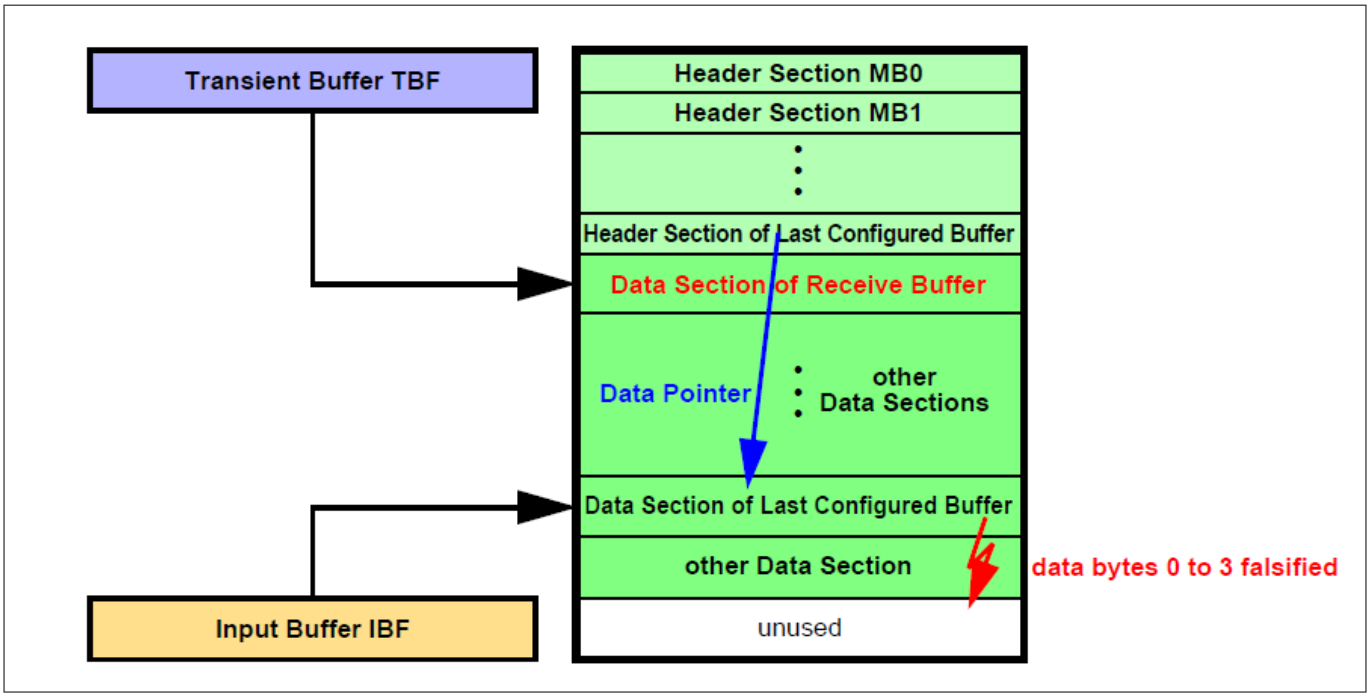
Figure 2 Message buffer transfer from IBF to Message RAM

After the Data Section of the selected message buffer in the Message RAM has been written, one additional write access overwrites the following word in the Message RAM which might be the first word of the next Data Section.

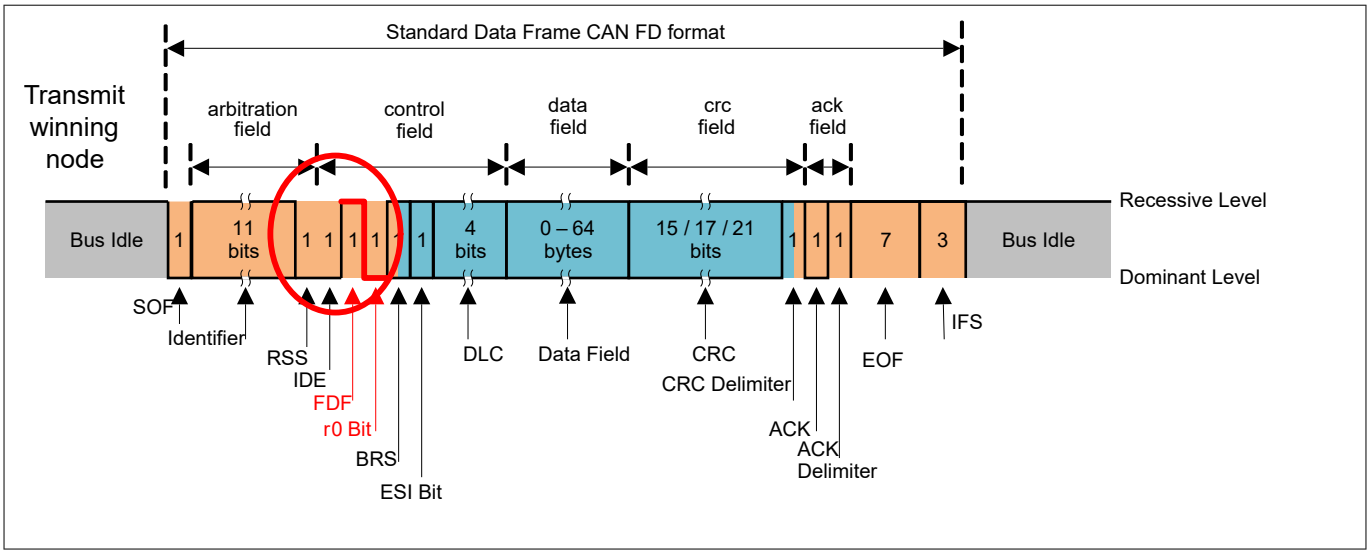
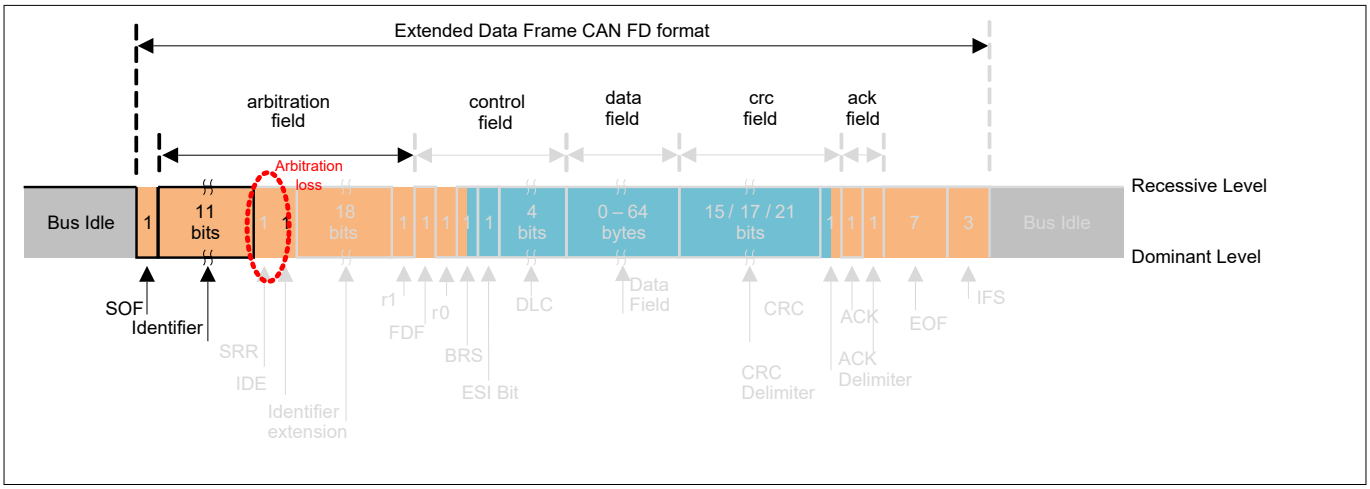
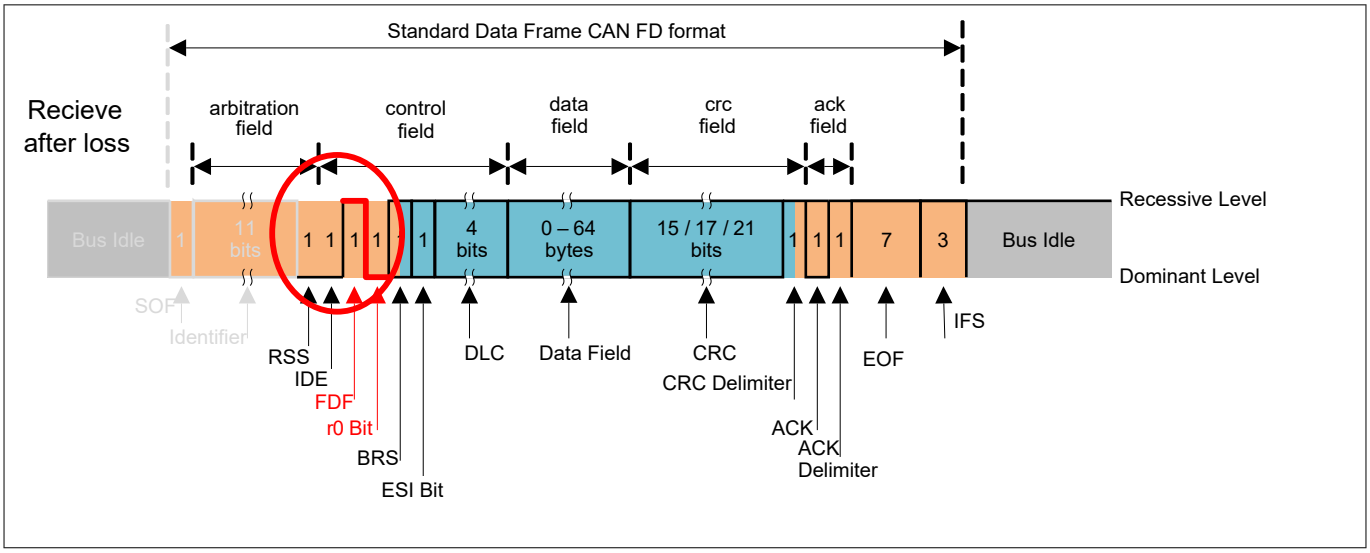
The device is producing more error frames within a network than a device with a hardsync at the FDF bit.

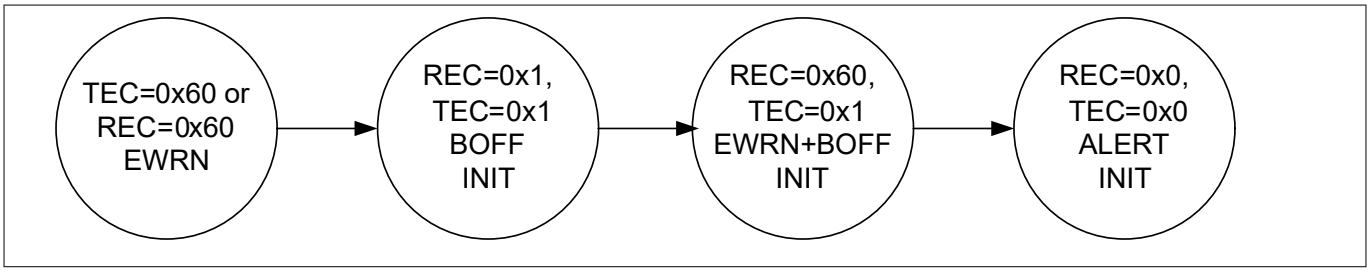
Figure 10 Alert Interrupt Behavior in case of Bus-Off

When the threshold for error warning (EWRN) is reached (default value of Error Warning Level EWRN = 0x60), then the EWRN interrupt is issued. The bus-off (BOFF) status is reached if TEC > 255 according to CAN specification, changing the MultiCAN module with REC and TEC to the same value 0x1, setting the INIT bit to 1_B, and issuing the BOFF interrupt. The bus-off recovery phase starts automatically. Every time an idle time is seen, REC is incremented. If REC = 0x60, a combined status EWRN+BOFF is reached. The corresponding interrupt can also be seen as a pre-warning interrupt, that the bus-off recovery phase will be finished soon. When the bus-off recovery phase has finished (128 times idle time have been seen on the bus), EWRN and BOFF are cleared, the ALERT interrupt bit is set and the INIT bit is still set.

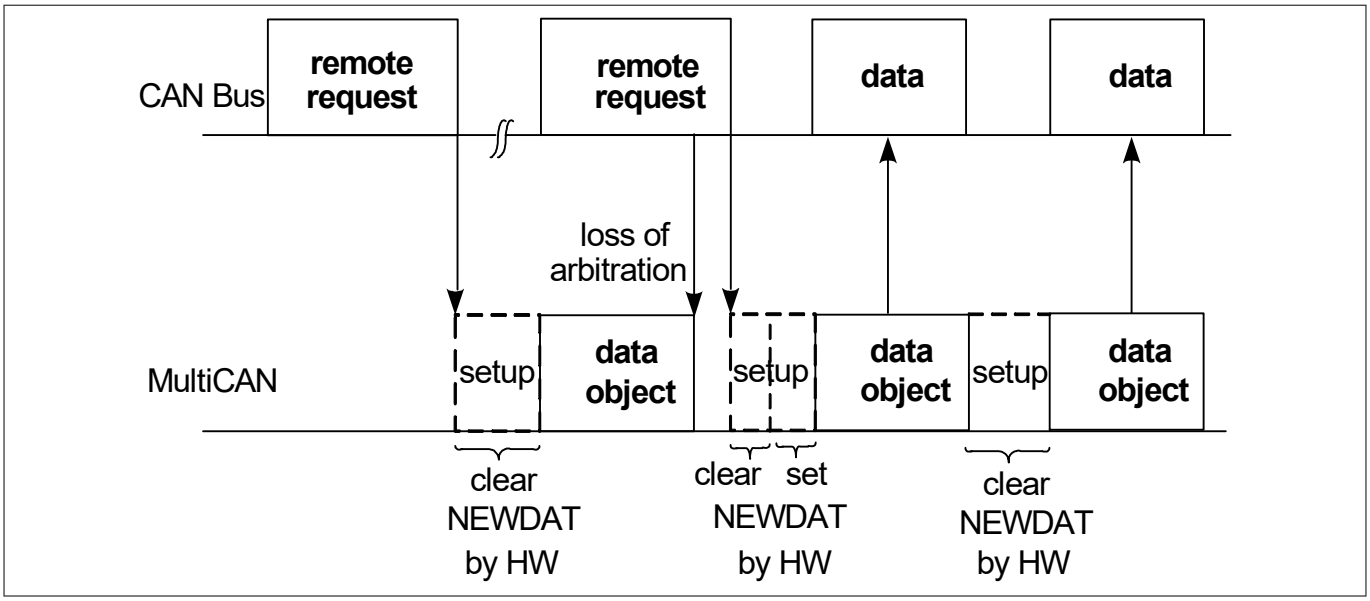
Figure 11 Loss of Arbitration

When the appropriate message object (data frame) triggered by the first remote frame wins the arbitration, it will be sent out and NEWDAT is not reset. This leads to an additional data frame, that will be sent by this message object (clearing NEWDAT).

There will, however, not be more data frames than there are corresponding remote requests.

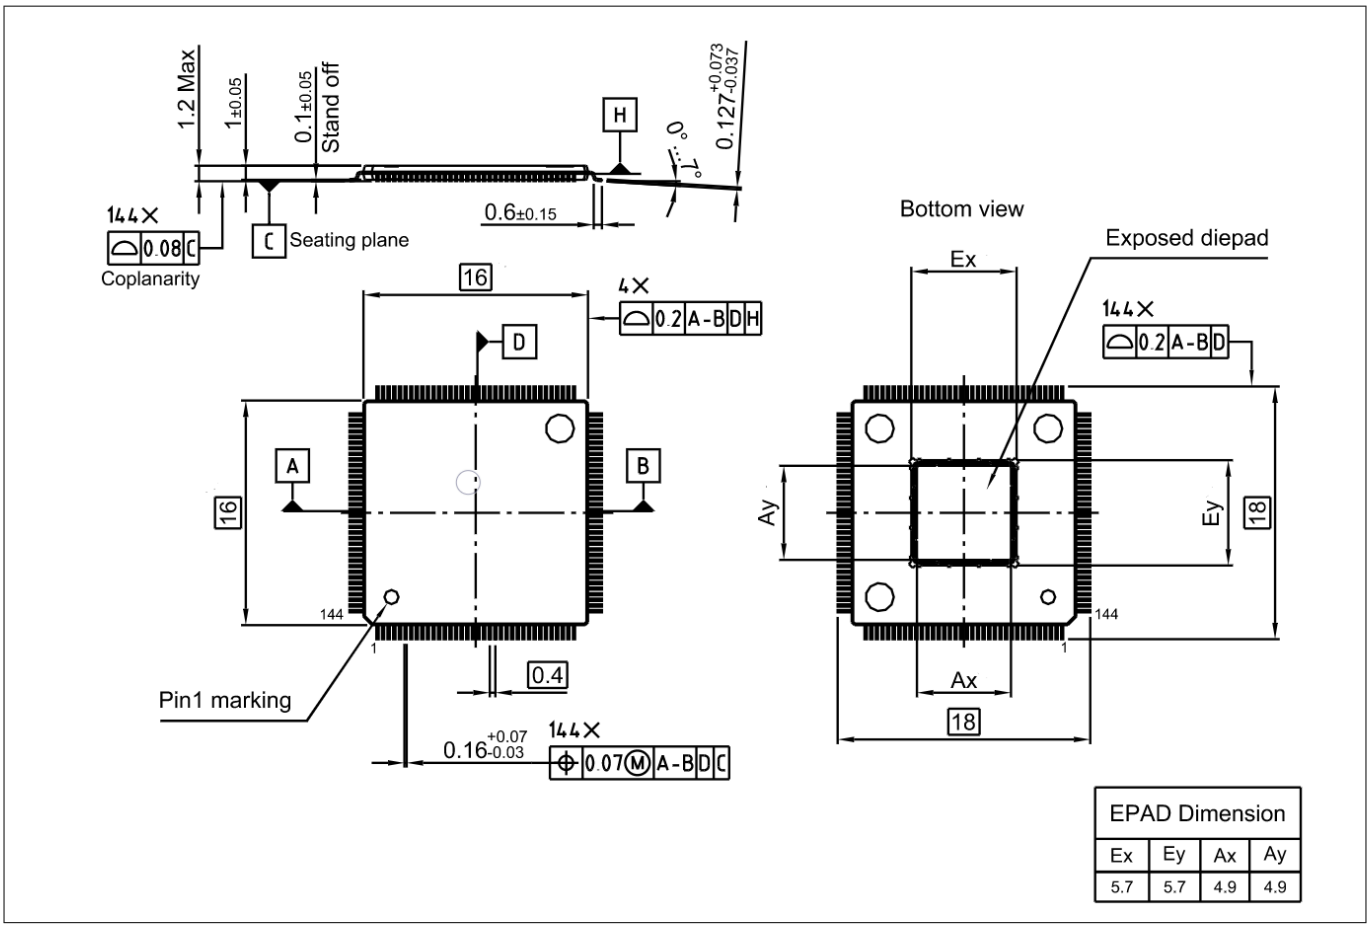
Figure 12 Package Outlines TQFP-144 for TC23x

***Note**: For the exposed pad of the TQFP-144 package of the TC23x, structural corner protrusions have to be considered for purposes of system design and integration with a maximum boundary of 6.2 mm.*

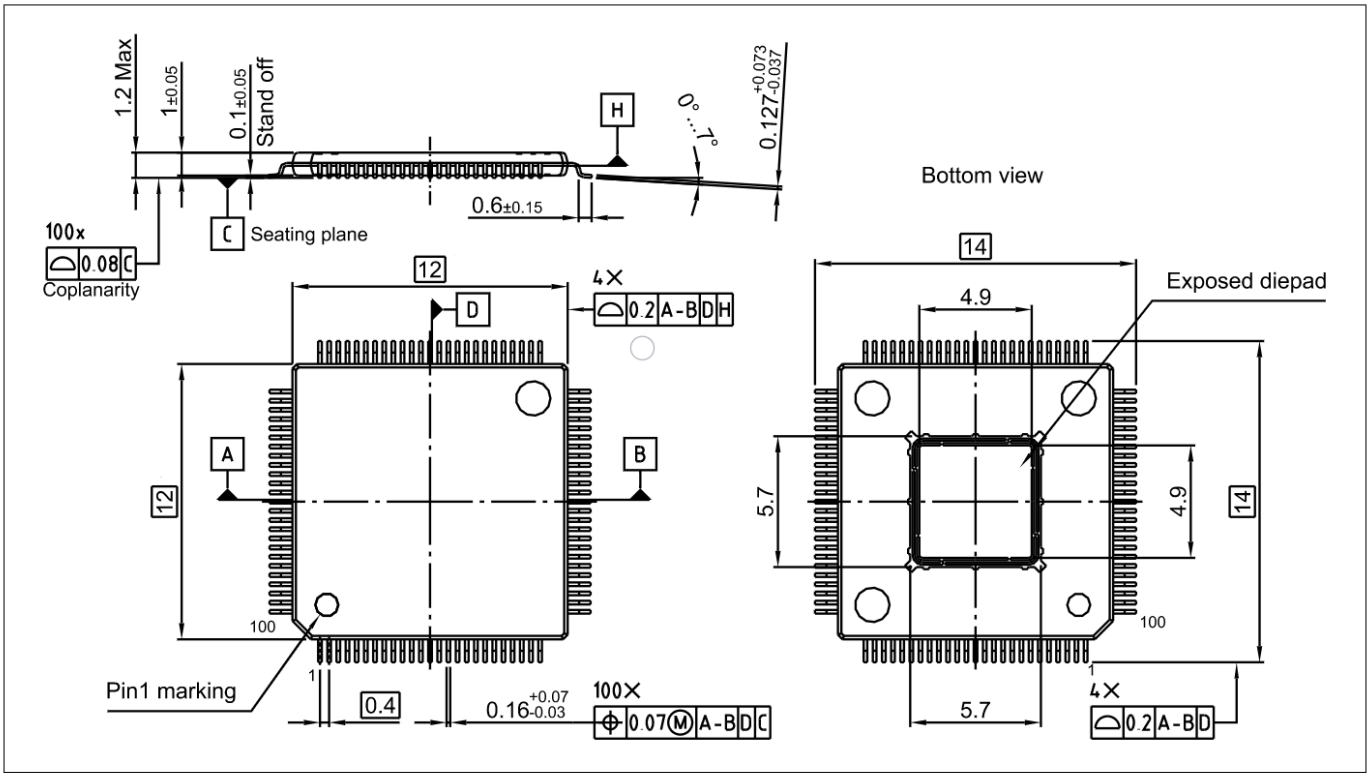
Figure 13 Package Outlines TQFP-100 for TC23x

***Note**: For the exposed pad of the TQFP-100 package of the TC23x, structural corner protrusions have to be considered for purposes of system design and integration with a maximum boundary of 6.3 mm.*

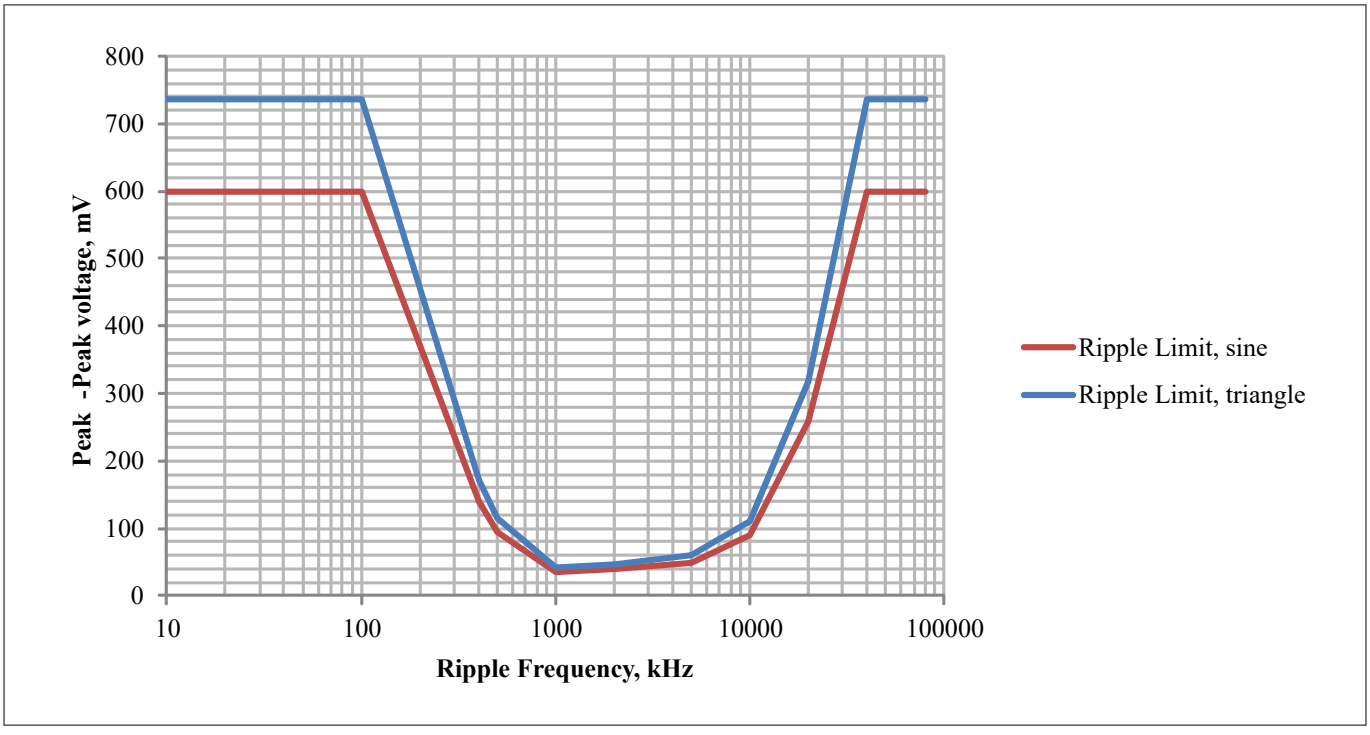
Figure 14 Ripple Voltage vs. Frequency Characteristic

The internal back-up clock is sensitive to specific power supply voltage disturbance/ripple caused by a voltage ripple intrinsic to DC-DC converters. Specific conditions such as insufficient filtering of the ripple may lead to improper behavior of the start-up scheme of the back-up clock, and thus stuck-at state during the start-up of the microcontroller until this condition is removed.
The acceptable voltage vs. frequency characteristic is portrayed below on the chart:

The diagram reflects acceptable ripple level during the cold start of the microcontroller at the respective VDDP3/VEXT/VEVRSB supply of the PMS subsystem, depending on the device and package type, as shown in the following table.

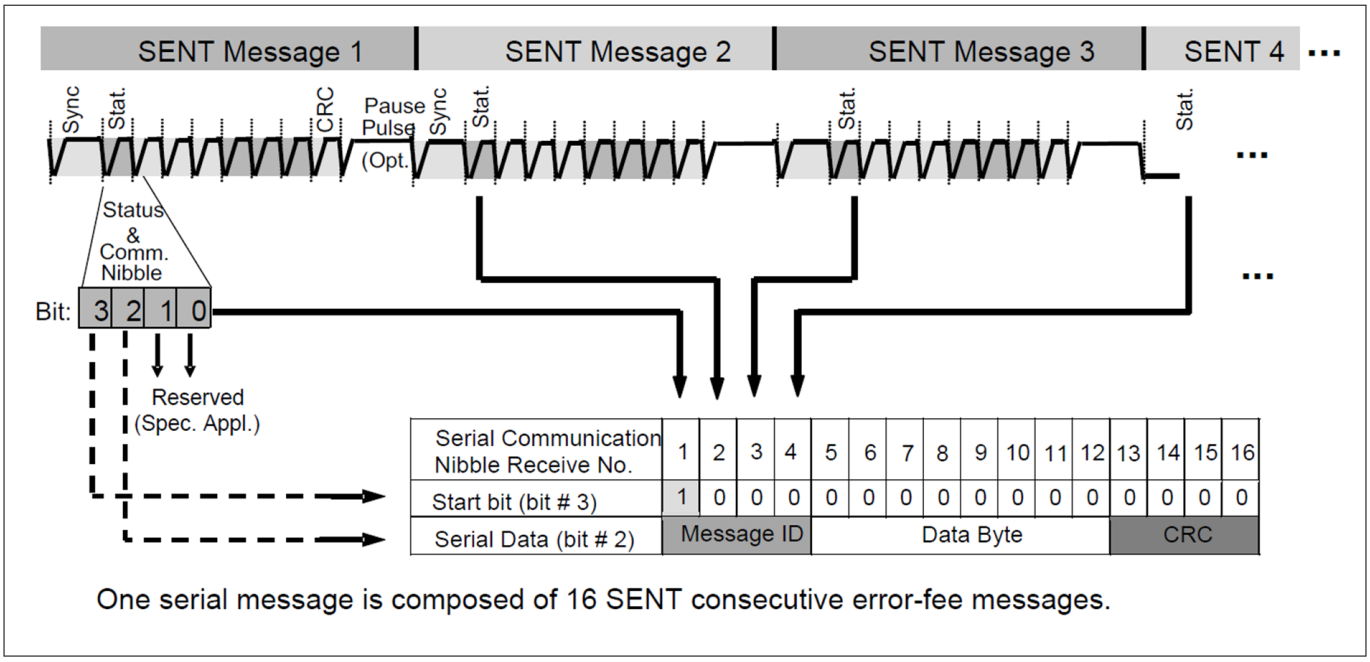
Figure 15 Short Serial Message, Serial Data Encoding over 16 messages

Figure 15 shows a corrected version of this figure.
