AURIX™ TC23x errata sheet

Marking/Step: ES-AC, AC

10681AERRA

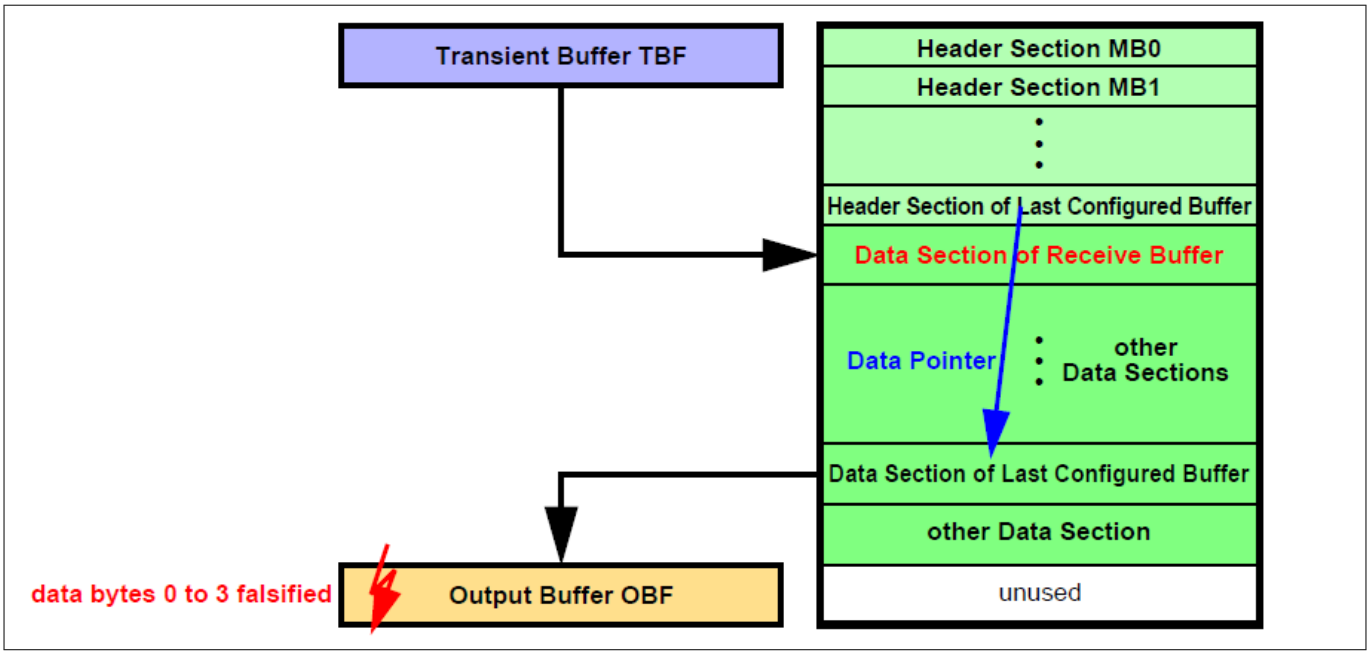
Figure 1 Message buffer transfer from Message RAM to OBF

When the message buffer has its payload configured to maximum length (PLC = 127), the OBF word on address 00h (payload data bytes 0 to 3) is overwritten with unexpected data at the end of the transfer.

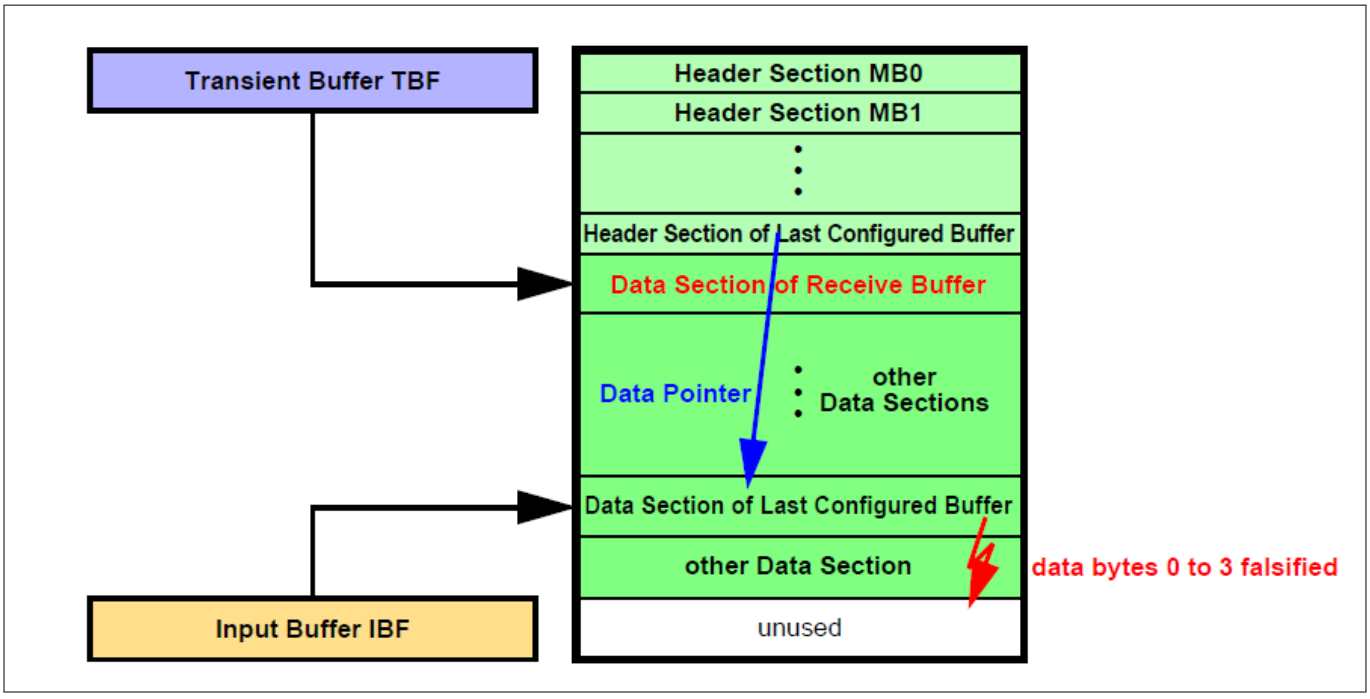
Figure 2 Message buffer transfer from IBF to Message RAM

After the Data Section of the selected message buffer in the Message RAM has been written, one additional write access overwrites the following word in the Message RAM which might be the first word of the next Data Section.

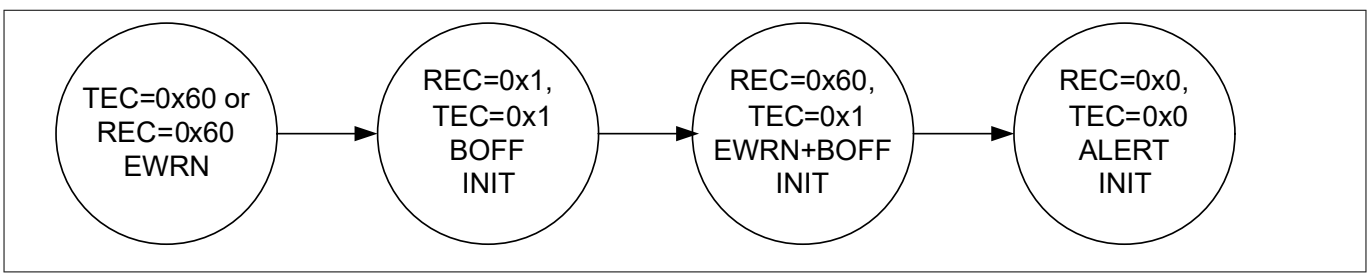
Figure 8 Alert Interrupt Behavior in case of Bus-Off

When the threshold for error warning (EWRN) is reached (default value of Error Warning Level EWRN = 0x60), then the EWRN interrupt is issued. The bus-off (BOFF) status is reached if TEC > 255 according to CAN specification, changing the MultiCAN module with REC and TEC to the same value 0x1, setting the INIT bit to 1_B, and issuing the BOFF interrupt. The bus-off recovery phase starts automatically. Every time an idle time is seen, REC is incremented. If REC = 0x60, a combined status EWRN+BOFF is reached. The corresponding interrupt can also be seen as a pre-warning interrupt, that the bus-off recovery phase will be finished soon. When the bus-off recovery phase has finished (128 times idle time have been seen on the bus), EWRN and BOFF are cleared, the ALERT interrupt bit is set and the INIT bit is still set.

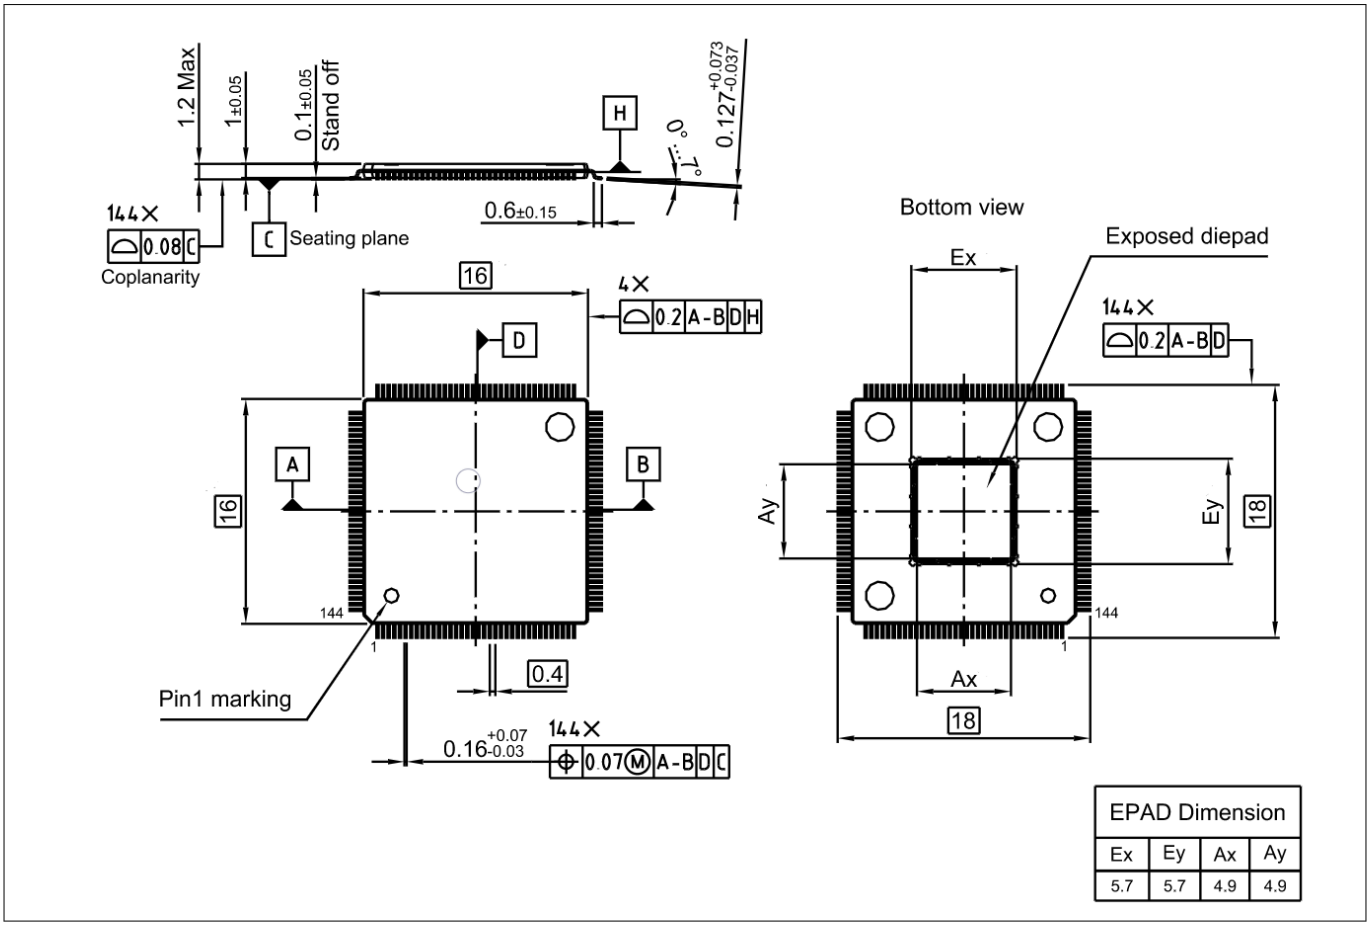
Figure 12 Package Outlines TQFP-144 for TC23x

***Note**: For the exposed pad of the TQFP-144 package of the TC23x, structural corner protrusions have to be considered for purposes of system design and integration with a maximum boundary of 6.2 mm.*

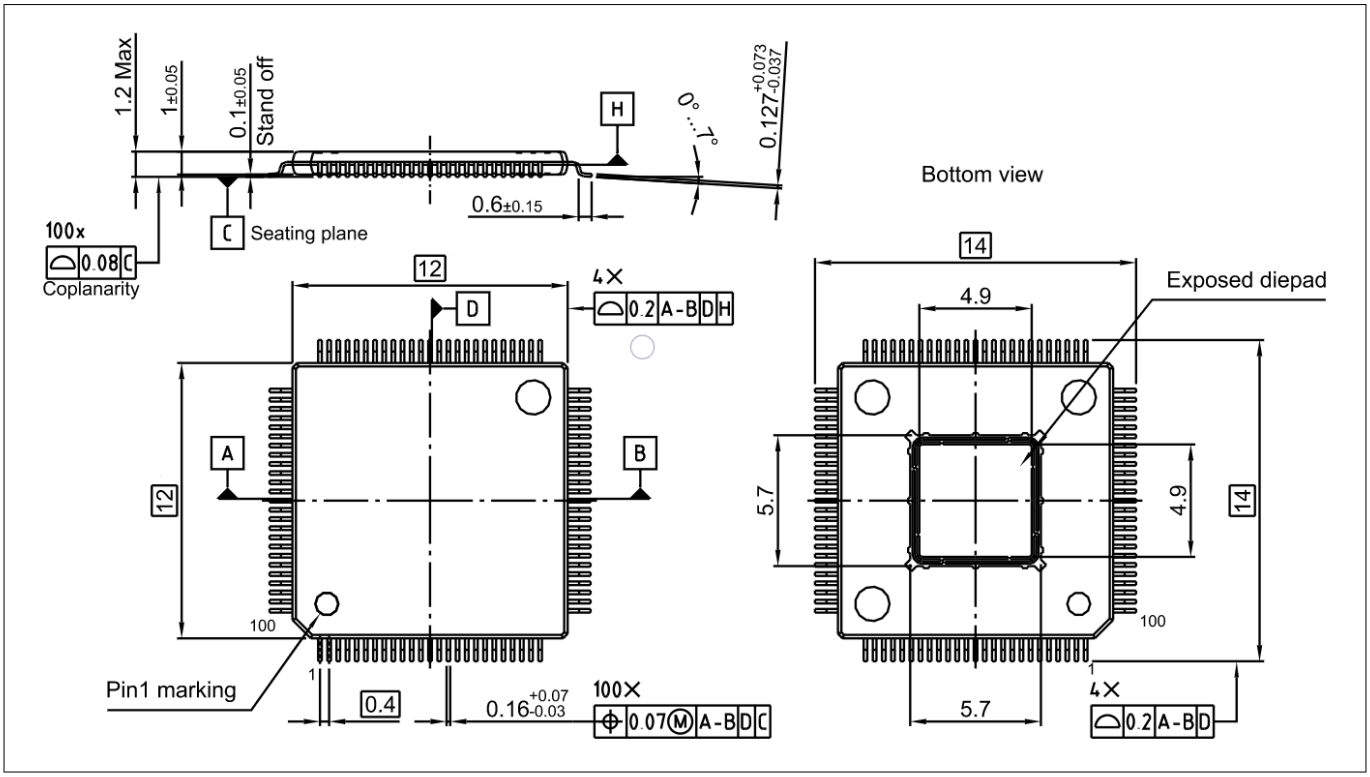
Figure 13 Package Outlines TQFP-100 for TC23x

***Note**: For the exposed pad of the TQFP-100 package of the TC23x, structural corner protrusions have to be considered for purposes of system design and integration with a maximum boundary of 6.3 mm.*
