AURIX™ TC33xEXT errata sheet

Marking/Step: (E)ES-AA, AA

10620AERRA

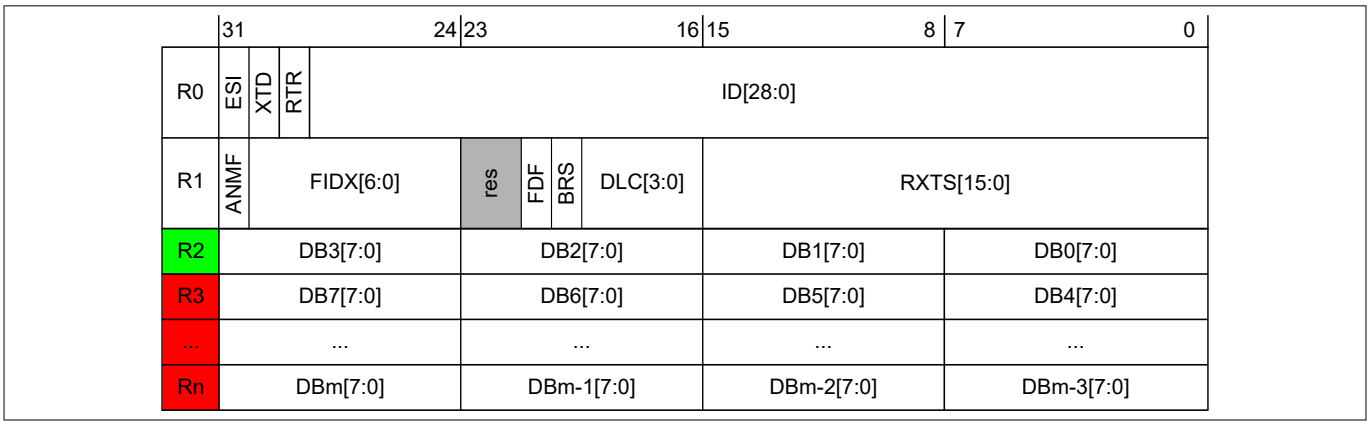
Figure 1 TC3xx - Rx Buffer and FIFO Element (R_i holds Data Byte DB(x+3)..DBx (with x=4*(i-2)))

Received data bytes (DB0..DBm) from the CAN Core are buffered in the cache of the Rx Handler before they are written to the Message RAM (in words of 4 byte). Data words inside the Message RAM are numbered from R2 to Rn (n ≤ 17).

Under the following conditions a received message will have corrupted data while the received message is signaled as valid to the host.

1. The data length code (DLC) of the received message is greater than 4 (DLC > 4)
2. The storage of Ri of a received message into the Message RAM (after acceptance filtering is done) has not completed before $R_{(i+1)}$ is transferred from the CAN Core into the cache of the Rx Handler (where 2 ≤ i ≤ 5)
3. While condition 1) and 2) apply, a concurrent read of data word Ri from the cache and write of data word $R_{(i+1)}$ into the cache of the Rx handler happens

Due to condition 3) the issue only occurs sporadically. Use an end-to-end (E2E) protection (for example, checksum or CRC covering the data field) and add it to all messages in the CAN system, to detect data corruption in received frames.

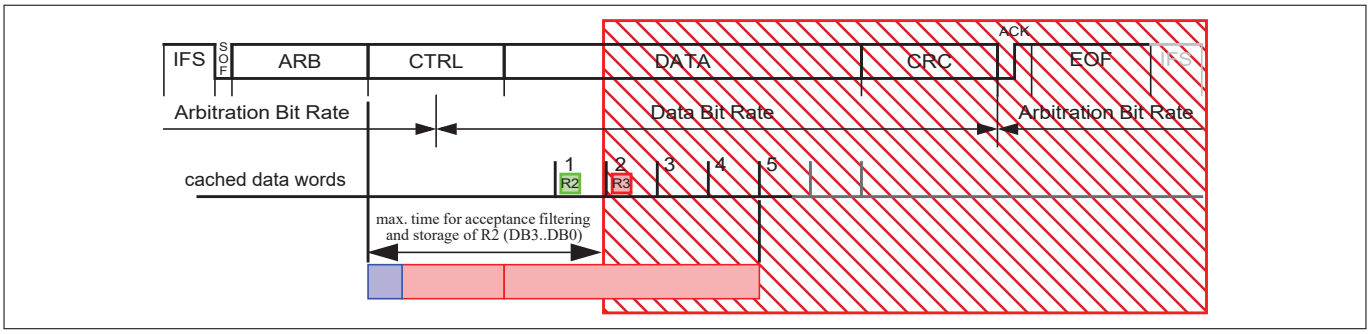
Figure 2 CAN Frame with DLC > 4

The issue may occur in FD Frame Format as well as in Classic Frame Format.

The figure that follows shows how the available time for acceptance filtering and storage is reduced.
