Microcontrollers

Errata Sheet

V0.1, 2005-03-30

Device	**XC164D-16F20F, -16F40F, -8F20F, -8F40F** **XC164N-16F20F, -16F40F, -8F20F, -8F40F** **XC164S-16F20F, -16F40F, -8F20F, -8F40F**
Stepping Code/Marking	**AC**
Package	**P-TQFP-100-16**

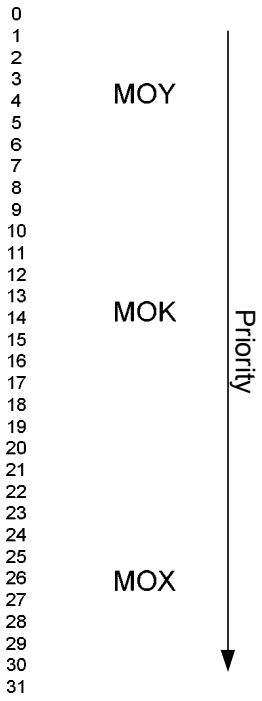
TwinCAN2.005: Double Send

Under the following conditions, the problem described below will occur:

Message Object X (MO_X, lower priority) is in the process of actually being transmitted, and then the transmit request bit for Message Object Y (MO_Y, higher priority) is set via the user software. Other message objects MO_0 ... MO_n may be pending for transmission, where the priorities are MO_0 > ..> MO_Y > .. > MO_K... > MO_n > MO_X. There is no message object MO_k which has a valid transmit request and a lower message number than MO_Y (priority of MO_K < priority of MO_Y).

MO_x is sent twice, MO_y is not sent.

MO_x is sent, but neither the transmit request is cleared, nor bit INTPND is set. Also no transmit interrupt is requested for MO_x. Instead, TXRQ of MO_Y is cleared, INTPND of MO_Y is set and a transmit interrupt is requested for MO_Y (if enabled), although MO_Y has actually not been transmitted.
If NEWDAT has been set for message object MO_Y, then MO_Y is setup for transmission by the TwinCAN additionally to the INTPND, otherwise MO_K will be transmitted. If NEWDAT has not been set for message object MO_Y, then MO_Y will not be transmitted at all, but the INTPND is set.
As TxRQ has not been cleared for MO_X, MO_X will be transmitted a second time.
The gateway mode is affected as well.

a) Remote frames have to be forbidden; otherwise an "uncontrolled" TxRQ will be set. Set Message Object Transmit Requests (TxRQs) in order from 0 to 31, rather than at random. This could be done by implementing a software array for transmit requests TxRQs[32]. When a TxRQ bit for a Message Object has to be set, the software should write to the corresponding location within the software array. On a regular basis, all transmit requests then have to be reset and set according to the settings within the software array, to enable all message objects with TxRQs to be updated in the correct order. Between reset and set the application has to wait for the length of two CAN frames.
In order to use the gateway mode, do not set the GDFS bit in MSGFGCR.

b) Under the same software control as in workaround a) TxRQs can be set, as long as CPUUPD is set and only reset in the natural order. In this case Remote Frames are allowed.
