Errata Sheet

Rel. 1.11, 2016-11

Device	**XMC1100**
Marking/Step	**EES-AA, ES-AA, AA**
Package	**PG-TSSOP-16/38, PG-VQFN-24/40**

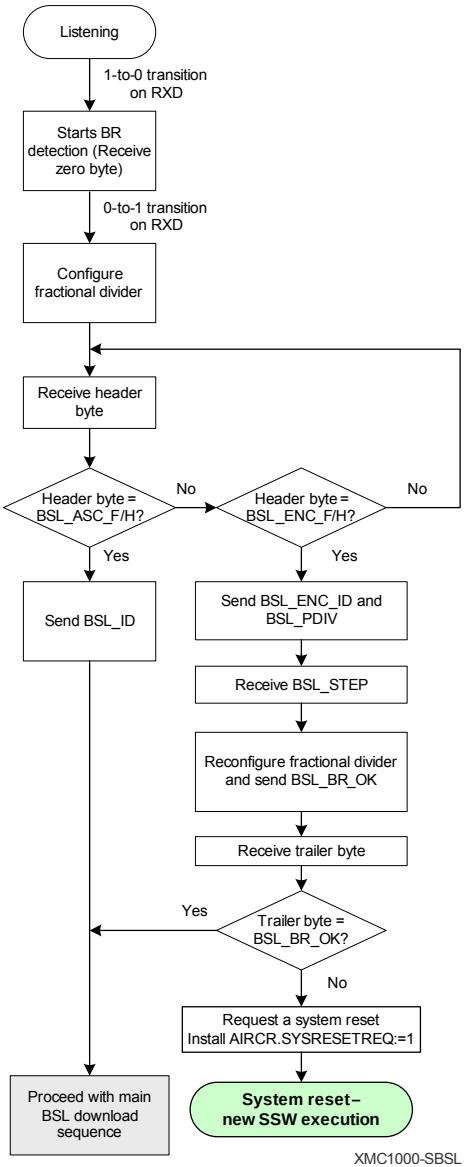
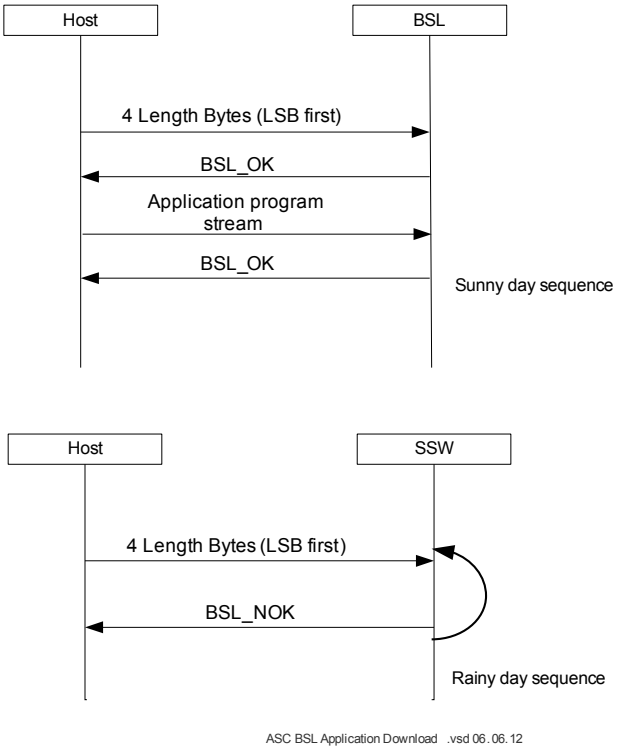
Figure 2 Baud Rate configuration sequence during ASC BSL entry

With the current implementation (refer to the “Bootstrap Loaders and User Routines” chapter in Reference Manual) the host device (e.g. a PC) may have problem to switch the baudrate fast enough after sending the request (BSL_STEP as of **Figure 2**) and is not able to receive the device acknowledge (BSL_BR_OK) correctly with the changed ASC channel speed. If this happens, the host will get some error condition - wrong response, start bit not detected, etc. In such a case the host has to ignore the error and send the trailer Byte (BSL_BR_OK) with the new baudrate. The correctness of the communication speed settings will be then decided by the host upon the response from the device after sending the length of code for downloading (refer to **Figure 3**).
