Errata Sheet

Rel. 1.10, 2016-11

Device	**XMC1300**
Marking/Step	**EES-AA, ES-AA, AA**
Package	**PG-TSSOP-16/38, PG-VQFN-24/40**

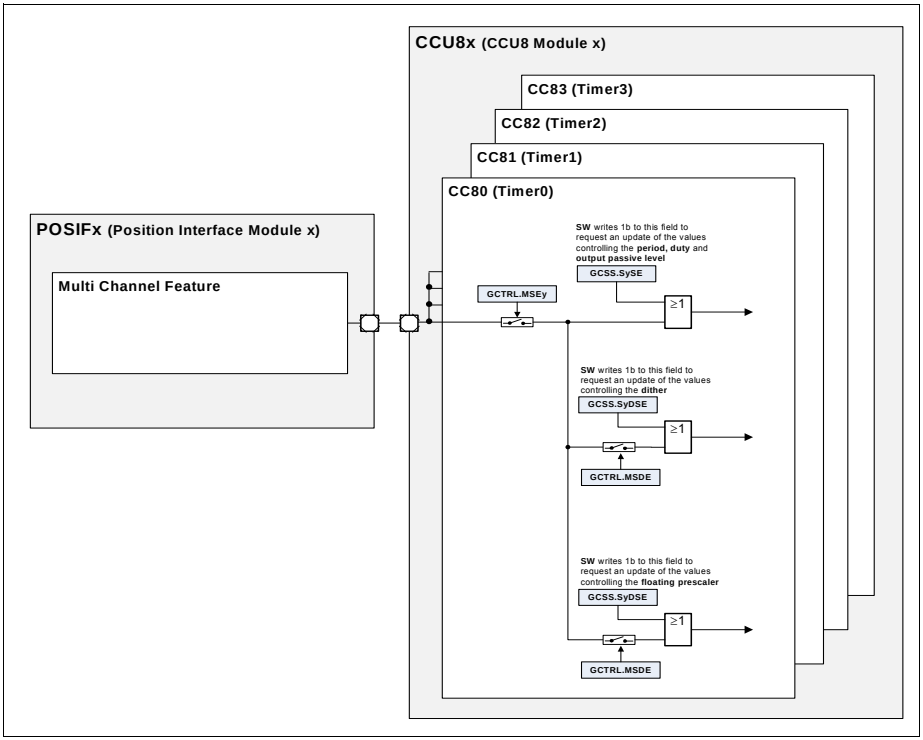
Figure 2 Value update trigger connection between CCU8x and POSIFx

On Figure 2, we see an example how this trigger is used to update at the same time teh duty cycle value of a timer inside the CCU8x and the multi channel pattern inside the POSIFx (the multi channel pattern can affect the CCU8x timer outputs therefore a synchronous update of all the values solves possible output glitches on the generated PWM signals).

On Figure 2, the SW has updated the next values for the duty cycle on a CCU8x Timer (it can be also for the period, output passive level and clock prescaler). After that it updates also the next value of the multi channel pattern inside the POSIFx module. After that, the POSIF reaches an internal state (dictated by specific conditions) where an update of the values is needed. it generates a trigger signal to the CCU8x Timer to signalize that an update of the duty cycle value needs to be done. After that timeframe, the POSIF waits for the handshake trigger of the CCU8x Timer to indicate that an update is going to be performed. At this specific time, both the values of the CCU8x Timer and POSIF are update completely synchronous.

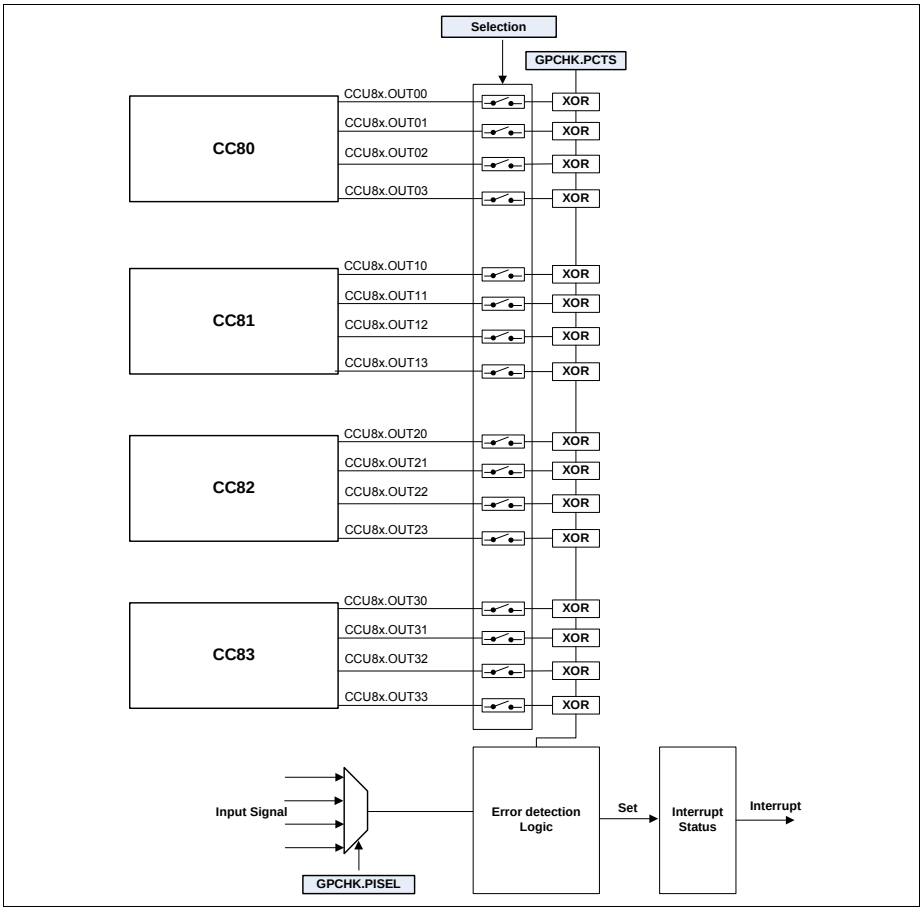
Figure 4 Parity Checker diagram

This is indeed only necessary if multiple interrupt sources are ORed together in the same interrupt line. If this is not the case and the parity checker error source is the only one associated with an interrupt line, then there is no need to read back the status information. This is due to the fact, that only one action can be triggered in the software routine, the one linked with the parity checker error.

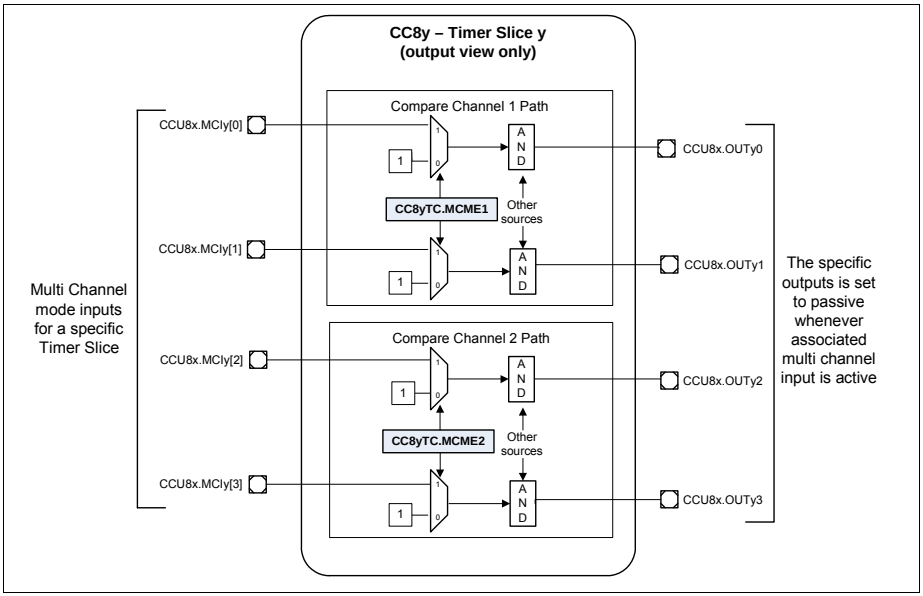
Figure 5 Multi Channel Mode diagram

After enabled, the Multi Channel mode is then controlled by several input signals, one signal per output. Whenever an input is active, the specific PWM output is set to passive level - Figure 1.

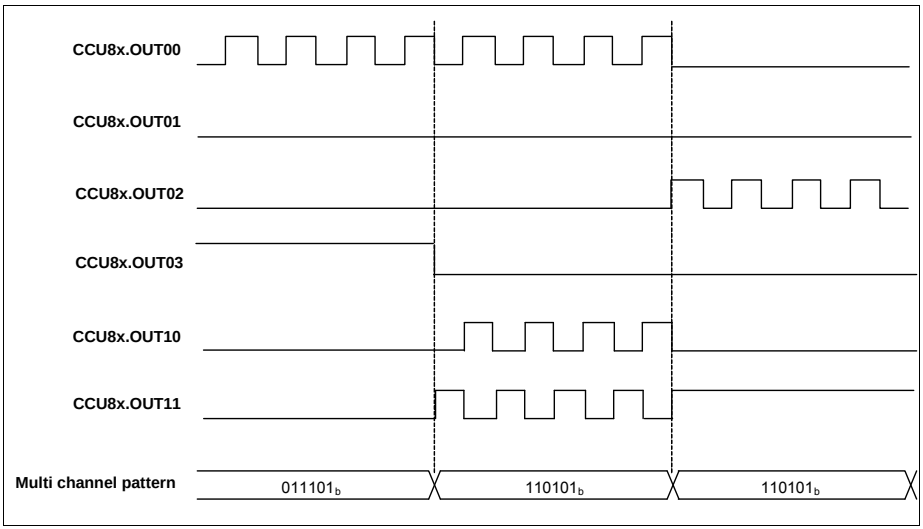
Figure 6 Multi Channel Mode applied to several CCU8 outputs

A normal use case is the parallel control of the PWM output for BLDC motor control. In Figure 2, we can see the Multi Channel Pattern being updated synchronously to the PWM signals. Whenever a multi channel input is active (in this case 0), the specific output is set into passive level (the level in which the external switch is OFF).

A glitch is present at the PWM outputs whenever the dead time of the specific compare channel is enabled - CC8yDTC.DTE1 and/or CC8yDTC.DTE2 set to 1_B (each compare channel has a separate dead time function) - and the specific multi channel pattern for the channel is 01_B or 10_B.

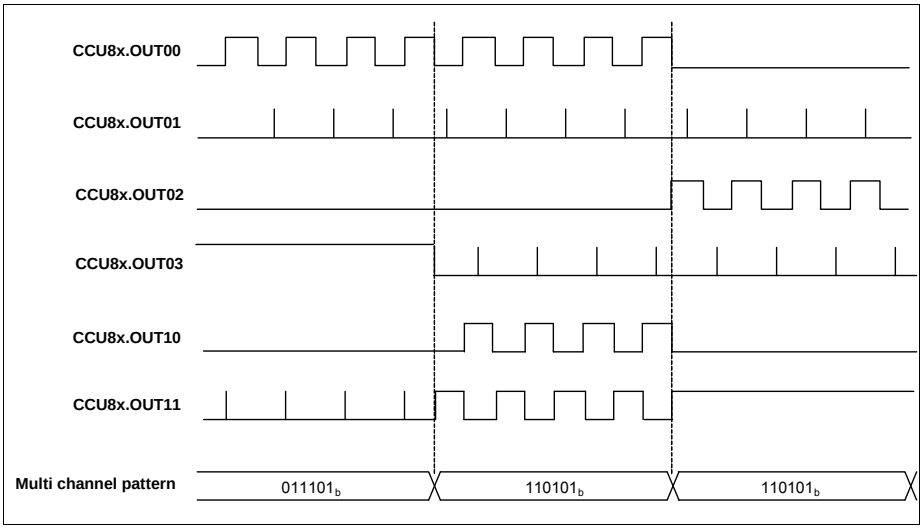
Figure 7 PWM output glitch

This glitch only affects the PWM output that is linked to the inverting ST path of each compare channel (non inverting outputs are not affected).

The effect of this glitch can be seen in Figure 3. The duration of the PWM glitch has the same length has the dead time value programmed into the CC8yDC1R.DT1F field (for compare channel 1) or into the CC8yDC1R.DT2F.

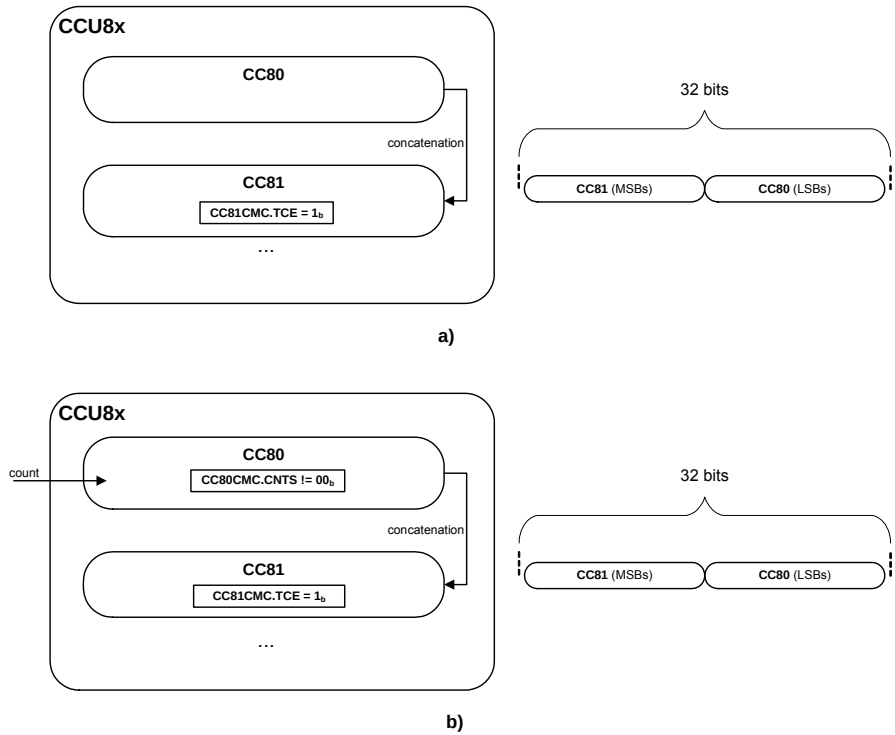
Figure 8 CCU8x concatenation feature resource configuration - a) without external count function; b) with external count function

Each CCU8 peripheral contains four sixteen bit timers. It is possible nevertheless to concatenate multiple timers to achieve a timer/counter with 32, 48 or 64 bits. To enable the concatenation feature, the CC8yCMC.TCE bitfield needs to be set to 1_B - Figure 1 a), where CCU8x represents a CCU8 peripheral instance x, and CC80 and CC81, represents timer 0 and timer 1 respectively (please notice that CC80 and CC81 are just used for simplicity, meaning that this function can be used also with the other timers inside CCU8x).

It is also possible to use an external signal as a count trigger. This means that when using an external count signal, the LSB timer is incremented each time that a transition on this external signal occurs - Figure 1 b).

Note: On Figure 1, the count signal is used in CCU80 because this timer represents the LSBs. While the count signal could be enabled in the MSB timer (CC81), this does not make sense when the timers are concatenate - because the count should be used to increment the LSB timer. The LSB timer will then in each wrap around, increment the MSB timer.

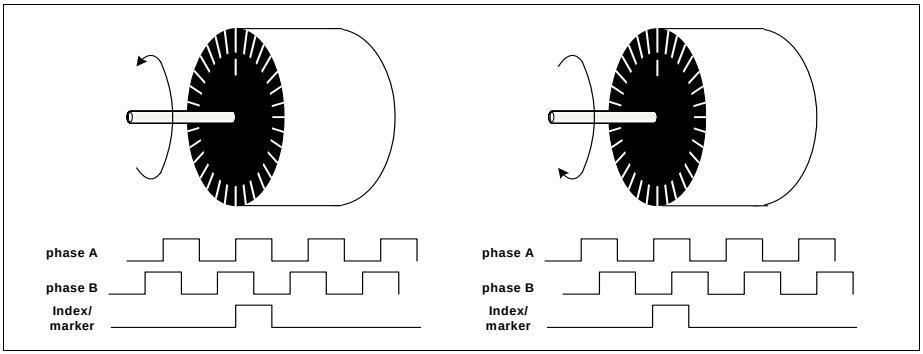
Figure 10 Different index signal types

Due to this fact it is not possible to use the POSIF to decode these type of signals (index with duration below 1/2 of the tick period).
