Errata Sheet

Rel. 1.4, 2021-01

Device	**XMC4100/XMC4200**
Marking/Step	**ES-BA, BA**
Package	**PG-VQFN-48, PG-(LT)QFP-64**

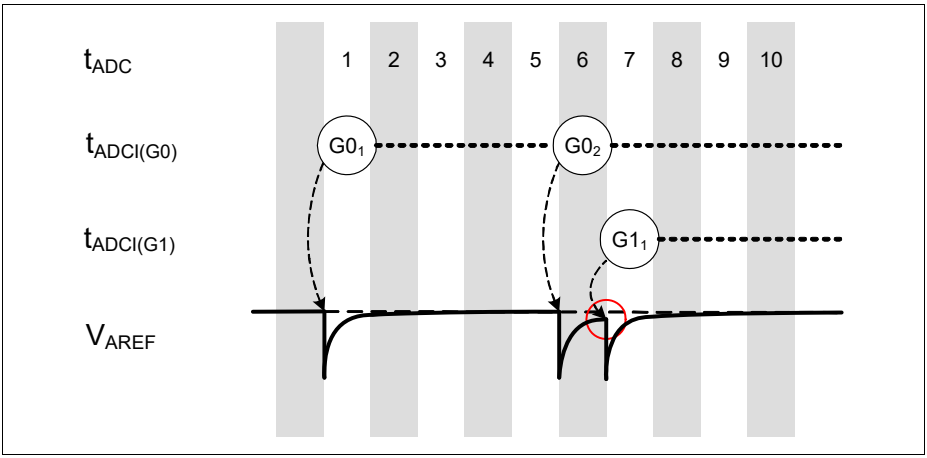
Figure 1 Influence of concurrent conversions on reference voltage

Due to this architecture, the individual prescalers may be displaced by one module clock as shown in the figure below for $G0_2$ and $G1_1$. In this example the division factor is 5 (DIVA=4).

In cycle 1 only the G0 conversion step is started. At start time the reference voltage is strobed and a certain amount of electric charge (see data sheet parameter Q_{CONV}) is consumed. This causes a drop of the reference voltage level V_{AREF}. Quantity of voltage drop depends on analog voltage level to convert.

In repeated mesurements using the example setup errors up to 25 LSB have been observed in 10-16 of 4096 conversions. Magnitude of the error however depends on the system configuration and load. The workaround therefore should be applied for all applications.

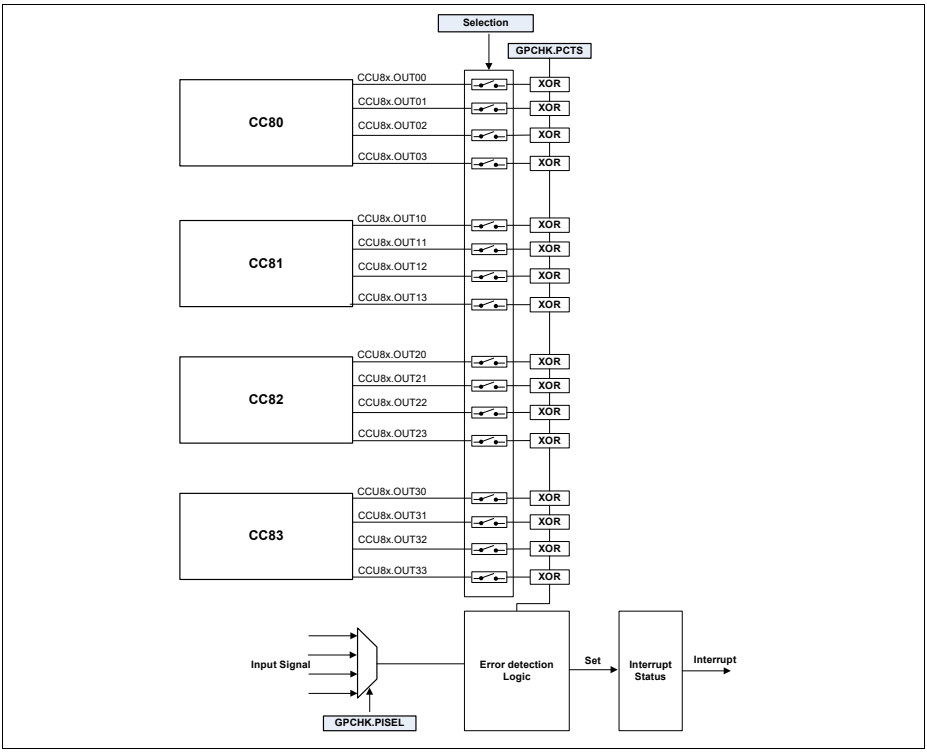
Figure 2 Parity Checker diagram

Each CCU8 module also contains a function called Parity Checker. This Parity Checker function, crosschecks the output of a XOR structure versus an input signal, as seen in Figure 1.

This is indeed only necessary if multiple interrupt sources are ORed together in the same interrupt line. If this is not the case and the parity checker error source is the only one associated with an interrupt line, then there is no need to read back the status information. This is due to the fact, that only one action can be triggered in the software routine, the one linked with the parity checker error.

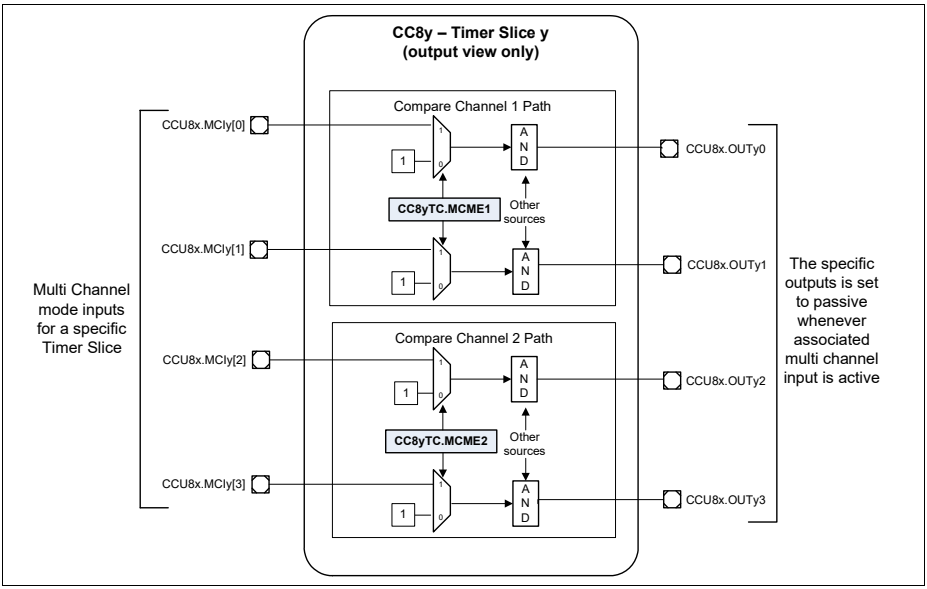
Figure 3 Multi Channel Mode diagram

After enabled, the Multi Channel mode is then controlled by several input signals, one signal per output. Whenever an input is active, the specific PWM output is set to passive level - Figure 1.

A glitch is present at the PWM outputs whenever the dead time of the specific compare channel is enabled - CC8yDTC.DTE1 and/or CC8yDTC.DTE2 set to 1_B (each compare channel has a separate dead time function) - and the specific multi channel pattern for the channel is 01_B or 10_B.

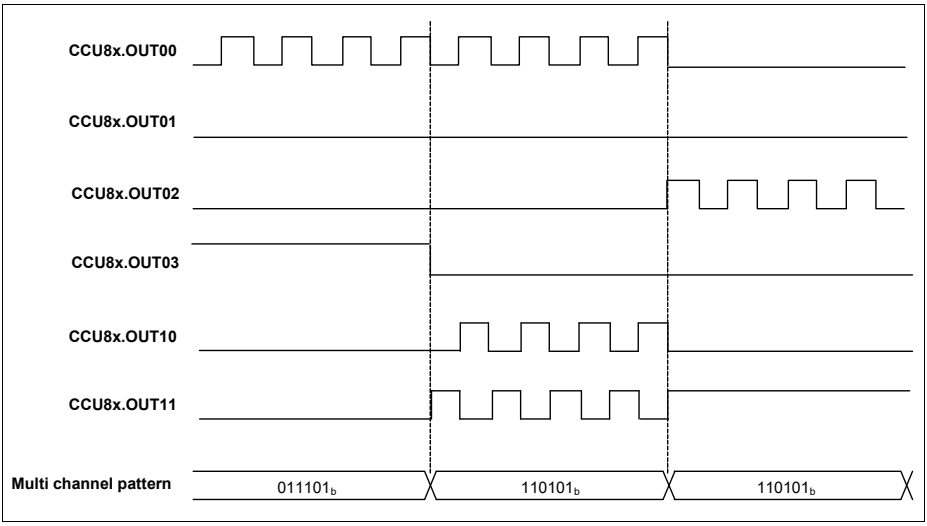
Figure 4 Multi Channel Mode applied to several CCU8 outputs

A normal use case is the parallel control of the PWM output for BLDC motor control. In Figure 2, we can see the Multi Channel Pattern being updated synchronously to the PWM signals. Whenever a multi channel input is active (in this case 0), the specific output is set into passive level (the level in which the external switch is OFF).

The effect of this glitch can be seen in Figure 3. The duration of the PWM glitch has the same length has the dead time value programmed into the CC8yDC1R.DT1F field (for compare channel 1) or into the CC8yDC1R.DT2F.

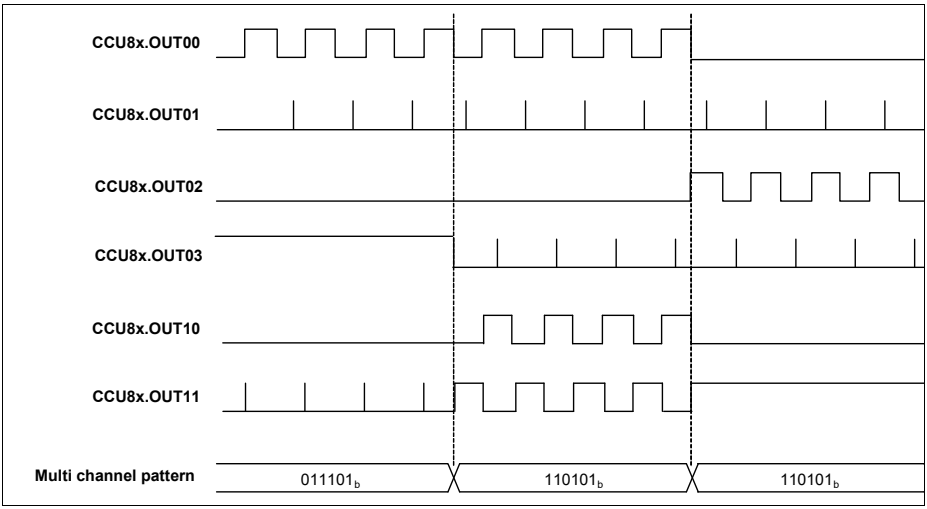
Figure 5 PWM output glitch

This glitch only affects the PWM output that is linked to the inverting ST path of each compare channel (non inverting outputs are not affected).

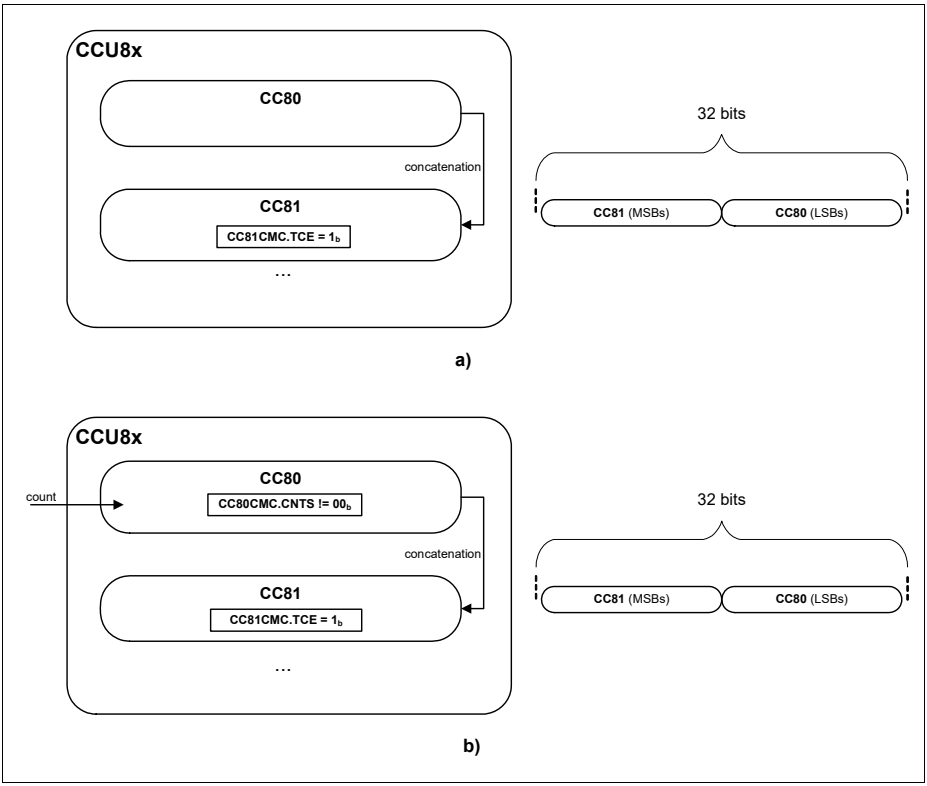
Figure 6 CCU8x concatenation feature resource configuration - a) without external count function; b) with external count function

Each CCU8 peripheral contains four sixteen bit timers. It is possible nevertheless to concatenate multiple timers to achieve a timer/counter with 32, 48 or 64 bits. To enable the concatenation feature, the CC8yCMC.TCE bitfield needs to be set to 1_B - Figure 1 a), where CCU8x represents a CCU8 peripheral instance x, and CC80 and CC81, represents timer 0 and timer 1 respectively (please notice that CC80 and CC81 are just used for simplicity, meaning that this function can be used also with the other timers inside CCU8x).

It is also possible to use an external signal as a count trigger. This means that when using an external count signal, the LSB timer is incremented each time that a transition on this external signal occurs - Figure 1 b).

Note: On Figure 1, the count signal is used in CCU80 because this timer represents the LSBs. While the count signal could be enabled in the MSB timer (CC81), this does not make sense when the timers are concatenate - because the count should be used to increment the LSB timer. The LSB timer will then in each wrap around, increment the MSB timer.

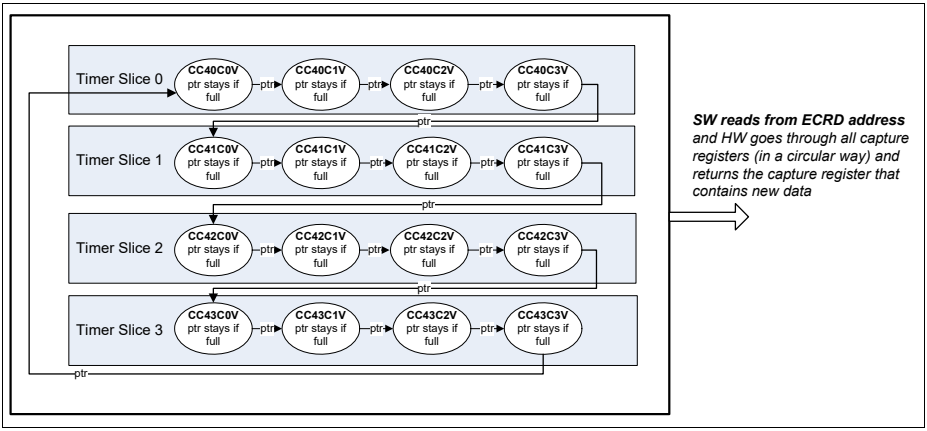
Figure 7 Extended Read Back access - example for CCU4 (CCU8 structure is the same)

Referring to **Figure 7**, the hardware every time that the software reads back from the ECRD address, will return the immediately next capture register that contains new data. This is done in a circular access, that contains all the capture registers from the Timer Slices that are working in capture mode.

- Timer X and Timer Y have 4 capture registers each and they are both configured with ECM = 1_B. At the moment that the software starts reading the capture registers via the ECRD address, we have already capture two values on Timer X and 4 on Timer Y. The ECRD read back will output CC4xC0V -> CC4xC1V -> CC4xC2V -> CC4xC3V -> CC4yC2V -> CC4yC2V (CC4yC3V value is lost)

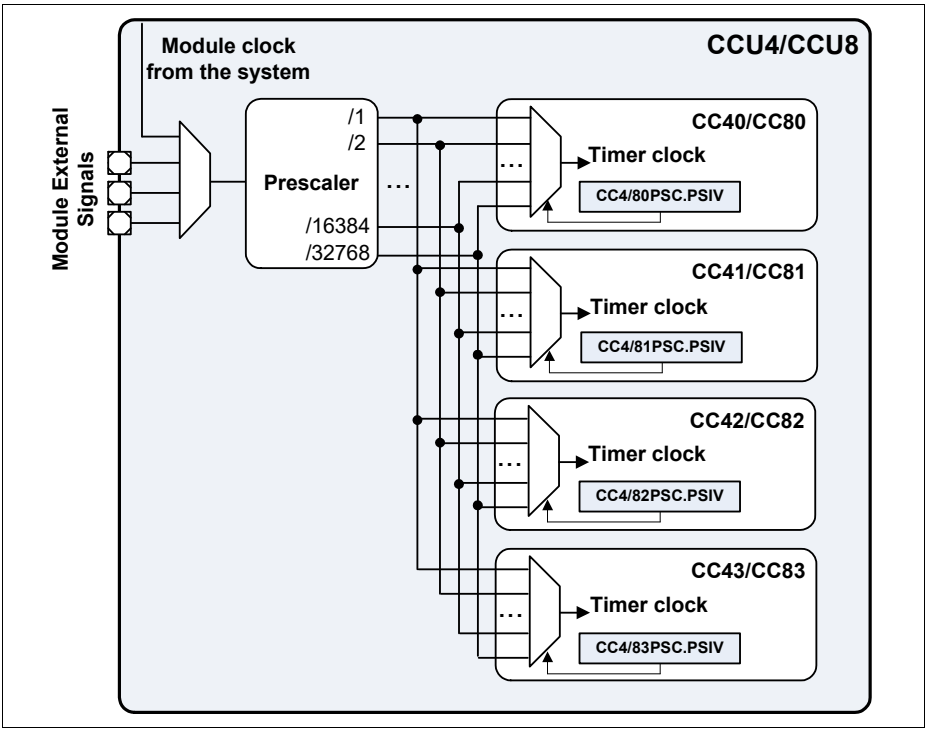
Figure 8 Clock Selection Diagram for CCU4/CCU8

Each CCU4/CCU8 module offers the possibility of selecting an external signal to be used as the master clock for every timer inside the module Figure 1. External signal in this context is understood as a signal connected to other module/IP or connected to the device ports.

This is only applicable if the Module Clock provided by the system (the normal default configuration and use case scenario) is not being used. In the case that the normal clock configured and programmed at system level is being used, there is not any type of constraints.

One should not also confuse the usage of an external signal as clock for the module with the usage of an external signal for counting. These two features are completely unrelated and there are not any dependencies between both.

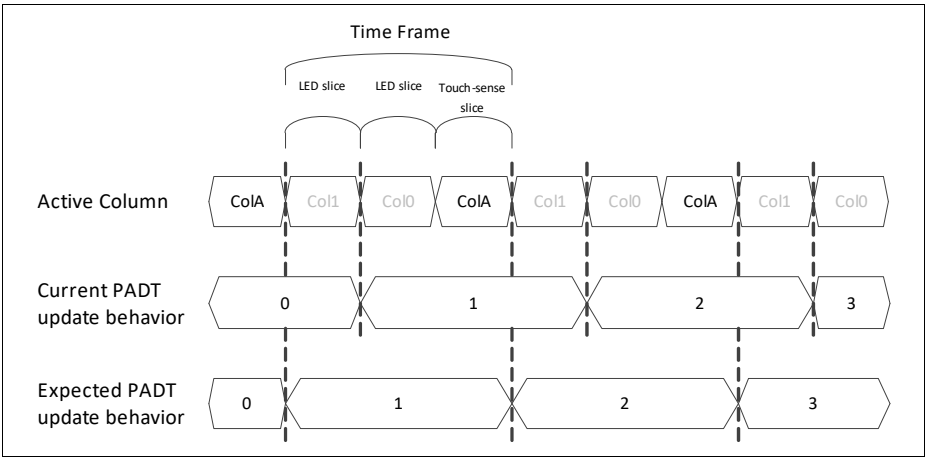
Figure 9 PADT update behavior

LEDTS_AI.001 Delay in the update of FNCTL.PADT bit field

The touch-sense pad turn (PADT) value is updated, not at the end of the touch-sense time slice (ColA), but one time slice later (**Figure 9**).

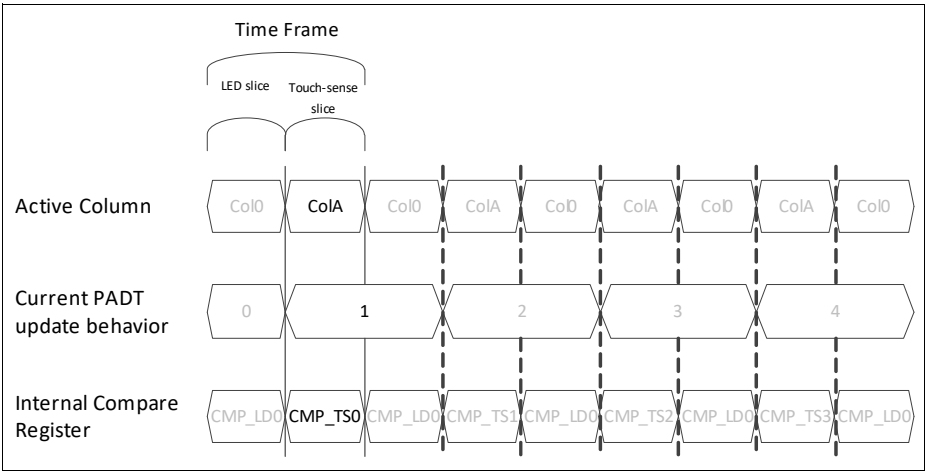
Figure 10 Effect of delay on the update of Internal Compare Register with 1 LED column enabled

If the number of LED columns enabled is smaller than 2, the delay will affect the activation period of the current active pad. At the beginning of every new Col A, the value of the current PADT's compare register is updated to the internal compare register. However, the delay causes the value of the previous PADT's compare register is updated to the internal compare register instead. This means that the current active pad would be activated with the duration of the previous pad's oscillation window (**Figure 10**). In addition to this, when no LEDs are enabled, pad turn 0 will prevail for one time slice longer before it gets updated (**Figure 11**).

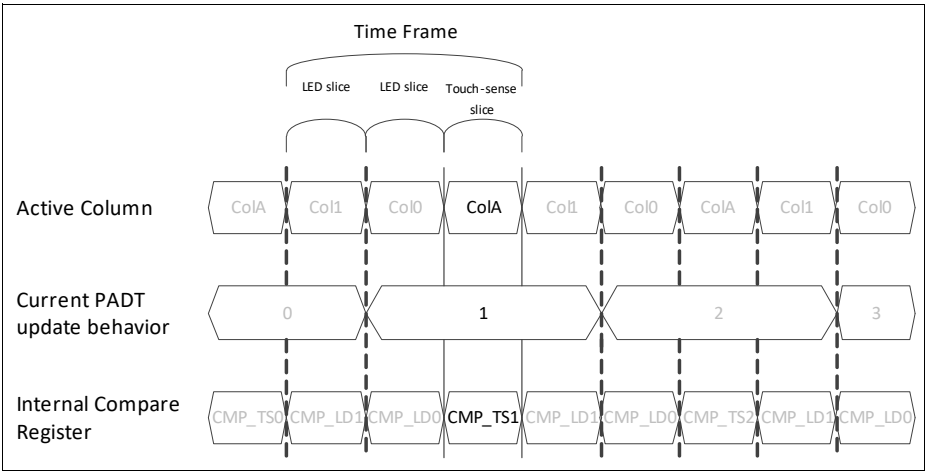
Figure 12 Internal Compare Register updated with correct compare register value with 2 LED columns enabled

If the number of LED columns enabled is 2 or more, the additional LED columns would provide some buffer time for the delay. So, at the start of a new touch-sense time slice, the update of PADT value would have taken place. Hence, the current active PADT compare register value is updated to the internal compare register (**Figure 12**).

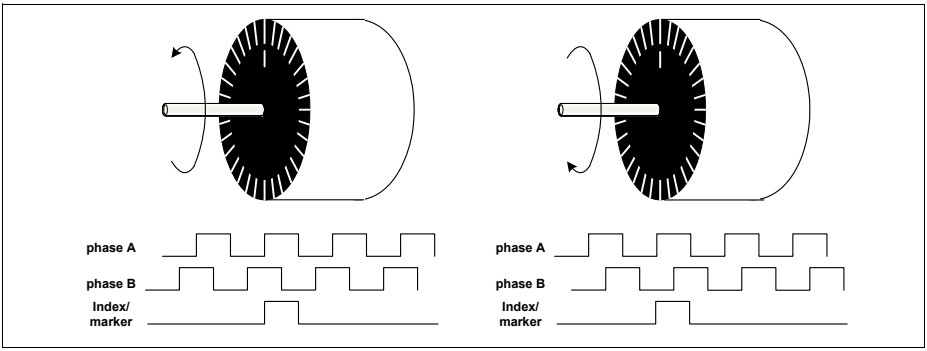
Figure 14 Rotary Encoder outputs - Phase A, Phase B and Index

POSIF_AI.001 Input Index signal from Rotary Encoder is not decoded when the length is 1/4 of the tick period

Each POSIF module can be used as an input interface for a Rotary Encoder. It is possible to configure the POSIF module to decode 3 different signals: Phase A, Phase B (these two signals are 90° out of phase) and Index. The index signal is normally understood as the marker for the zero position of the motor Figure 1.

When the index signal is smaller than 1/2 of the tick period, the POSIF module is not able to decode this signal properly, Figure 2 - notice that the reference edge of the index generation in this figure is the falling of Phase B, nevertheless this is an example and depending on the encoder type, this edge may be one of the other three.

To make usage of the Index signal, when the length of this signal is less than 1/2 of the tick period, one should connect it directly to the specific counter/timer. This connection should be done at port level of the device (e.g. connecting the device port to the specific Timer/Counter(s)), Figure 3.

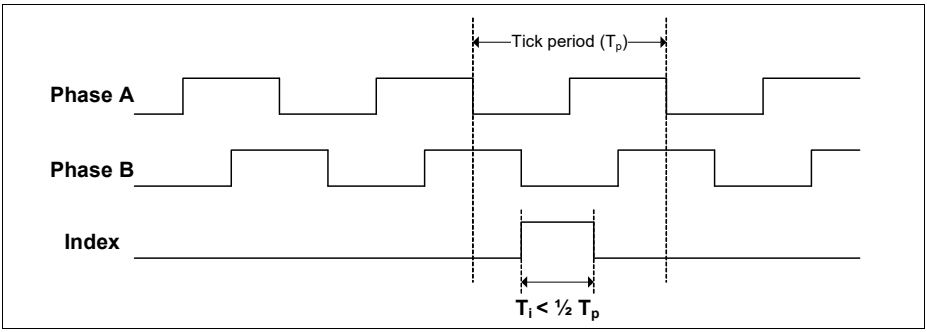
Figure 15 Different index signal types

Due to this fact it is not possible to use the POSIF to decode these type of signals (index with duration below 1/2 of the tick period).

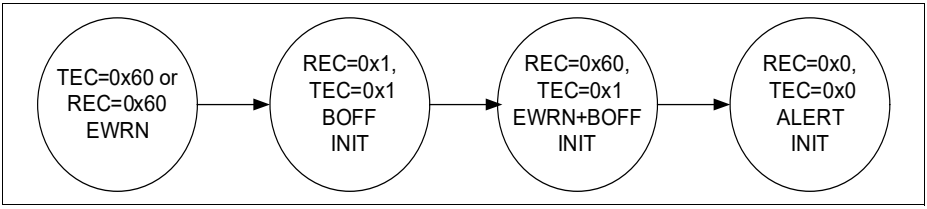
Figure 17 Alert Interrupt Behavior in case of Bus-Off

MultiCAN_AI.H007 Alert Interrupt Behavior in case of Bus-Off

The MultiCAN module shows the following behavior in case of a bus-off status:

When the threshold for error warning (EWRN) is reached (default value of Error Warning Level EWRN = 0x60), then the EWRN interrupt is issued. The bus-off (BOFF) status is reached if TEC > 255 according to CAN specification, changing the MultiCAN module with REC and TEC to the same value 0x1, setting the INIT bit to 1_B, and issuing the BOFF interrupt. The bus-off recovery phase starts automatically. Every time an idle time is seen, REC is incremented. If REC = 0x60, a combined status EWRN+BOFF is reached. The corresponding interrupt can also be seen as a pre-warning interrupt, that the bus-off recovery phase will be finished soon. When the bus-off recovery phase has finished (128 times idle time have been seen on the bus), EWRN and BOFF are cleared, the ALERT interrupt bit is set and the INIT bit is still set.

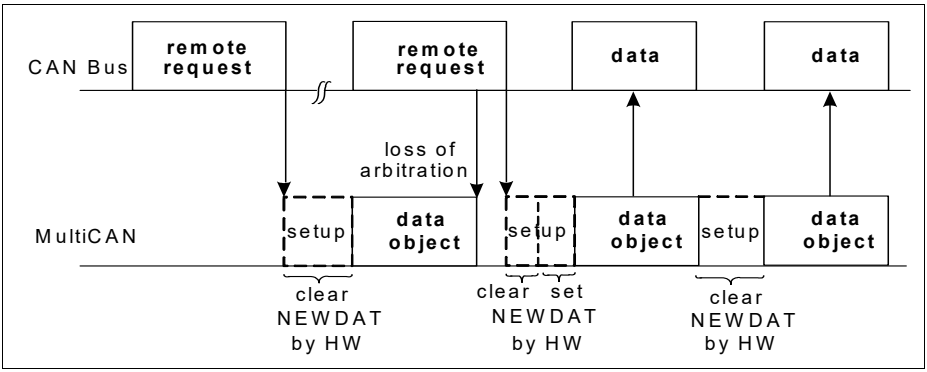
Figure 18 Loss of Arbitration

When the appropriate message object (data frame) triggered by the first remote frame wins the arbitration, it will be sent out and NEWDAT is not reset. This leads to an additional data frame, that will be sent by this message object (clearing NEWDAT).

There will, however, not be more data frames than there are corresponding remote requests.

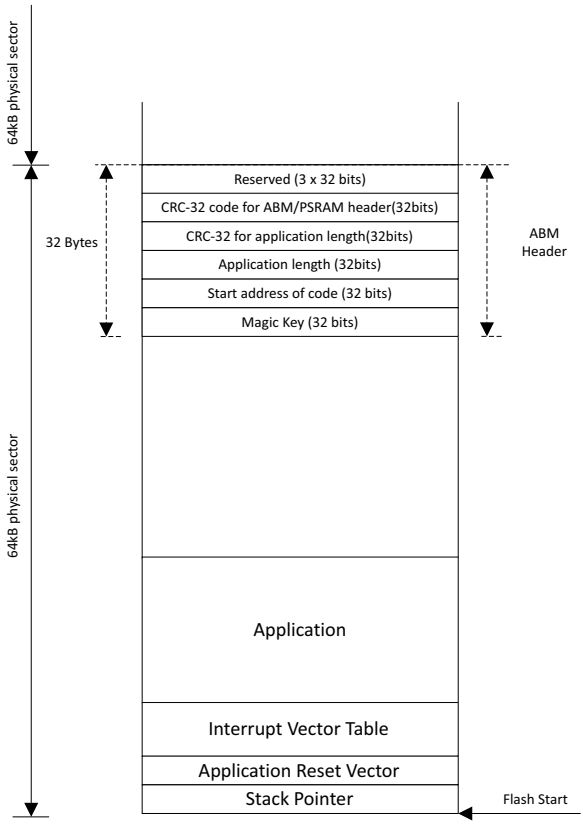
Figure 19 ABM/PSRAM Header - Location of reserved bytes

The following figure provides a detailed view on the location of the reserved bytes:
