Errata Sheet

Rel. 1.1, 2012-04-04

Device	**TC1724F/N, TC1728F/N**
Marking/Step	**ES-AB, AB**
Package	**see Data Sheet**

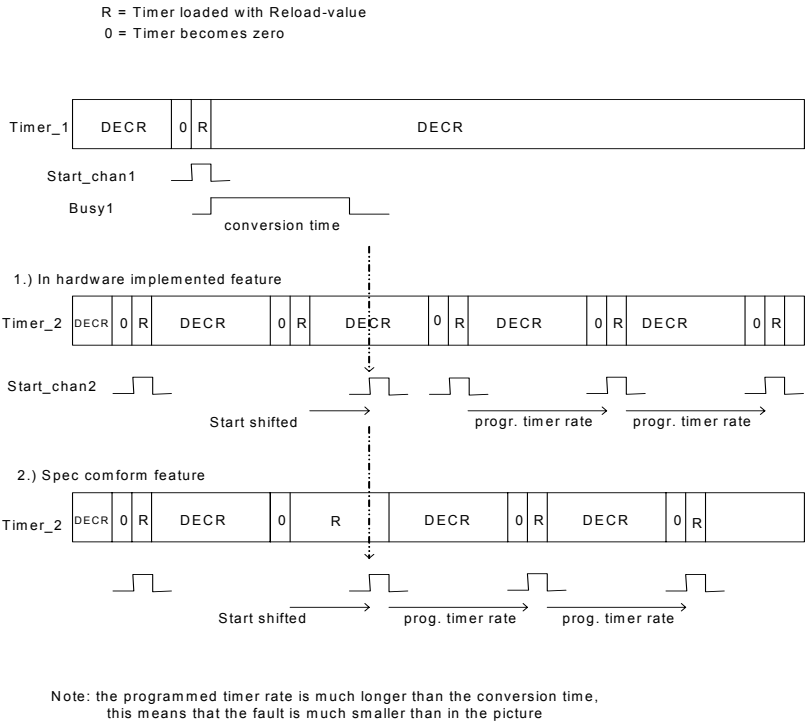
Figure 1 Timing concerning equidistant multiple timers

The correct behavior would be a reload when the requested conversion (of channel_2) is started.

Therefore the start of conversion for channel_2 is delayed by maximum one conversion-time. After this delay it will be continued with equidistant conversion-starts. Please refer to the following figure.

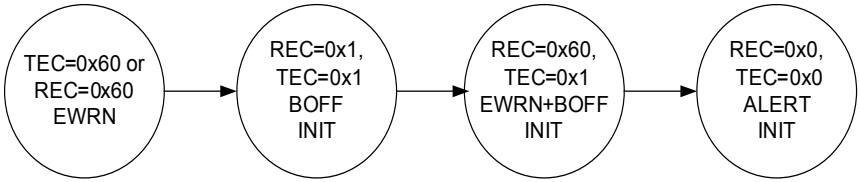
Figure 2 Alert Interrupt Behavior in case of Bus-Off

The MultiCAN module shows the following behavior in case of a bus-off status:

When the threshold for error warning (EWRN) is reached (default value of Error Warning Level EWRN = 0x60), then the EWRN interrupt is issued. The bus-off (BOFF) status is reached if TEC > 255 according to CAN specification, changing the MultiCAN module with REC and TEC to the same value 0x1, setting the INIT bit to 1_B, and issuing the BOFF interrupt. The bus-off recovery phase starts automatically. Every time an idle time is seen, REC is incremented. If REC = 0x60, a combined status EWRN+BOFF is reached. The corresponding interrupt can also be seen as a pre-warning interrupt, that the bus-off recovery

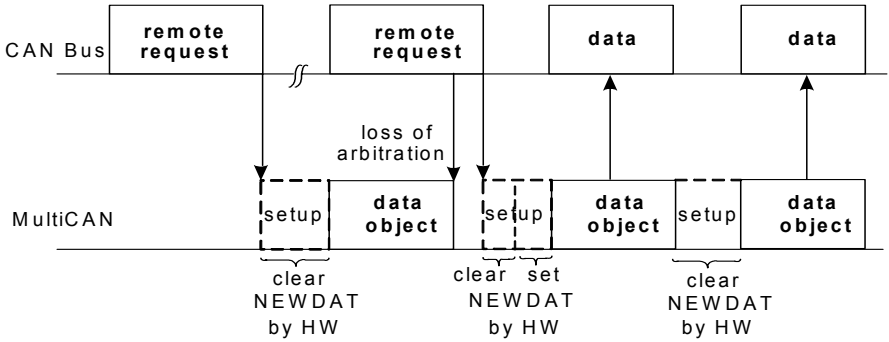
Figure 3 Loss of Arbitration

When the appropriate message object (data frame) triggered by the first remote frame wins the arbitration, it will be sent out and NEWDAT is not reset. This leads to an additional data frame, that will be sent by this message object (clearing NEWDAT).

There will, however, not be more data frames than there are corresponding remote requests.

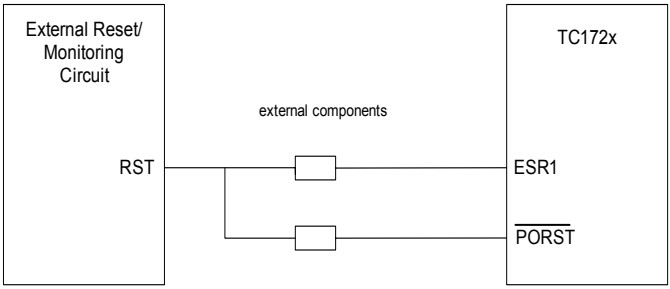
Figure 4 $\overline{\text{PORST}}$ Redundancy Path

FMEA considerations of such a failure mode recommend that the device is set into a safe reset state when $\overline{\text{PORST}}$ cannot be activated from external devices (voltage regulators, safety monitors) in case critical failures are observed in the system and the microcontroller needs to be set into reset as a result.

a) Connect the reset line additionally to the ESR1 pin (or other appropriate pins) to provide a redundant path to detect such a failure mode.

b) Activate internal voltage monitoring for external supply which acts as a redundant supply watchdog in addition to the supply monitoring carried out by the external regulator.
