Errata Sheet

Rel. 1.2, 26.02.2010

Device	**TC1736**
Marking/Step	**EES-AA, ES-AA, AA**
Package	**PG-LQFP-144-10**

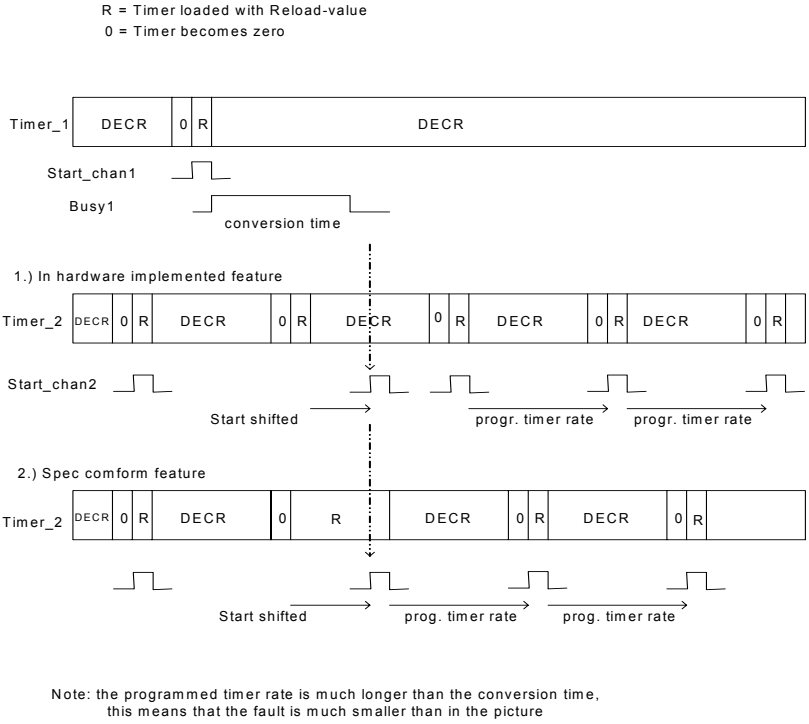
Figure 1 Timing concerning equidistant multiple timers

The correct behavior would be a reload when the requested conversion (of channel_2) is started.

Therefore the start of conversion for channel_2 is delayed by maximum one conversion-time. After this delay it will be continued with equidistant conversion-starts. Please refer to the following figure.

Workaround

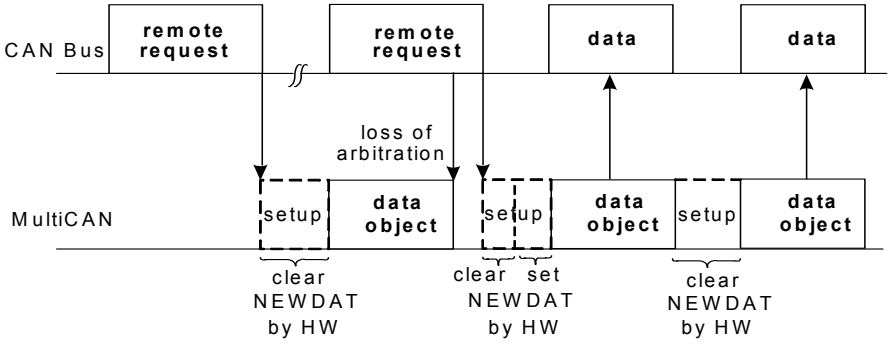
Figure 2 Loss of Arbitration

When the appropriate message object (data frame) triggered by the first remote frame wins the arbitration, it will be sent out and NEWDAT is not reset. This leads to an additional data frame, that will be sent by this message object (clearing NEWDAT).

There will, however, not be more data frames than there are corresponding remote requests.
