Errata Sheet

Rel. 1.3, 2014-02-21

Device	**TC1762**
Marking/Step	**EES-AC, ES-AC, AC**
Package	**PG-LQFP-176-2**

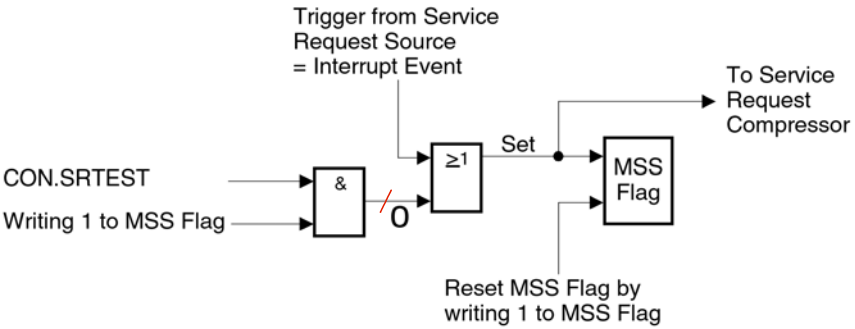
Figure 1

ADC_TC.023 Setting the MSS-flag doesn't generate an interrupt in TEST-MODE

It is possible to generate a software triggered interrupt event in TESTMODE (`ADCx_CON.SRTEST=1`) by setting one of the bitflags in register `ADCx_MSS0/1`. Due to the fact, that this mechanism is not working, it is not possible to generate a corresponding interrupt by software.

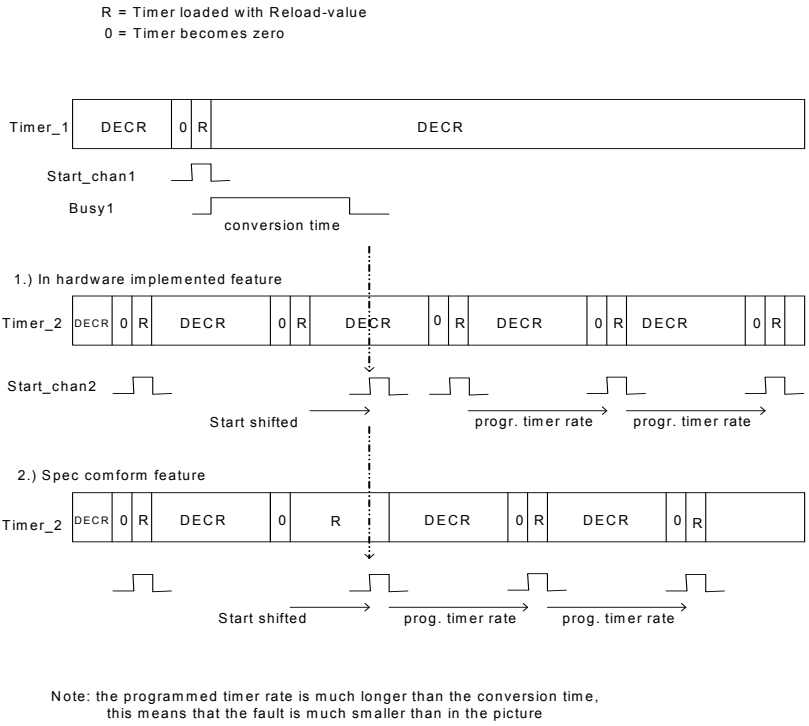
Figure 2 Timing concerning equidistant multiple timers

The correct behavior would be a reload when the requested conversion (of channel_2) is started.

Therefore the start of conversion for channel_2 is delayed by maximum one conversion-time. After this delay it will be continued with equidistant conversion-starts. Please refer to the following figure.

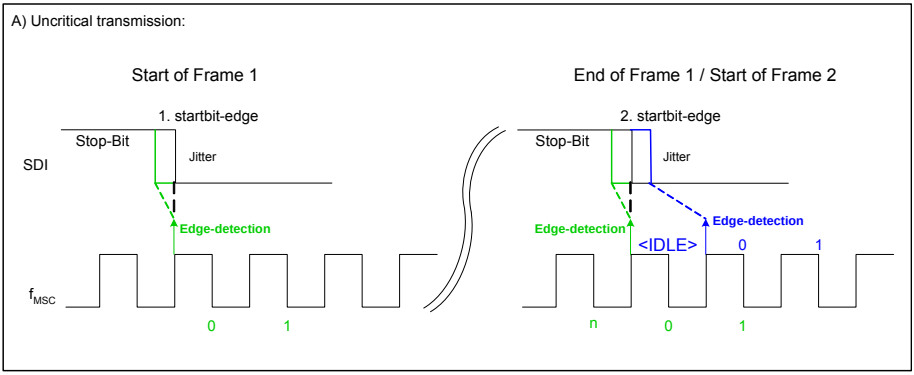
Figure 3 Uncritical transmission

As the falling startbit edge is shifted to the left of the rising clock edge (**Figure 3** left), there occurs a secure detection of the next start-bit edge in the last cycle of the previous frame (here cycle n, **Figure 3** right) independant from the applied jitter to this edge.

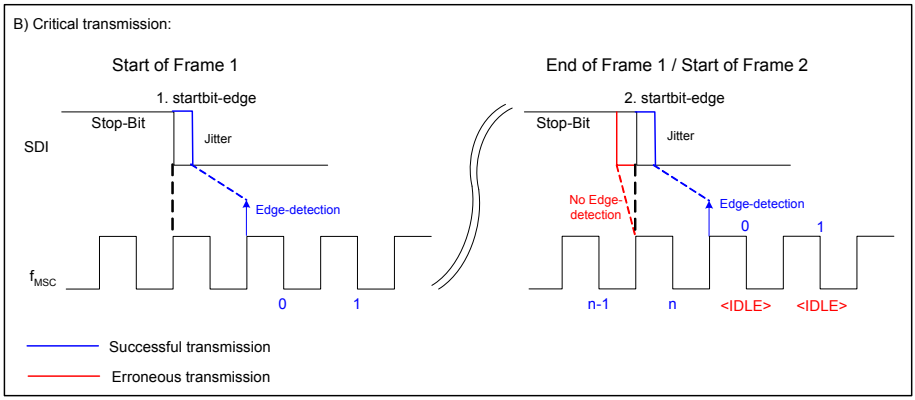
Figure 4 Critical transmission

If the high-low edge of the start-bit in the first frame is just not detected by the near clock-edge (**Figure 4** - left) and the start-bit edge of the second frame is jittering to cycle n-1 (**Figure 4** - right, red coloured), then an erroneous transmission will take place. In this case the state-machine switches to IDLE after the last state n and wakes up on the next falling edge that may be a data-bit recognized as a start-bit. If the start-bit of the second frame is jittering to cycle n (**Figure 4** - right, blue colored), then the state-machine will not switch to IDLE but will start receiving the next frame correctly.

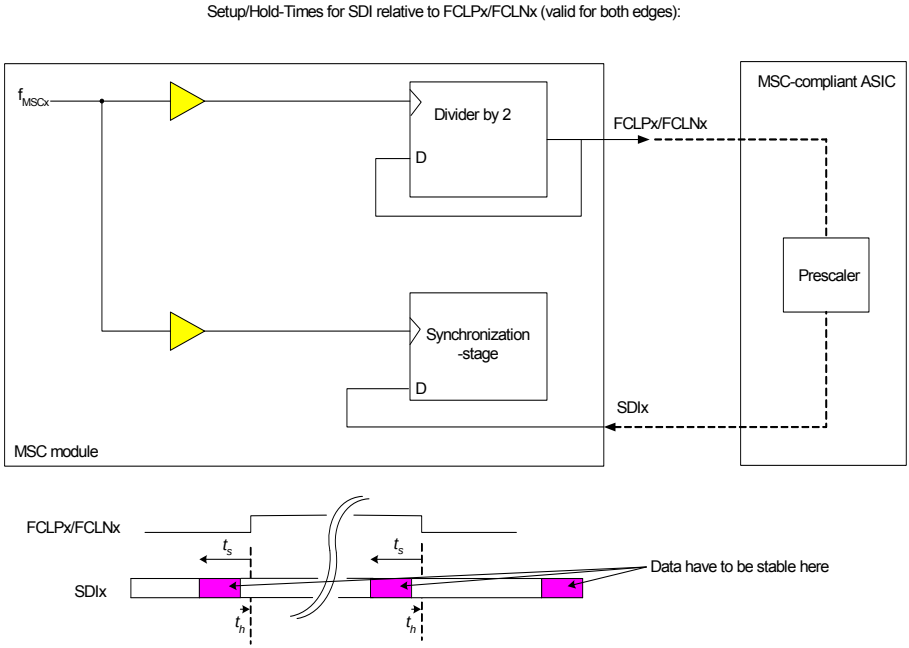
Figure 5 Delay adjustment relative to the module clock

The delay depends on the maximal skew in the data-stream. For this workaround the downstream clock FCLPx/FCLNx can be measured as reference and the data stream at the input of the upstream channel SDIx has to be adjusted according to the setup- and hold-times of the input-pins SDIx.

Figure 5 shows the principle blockdiagram of the input synchronization stage of the MSC module.

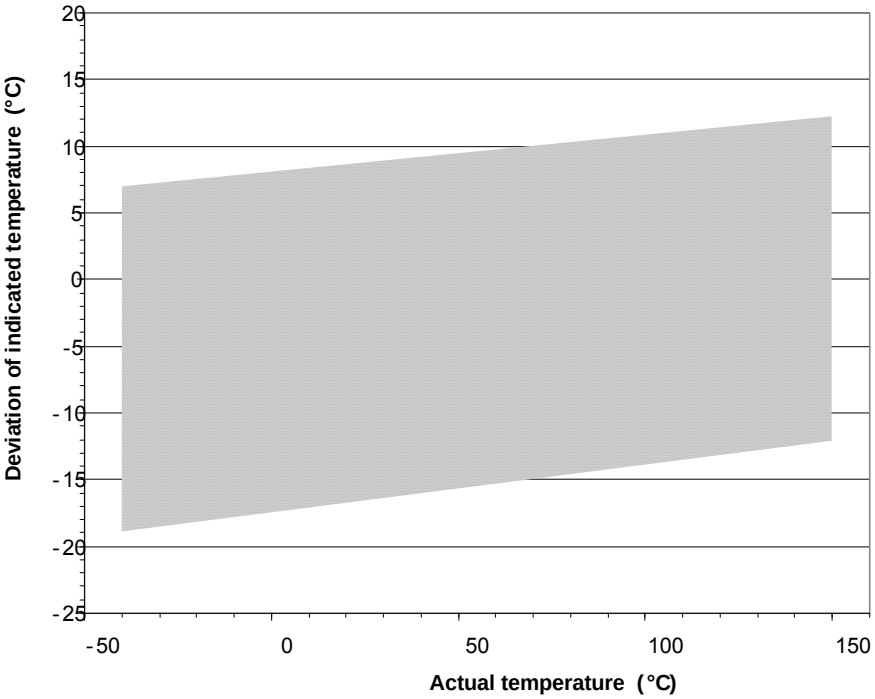
Figure 9 Current accuracy range

The deviation using these formulas is:

- +/-12°C at T_J = 150°C
- +9/-17°C at T_J = 25°C
- +7/-19°C at T_J = -40°C

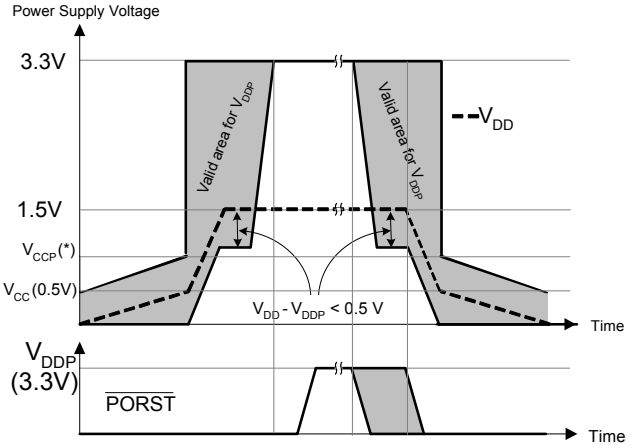
Figure 10 Exemplary power-up/down sequence

As per Data Sheet, V_{DD} - V_{DDP} < 0.5 V has to be valid at any time in order to avoid increased latch-up risk. The figure below shows the possible V_{DDP} values as shaded region for an exemplary V_{DD} ramp. Moreover, the following rules apply:

- All analog voltages (V_{DDOSC3}, V_{DDM}, V_{DDMF}, V_{DDFL3}) must also follow V_{DDP} power-up/down sequence.
- V_{DDAF}, V_{DDOSC} must follow V_{DD} power-up/down sequence.
- The absolute value of the maximum allowed deviation between any two supplies is 0.5 V while the 1.5V supplies are below their specified operating conditions.

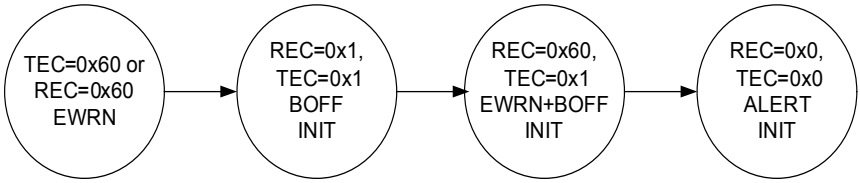
Figure 11 Alert Interrupt Behavior in case of Bus-Off

The MultiCAN module shows the following behavior in case of a bus-off status:

When the threshold for error warning (EWRN) is reached (default value of Error Warning Level EWRN = 0x60), then the EWRN interrupt is issued. The bus-off (BOFF) status is reached if TEC > 255 according to CAN specification, changing the MultiCAN module with REC and TEC to the same value 0x1, setting the INIT bit to 1_B, and issuing the BOFF interrupt. The bus-off recovery phase starts automatically. Every time an idle time is seen, REC is incremented. If REC = 0x60, a combined status EWRN+BOFF is reached. The corresponding interrupt can also be seen as a pre-warning interrupt, that the bus-off recovery phase will be finished soon. When the bus-off recovery phase has finished (128 times idle time have been seen on the bus), EWRN and BOFF are cleared, the ALERT interrupt bit is set and the INIT bit is still set.

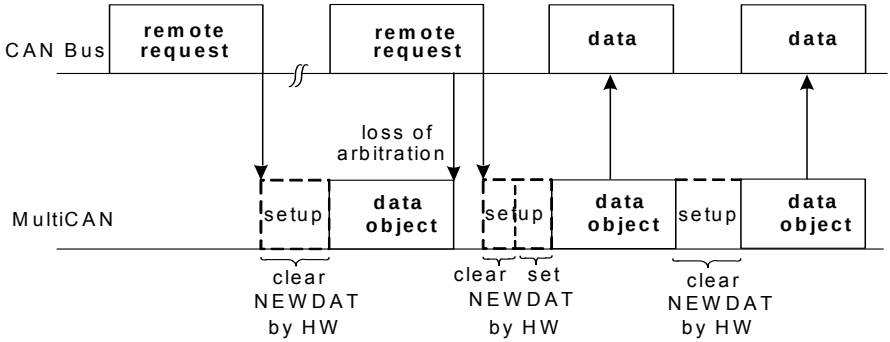
Figure 12 Loss of Arbitration

When the appropriate message object (data frame) triggered by the first remote frame wins the arbitration, it will be sent out and NEWDAT is not reset. This leads to an additional data frame, that will be sent by this message object (clearing NEWDAT).

There will, however, not be more data frames than there are corresponding remote requests.
